# LEAKAGE, EVAPORATION AND SEDIMENTATION AFFECTING WATER STORAGE IN ARID AREAS: CASE STUDIES OF THE FOUM EL GHERZA AND GARGAR DAMS, ALGERIA

Benfetta H. N. E.<sup>1</sup> and Ouadja A.<sup>2</sup>

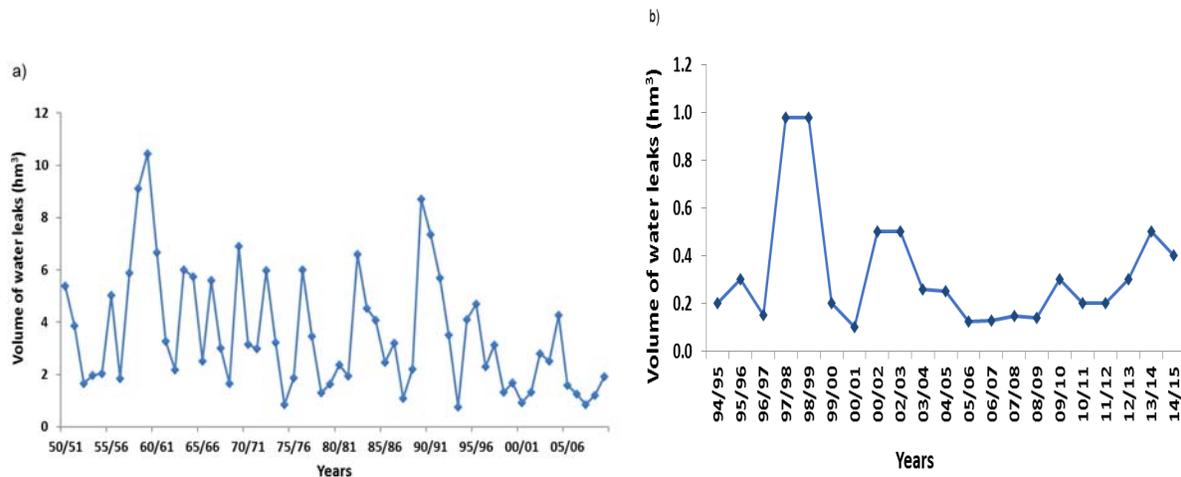
In this section, we consider the variations in total volume of leakage and leakage flow and their associations with variations in volume and lake water level of the two reservoirs. In Figure-7a, we present the variation of the volume of leakage at Foum el Gherza over time for hydrological years from 1950 to 2010. Just after the dam filling in 1952, leakages started to appear immediately downstream of the dam (1.6 million m<sup>3</sup> in 1952/53 and 2.0 million m<sup>3</sup> for the next two years). Construction was then resumed between 1954 and 1957 including reinforcement of the hydraulic works and the injection of a grouting curtain. Large leakages of 10.44 and 8.71 hm<sup>3</sup> occurred in 1959/1960 and 1989/1990 because of the deterioration of the grouting curtain and the increased precipitation during those years. These increases in leaks suggest that the waterproofing effect of the grouting curtain is no longer effective, allowing further deterioration in the underlying massif and foundations of the dam. However, reduction of precipitation led to a corresponding decrease in water leakage in later years [5] [20].

The average annual loss of water through leakage at the Gargar dam was 0.3 hm<sup>3</sup> year<sup>-1</sup>. Figure-7b shows leakage volume estimated by the ANDT for the period 1994-2015 and highlights significant variation over time with leakage volumes peaking in 1997-1999 because of increased precipitation.

**Figure-7.** Total annual leakage calculated for the (a) Foum el Gherza and (b) Gargar dams; source: own study.

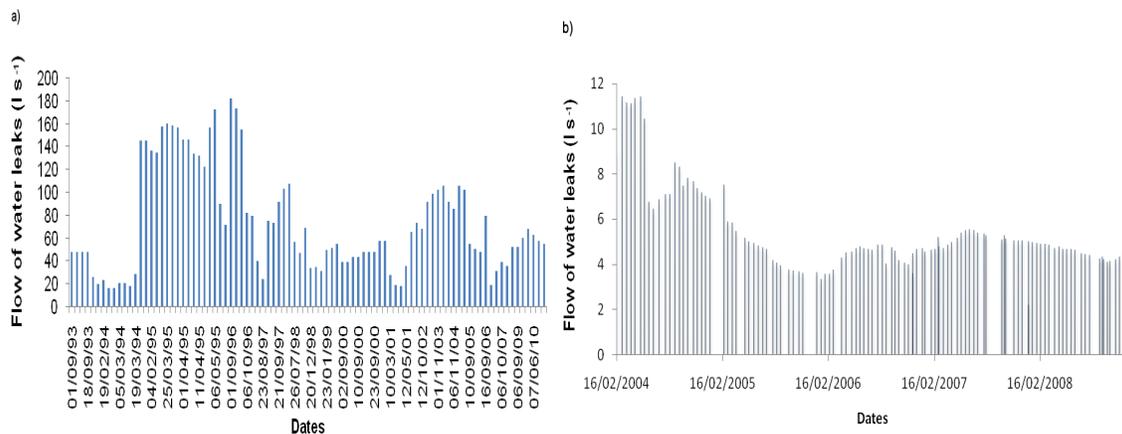
In Figure-8a, we consider leakage according to flow rate. Water leakage flow increased from 56 L s<sup>-1</sup> in 1993 to 180-190 L s<sup>-1</sup> in 1996; however, the reduction of the water volume in the reservoir caused substantial decreases in leakage flow, reaching 20 L s<sup>-1</sup> by March 1994 and 10 L s<sup>-1</sup> by August 1997. The total flow increased steadily after 1994 and later reached record values exceeding 180 L s<sup>-1</sup>. The decrease or increase of leakage flow primarily occurs according to the progressive reduction or gradual increase in the volume of water in the reservoir. We identified a clear positive relationship

Figure-8b indicates leakages in terms of flow rate. Maximum leakage of  $8.5 \text{ L s}^{-1}$  was recorded in February 2004, reaching  $12 \text{ L s}^{-1}$  in May 2004. Levels subsequently decreased due to falling water levels in the reservoir, reaching  $2.25 \text{ L s}^{-1}$  in January 2008 [2]. We further assessed leakage flow from the two banks separately. Flow rate through the left bank exceeded  $4.3 \text{ L s}^{-1}$  in February 2004, reaching  $5.98 \text{ L s}^{-1}$  in May 2004. The flow rate subsequently decreased, due to the reduction in the volume of water in the reservoir, reaching  $0.81 \text{ L s}^{-1}$  in January 2006. The flow rate through the right bank exceeded  $4.6 \text{ L s}^{-1}$  in February 2004, reaching the same value as the right bank ( $5.98 \text{ L s}^{-1}$ ) in May 2004. Like the

left bank, the reduction in the volume of water in the reservoir led to a considerable decrease in the flow rate, reaching  $2.25 \text{ L s}^{-1}$  in November 2006. The upstream body of water at the foot of the dam is separated from the basin by a cofferdam. Although leaks were observed in the joints of the injection and drainage galleries of both banks, they were greater in the right bank. This is because the right bank is in contact with the reservoir, while the left bank is in contact with the body of water located upstream of the dam. Leakage in the two galleries increases as a function of reservoir level increase and decreases due to sealing after a long period. Some leaks are sealed by the adhesion of molten limestone [1] [2].

**Figure-8.** Variation of leakage flow rate over time calculated for the (a) Foum el Gherza and (b) Gargar dams; source: own study.

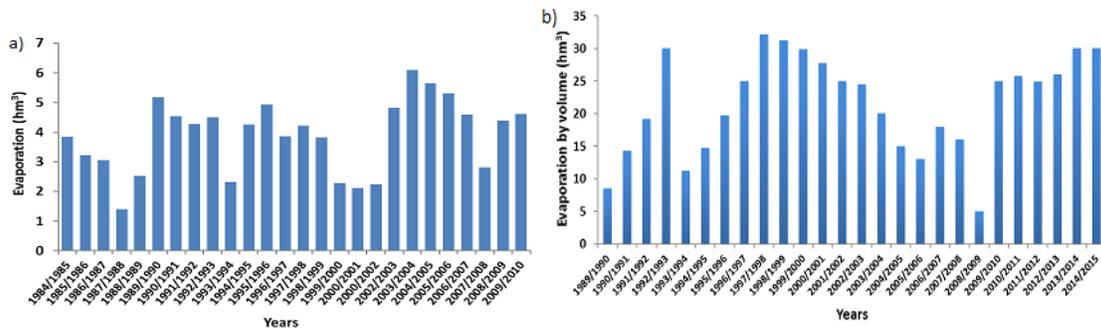
Figure-9a shows the evaporation losses provided by the ADNT for the Foug el Gherza dam. The evaporation losses ranged from 0.98 to 6.64 hm<sup>3</sup> year<sup>-1</sup> and the annual average value was approximately 3.8 hm<sup>3</sup>. The volume lost by the evaporation of the lake and the leaks through banks is similar to that required for the irrigation of date palms (~10 hm<sup>3</sup> year<sup>-1</sup>). In 1998/1999, a particularly dry year, the evaporated volume (5 hm<sup>3</sup>) was twice that intended for irrigation that year.

The analyses presented here are based on operational data provided by the ADNT for the period 1989-2015 [2] [6]. Figure-9b shows losses due to evaporation at Gargar dam. These range from 5-32.2 hm<sup>3</sup> year<sup>-1</sup>, with an annual average of 21.6 hm<sup>3</sup> year<sup>-1</sup> [8] [2]. Evaporation is an important issue at Gargar, considering the geographical situation and, particularly, the large surface area of the dam reservoir. At the Gargar dam, the evaporation level has typically remained above the water requirement for irrigation during the exploitation period.

**Figure-9.** Variation of evaporation over time at the (a) Foug el Gherza and (b) Gargar dams; source: own study.

There are several possible approaches to reducing evaporation from dam reservoirs. For example, the surface of the water exposed to the sun can be reduced by floating wax covers (85% polyethylene with microscopic pearls) or other reflective surfaces that change the characteristics of the water surface, reflecting sunlight and reducing evaporation [9]. Fatty acids, amines and ketone bodies can be used to produce a thin coating layer on the water surface and have been shown to have no negative environmental or water quality impacts [15] [17]. Finally, evaporation is more effective under windy conditions. Vegetative and non-vegetative windbreaks can be effective; however, vegetative windbreaks contribute to evaporation through evapotranspiration. Crow (1963) showed that in small reservoirs, non-vegetative windbreaks reduced evaporation by 9% under average wind speed of 4.5 m s<sup>-1</sup>. More research is required to assess windbreaks and other evaporation reduction methods for large reservoirs in arid areas.

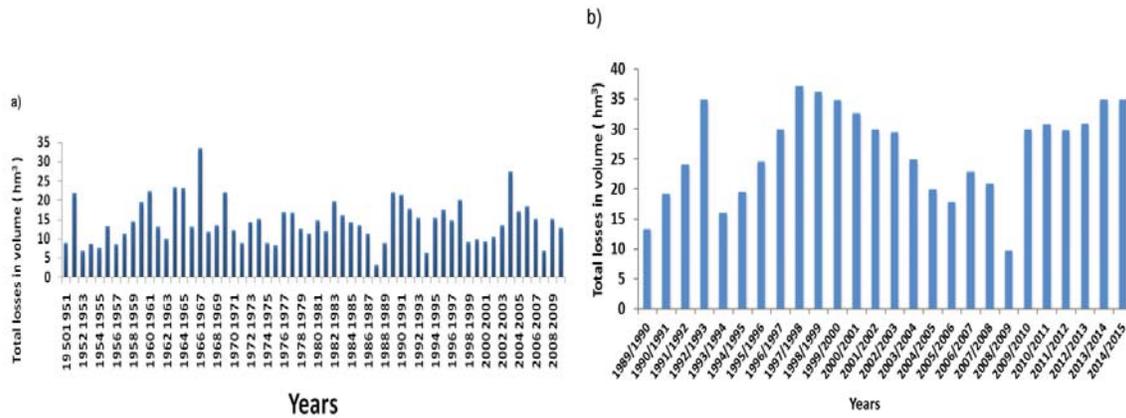
The total losses of water and capacity of each dam based on the calculation from Equation (3) and the ANDT data are expressed in Figure-10. The Foum el Gherza dam has lost a volume estimated at 25 million m<sup>3</sup> over 42 years from sedimentation, with a water leakage average annual volume estimated at 3.49 hm<sup>3</sup> and an annual evaporation volume of 3.38 hm<sup>3</sup>. We thus estimated the total losses of volume at 32 hm<sup>3</sup> for 1992 (about 68% of the total capacity of the dam). We estimate the losses volume in 2016 as follows: average water leakage annual volume is 3.49 hm<sup>3</sup>, annual volume average of evaporation is 3.38 hm<sup>3</sup>, and sedimentation volume is 39.6 hm<sup>3</sup> in 2016. The total volume of losses was estimated at 46 hm<sup>3</sup> (about 98% of the total capacity of the dam). Table-1 shows these losses as a proportion of total losses for the period 1950-2016. We conclude that water leakage and sedimentation are the most important

factors that lead to water losses and reduce the capacity of the Foum el Gherza Dam. Thus, it is necessary to control these problems to reduce water losses. Leakage increases with reservoir level over time and these losses are high and strongly affect the total losses of the dam. Losses from sedimentation are less important than those from leakage and evaporation at this dam. The volume lost by the evaporation of the lake and the leaks through banks are similar to those required for the irrigation of date palms [6]. The leakage situation is critical in Foum el Gherza and may threaten the structural stability of the dam. However, because of the geological complexity of the site, more experiments are required to better understand and better address the leakage phenomena. The problem of Foum el Gherza dam is almost certainly due to the poor choice of the site despite the good original maintenance [2] [6].

Figure-10. Variation of total losses in volume over time at the a) Foum el Gherza and b) Gargara dams; source: own study.

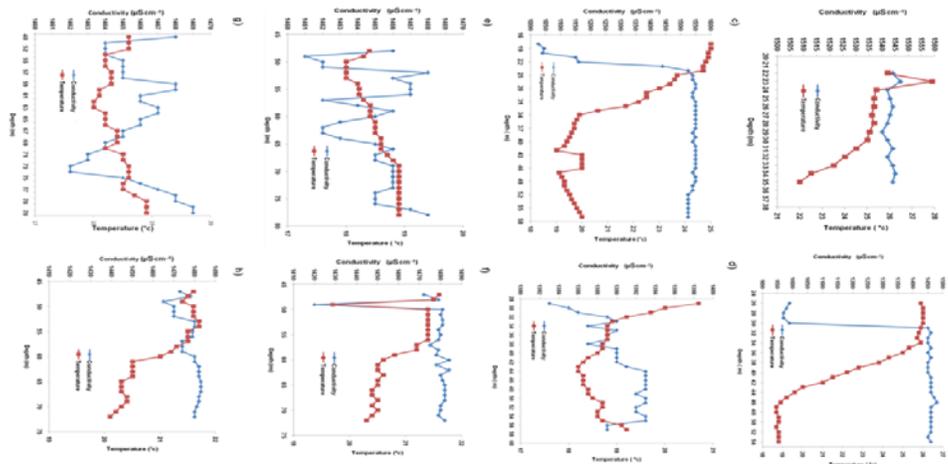
The temperature and EC profiles indicate the presence of vertical and horizontal flows. The vertical flows are represented by the approximately constant temperature and EC values. The oblique flows, almost horizontal from the reservoir, are indicated by the lower EC values and homogeneous temperature values [19]. This is an indicator of the degraded state of the geological layers of both banks. The temperature and the EC vary with depth according to the geothermal gradient and geological layers, which further confirms the degradation due to water leak evolution by infiltration [17] [20]. The moderate values of EC ( $\sim 1000 \mu\text{S cm}^{-1}$ ) indicate high mineralization; however, EC decreased with depth towards the Maastrichtian limestone groundwater. This salinity is

Figure-11. Electrical conductivity and temperature profiles for selected piezometers on the left and right banks of the Foum el Gherza dam; a) LB-S25, b) LB-S26, c) LB-27, d) LB-S50, e) RB-S35, f) RB-S33, g) RB-S30, and h) RB-S38; source: own study.
