IDENTIFICATION OF DAMAGING ASSETS IRRIGATION LEVELS OF THE TERTIARY TO THE AREA BISSUA BASED ON GEOGRAPHIC INFORMATION SYSTEM (GIS)

Abdul Rivai Suleman, Muh. Taufik Iqbal, Evi Bahrul, and Muh. Iqbal Ashari

Department of Civil Engineering, State Polytechnic of Ujung Pandang, Jl. Perintis Kemerdekaan Makassar, South Sulawesi, Indonesia

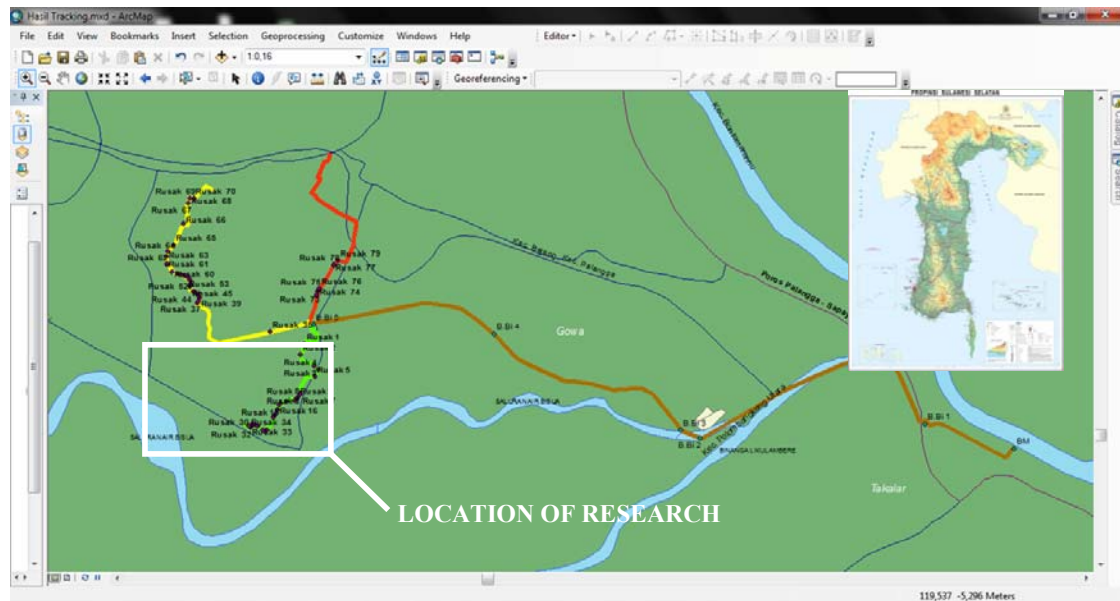
Figure-2. Map of the identification result of damage.

At the tertiary channel Bi 5 left the irrigation of Bissua, irrigated area is 49.60 hectares with water needs of 44.96 liters/sec. Based on Table-4, there are some points that are damaged, both heavily damaged and lightly damaged. If it were presented, the amount of total damage amounting to 1.112%, heavily damaged 3.185%, damaged 0%, with minor damage 3.545% and good condition 92.158%, the main problem on the line on this one is the amount of damage is caused by the people who do the tapping of irrigation water on parts that are not permitted.

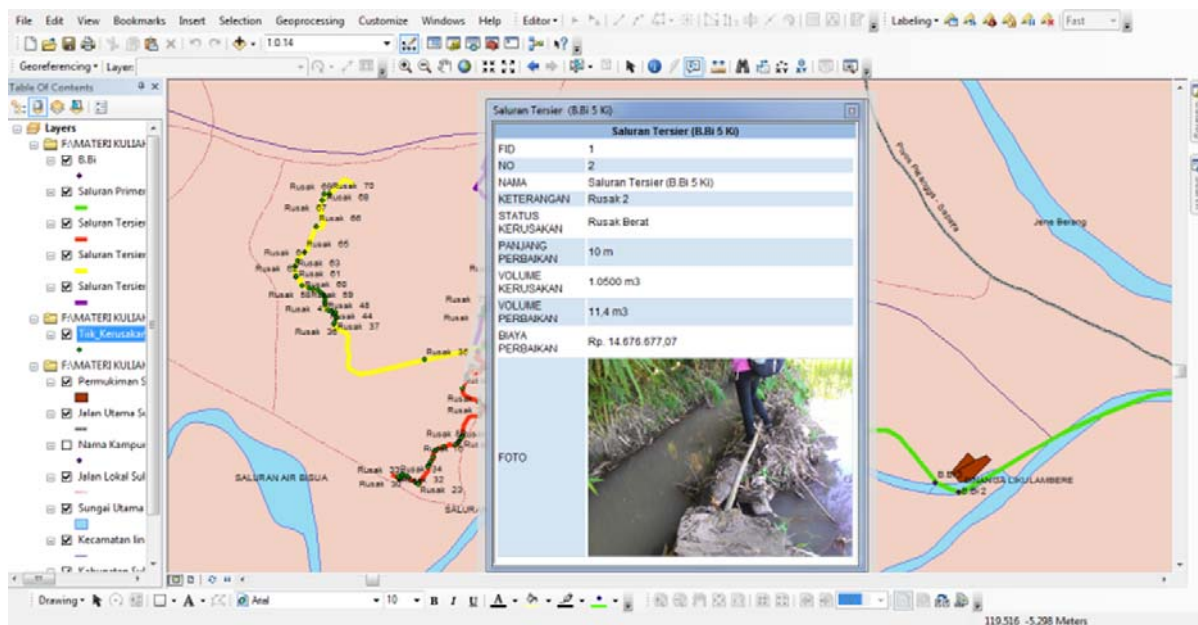
Figure-4. Photo display of software.

- d) Activate one layer, click the HTML Popup icon, then click on a point to bring up the information (images, types of damage, costs, etc.), as shown in Figure-4, following;
