# DEVELOPMENT OF CONDITION RATING OF SHOTCRETE LINING OF HYDROELECTRIC POWER STATION BASED ON CONDITION ASSESSMENT OF ITS DISTRESSES

Fathoni Usman, Nursimaa Banuar and Zakaria Che Muda

Civil Engineering Department, Universiti Tenaga Nasional, Malaysia

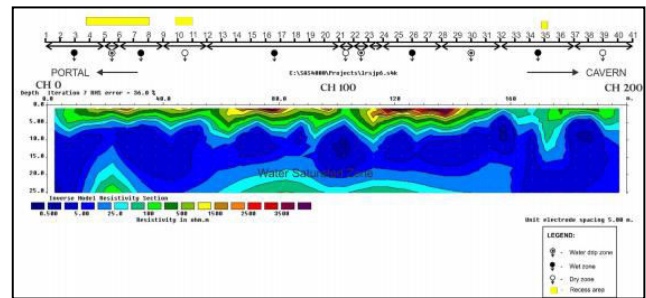
**Figure-2.** Resistivity result on the right wall of MAT.

Most water leakages occurred were discovered at chainage 0+000 to 0+025 with total of 26 leakages presents with 2.5 average rating value. Moreover, the longest crack also was identified at chainage 0+001.5 with 1091 mm length diagonally. Based on the resistivity survey, there are water saturated zone was developed behind the shotcrete lining on the right wall, left wall and crown of chainage 0+000 to 0+200. However, almost whole area on the right wall was saturated by water as shown in Figure-2 to Figure-4. Thereby, water pressure behind the shotcrete may triggered the formation of cracks which was confirmed by visual inspection earlier at chainage 0+001.5. This situation is due to lack of weeping hole that required to drain the water to seeping out. Similarly, as presented in Figure-5, results from GPR indicates the condition of rock on the left wall of MAT is highly fractured and highly saturated. This explains that area contains relatively high of wetness with high density of fractures.

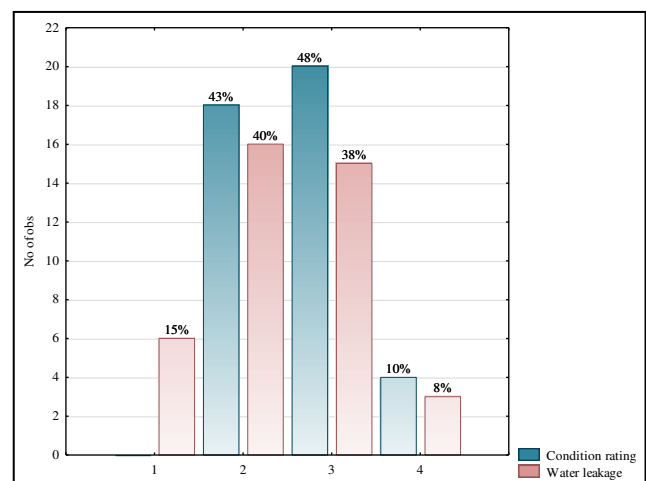
**Figure-6.** Difference of condition rating system.

The analysis of condition rating that combining major distresses revealed that there are range of difference between the condition rating given by water leakage rating alone. The difference was relatively high, which ranged from 4% -15%. Figure-6 present the comparison of condition rating from both rating system.
