THE IMPORTANCE OF FORMER QUARRY ROCK SLOPE ASSESSMENT FOR SUSTAINABLE INFRASTRUCTURE DEVELOPMENT

Hamzah Hussin^{1,2}, Tajul Anuar Jamaluddin² and Nurhazren Fauzi¹

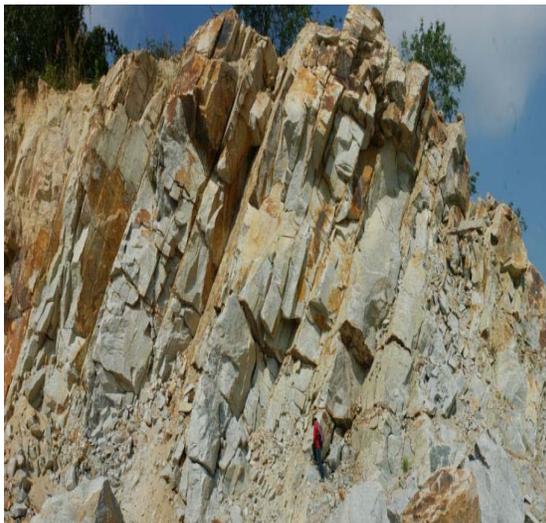
The bedrock geology of the area is essentially consisting of granite, locally known as Kajang Granite and it is also part of the Kuala Lumpur Granite. The granite is composed mainly of medium to coarse-grained, equi granular to moderately porphyritic textured, light grey muscovite-biotite granite. The granite is consisting predominantly of quartz, plagioclase, K-feldspar with some amount of biotite and muscovite (Figure-3). The exposed rock masses vary in weathering grades from fresh (grade I) to slightly weathered (grade II), moderately weathered (grade III) and highly weathered (grade IV) rocks. These rock slopes were formerly rock quarry faces, thus forming steep high craggy rock slopes with numerous protruding overhangs and loose blocks resulted from past rock blasting activities (Figure-4).

Figure-4. Nature of a rock quarry face. Note the loose overhanging blocks and some of the fallen blocks on the floor.

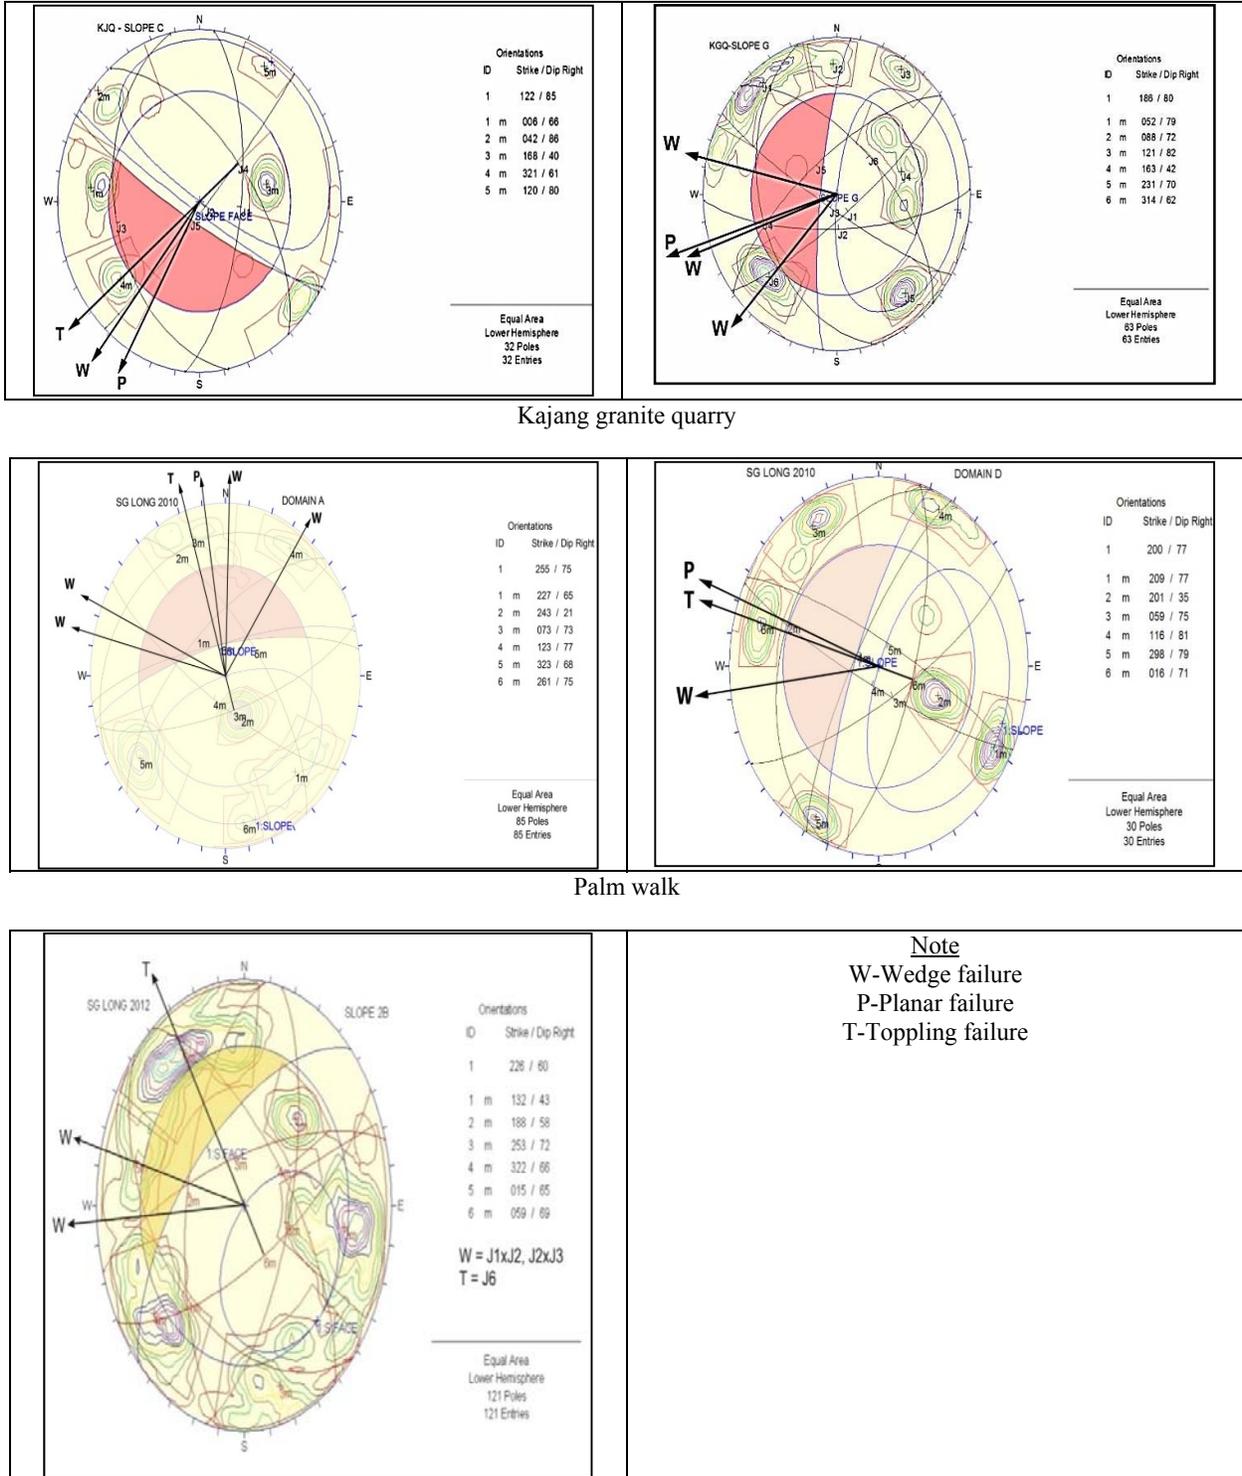
Kinematic stability assessment was done to five rock slopes. The analysis is shown in Figure-5. In general, rock slopes in this area had potential to fail in multiple modes either as one or combination of the following modes of failure:

The most common potential failure is wedge failure because of the high number of discontinuities set present in the rock mass. The minimum number of failures that could potentially occur is three and the highest number is six. Both slopes at Kajang Granite Quarry have the potential to fail in wedge, planar or toppling failures

slopes are unstable and have high potential for slope failures. These findings are comparable with previous research [2, 13, 18].

Figure-5. Result of kinematic stability analysis for three sites in this research.

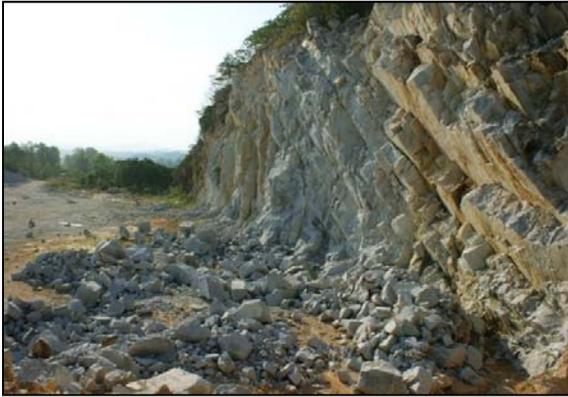
and it had been proven accurate based on field observations as shown in Figure-6. Similar conditions can also be seen for slopes at Palm Walk (Figure-7) and Mayang Kiara. This analysis concluded that all quarry cut

Figure-6. Side view of slope C at Kajang granite quarry. Note the highly persistent joint sets, and numerous loose, overhanging blocks, and the potential of toppling and wedge failures.

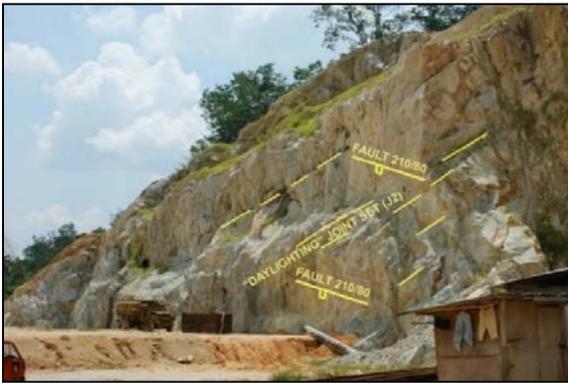
Figure-7. View of domain D slope at palm walk. The potential planar failure caused by day lighting joint set.
