# FLUID STRUCTURE INTERACTION ANALYSIS ON FAILURE OF FRANCIS TURBINE RUNNER BLADES

This paper describes the influence of tail profile of francis turbine blade on creation of vortexes and cavitation and its effects on initiation of crack. Fluid structural analysis is utilized to determine the location of Von-Karman vortexes and the positions in which cavitation occurs. Incompressible viscous Navier-Stokes formula was solved by CFD numerical method, meanwhile the stress distribution on the runner blades are calculated in FEM. It led to indicate the situation of crack nucleation and the results are perceived for both existence and retrofitted blades.

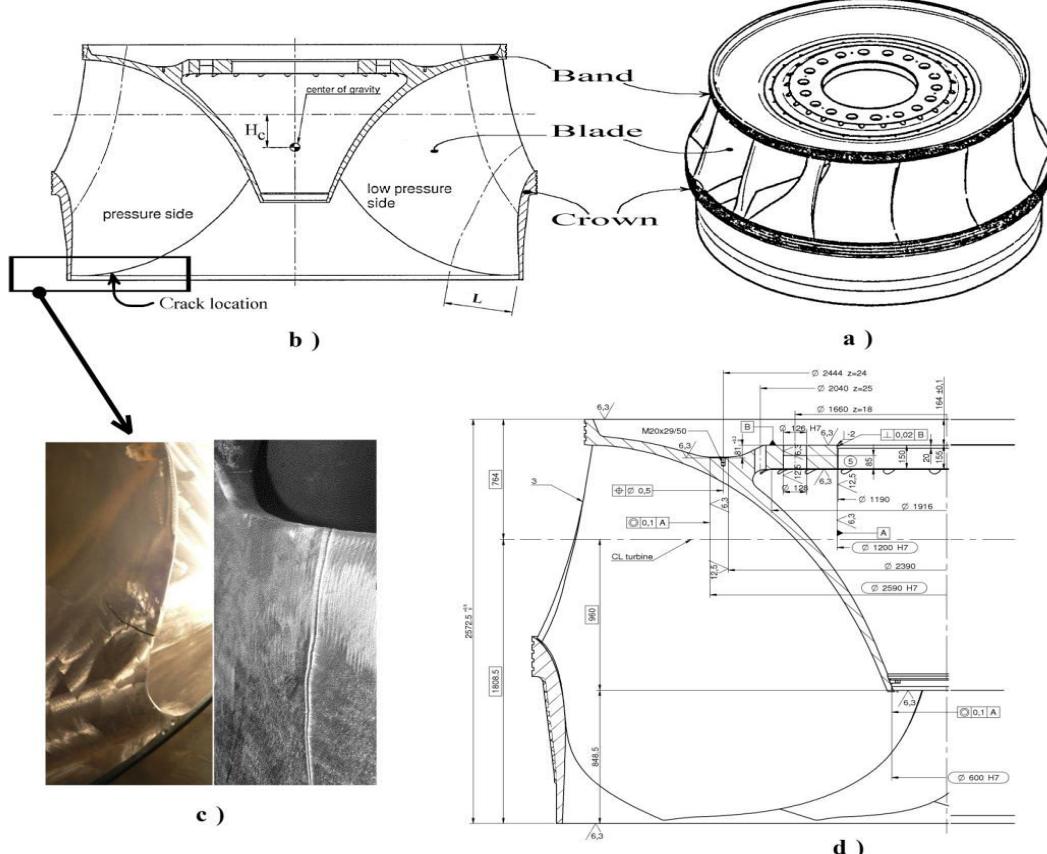
**Figure-1.** General view of runner a) Isometric view b) Section view c) crack d) General dimension.

In Figure-1-a the isometric view of the runner is shown which consist of 15 blades. In Figure-1-b the cross section of runner is depicted to illustrate the dimension and the overall shape of blades. In the Figure-1-c the created crack in the reality of existence runner is shown. In part d of Figure-1, overall and detail dimension of runner were illustrated. It includes the dimension of crown, band, blade and the detail of the runner connection.

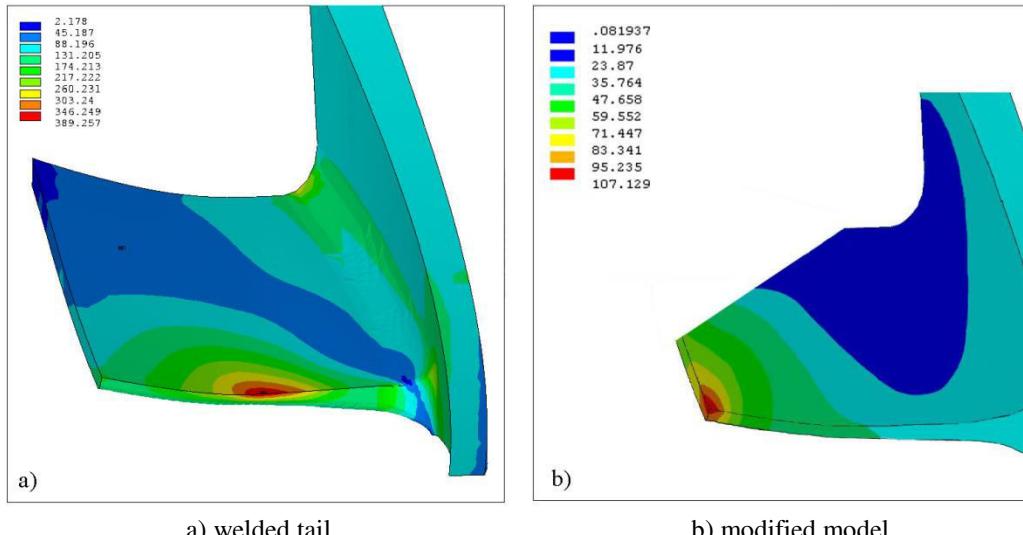
In the Figure-2a the Von-Mises stress due to runaway of runner are shown. The stress distribution of existing runner illustrates that the max stress are located near the connection line of blade and crown and at the connection also the stress range is high, though near this region the stresses are a little decreases. The stress concentration come out of the area of blade and crown connection and the amount of stress declined significantly.

This condition is not a safe mode for operation of turbine; the turbine parts are designed to convert the water kinetic energy to electrical, but when the crack initiate a part of kinetic energy is absorbed to create the crack and propagate it. Secondly, the efficiency of runner comes down as the length of crack increases. Third is propagation of crack will lead to unbalance of the runner which causes high unforeseen forces that may disturb generator, shafts and other rotating part.

**Figure-2.** Von-Mises stress in runaway condition.

In the Figure-2b, the Von-Mises stress distribution in rehabilitated runner is shown. The results of modified case demonstrates that the stress concentration come out of the area of blade and crown connection and the amount of stress declined significantly, too. Also the distribution of energy and stresses on the tail of blade become wider, so the minimum energy to initiate the crack will not be gathered in a point.

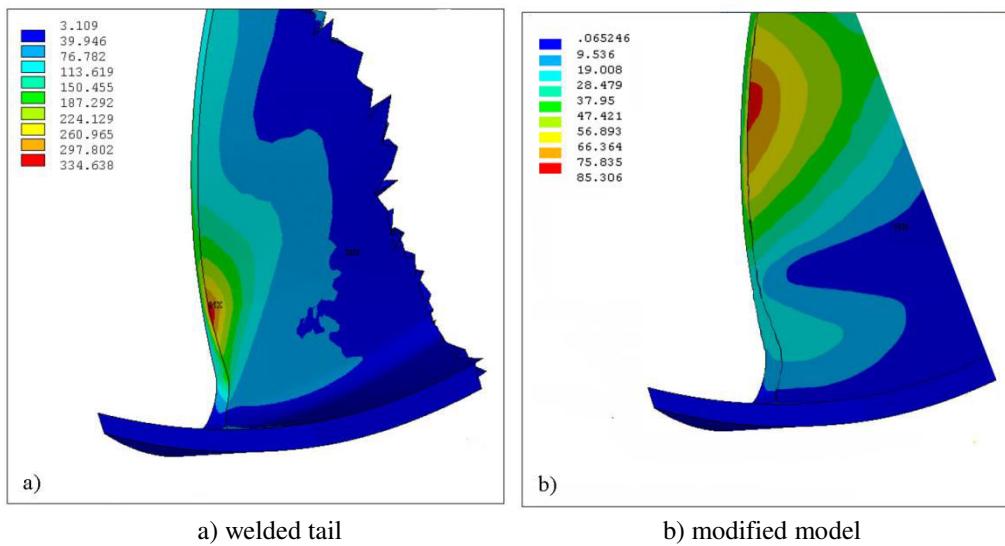
**Figure 3.** Von-Mises stress in no-load condition.

This case is not a safe mode for operation of runner; the runner is not designed to bear this high stress load continuously; and it affects seriously on the efficiency of turbine and declines it. In this case as the crack propagates, being near the crown, it may cause to separate the blade and crown.

In Figure-3b, the Von-Mises stress distribution in rehabilitated runner is shown. In this case, the stress concentration come out of the area of blade and crown connection and the amount of stress declined significantly. In Figure-4a the graph of Von-Mises stresses in runaway condition in the tail line of blade is shown. The curves are normalized in the direction of tail line by  $x/L$  which starts from the crown side as zero point. In the vertical axis the stresses are normalized by  $S/S_{\max}$ . The first curve shows that the location of maximum stress is near to the crown and with a high slope its amount decreases as it moves far from the crown. But in the rehabilitated blade the

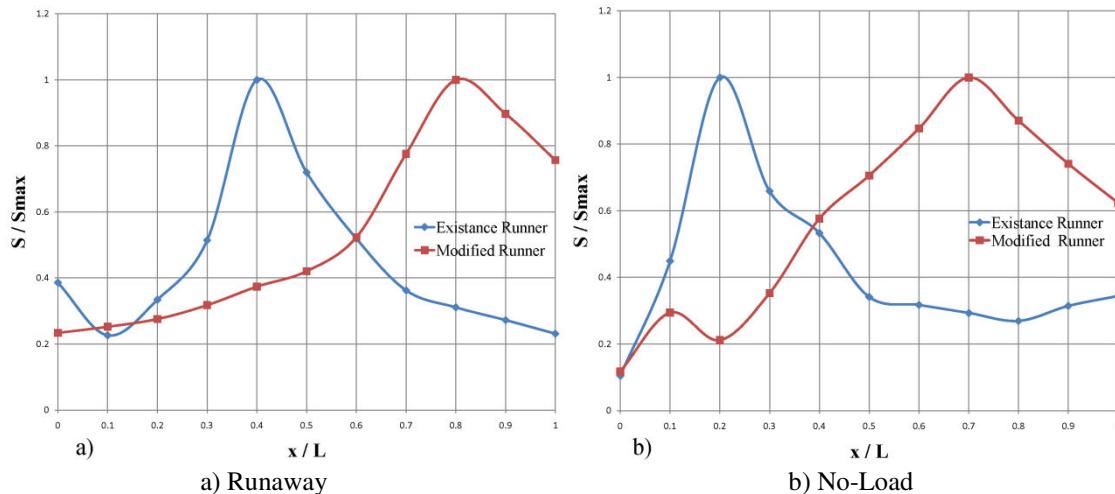
In the Figure-4, Von-Mises stresses due to no-load case of runner working condition are shown. In the left, the stress distribution of existing runner demonstrates the location of maximum Von-Mises stress at the tail of blade which is not far from crown; also its magnitude is too high.

maximum is a little farther from the starting point and in both side of the peak point there are smoother slope of variation of stresses. It demonstrates that gradient of stresses is higher in the first curve and it located in the region in which the cracks created in the existing runner.

In Figure-4b, the curves show the distribution of Von-Mises stress in no load condition. Like the Figure-4a, it is normalized in both axis. The graph expresses that in the existing runner the peak stress position is near the crown but not as close as in runaway condition. In contrast, in the second curve in this figure which belongs to the rehabilitated blade the maximum stress reduces in magnitude and is too far from the crown to induce stress concentration. Comparing these two curves illustrates that the gradient of stress in the existing model is bigger than the stiffened blade and the location of highest stress point in the first curve is nearer to the clamping side.

**Figure 4.** Stress magnitude on tail line.

In both Figure (4-a) and (4-b), it is shown that the maximum Von-Mises stress occurs in the cracking area. Also the extreme amount of gradient exists near the maximum calculated point. Both of these conditions are the main phenomena to generating the crack. In the other hand, as the stress is distributes in stiffened blade, the energy exerted on the tail is distributes widely and restricts to act on specific point. Hence the minimum energy to create the crack will not reacted by the fluid on a point. It proves that by the new method of stiffening the energy of fluid distributed widely on the tail of runner and causes that the maximum stress decreases. It lead to a situation that the minimum energy to start cracking will not exist in the tail.
