GEOTECHNICAL INVESTIGATION OF CAVITY AND SETTLEMENT AT BESRAYA HIGHWAY, JALAN KUCHAI LAMA

Adnan D.¹, Noorasyikin M. N.², Ismacahyadi B.¹ and Samad A. R.¹

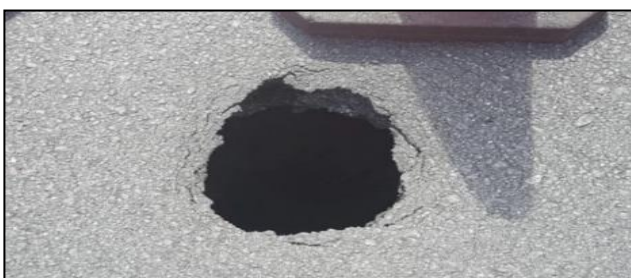
**Figure-1.** Cavity appearing underneath the road surface.

A pipe jacking work was constructed to channel the sewerage pipe for a 22-storey service apartment which runs underneath the BESRAYA highway at Jalan Kuchai Lama section. One (1) year post construction, cavities are present in the middle of the tunnel crown of about 1.5 m across the highway shown in Figure-1.

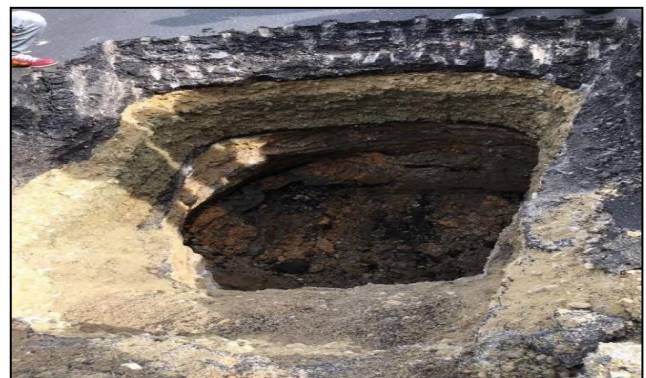
**Figure-2.** Excavation work to observe cavity beneath the pavement surface.

The section was excavated, and soil was filled into the cavities and compacted shown in Figures 2 and 3. However, there is water ponding in the existing cavity. A

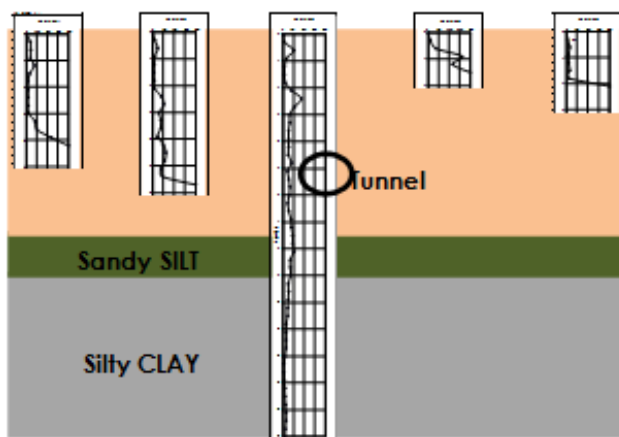
Figure-10. Subsoil profile for Line 1.

Results of JKR Probe for the proposed above mentioned project were stipulated in JKR Probe MP1 – MP5 for Lines 1, 2, 3 and 4. Based on the results of the JKR probes, for the first 0.3 m, the soil is considered to be medium dense with the no. of blows ranging between 30 to 80 blows/300 mm. However, as it reaches only 0.6 m the soil becomes very dense with blows exceeding 200/300 mm. This indicates that the platform is founded on very dense silty SAND and it seems that the water table is 1.2 m below the fill profile. Figure-10 through 24 illustrate the ground profile and the expected groundwater beneath the pavement.

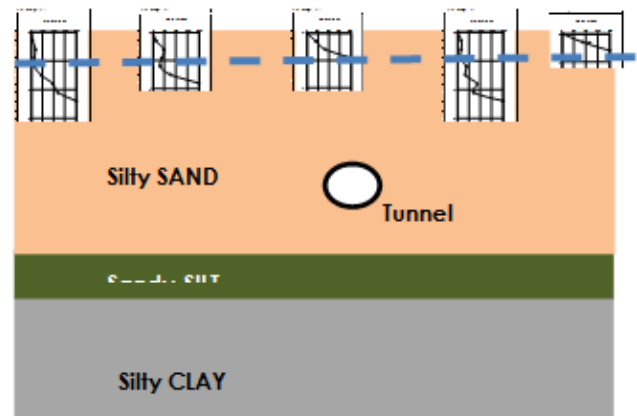
Figure-11. Subsoil profile for Line 2.

As shown in Figure-11, the center profile where the tunnel is installed showed loose to medium dense silty SAND. The groundwater table is expected at 1 m below the pavement surface due to the sudden reduction of the number of blows from the JKR probe. In addition, the values from the probe indicate low values hence, this promote to the weakening on the soil layer below the tunnel. There is a possibility of the silt/clay layer

experiencing additional settlement since the bearing resistance is low.

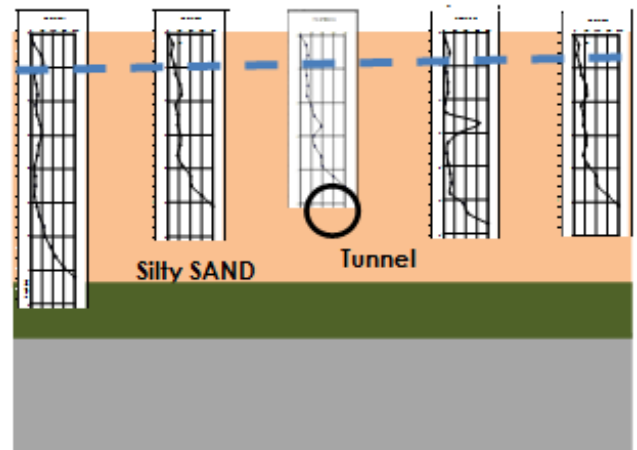
Figure-12. Subsoil profile for Line 3.

Figure-12 shows the control line to observe the initial condition of the fill, whereby the silty SAND is very dense. The groundwater table is expected at 0.9 m below the pavement surface due to the sudden reduction of the number of blows from the JKR probe. This shows that the existing fill was compacted to the specification in accordance to the PWD standard.

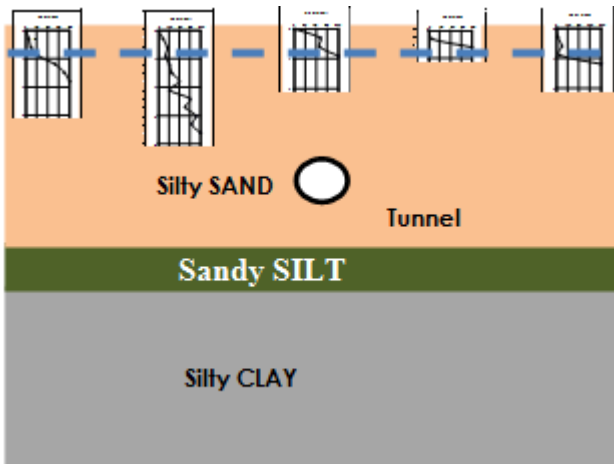
Figure-13. Subsoil profile for Line 4.

From the probe values shown in Figure-13, the groundwater is presumed to be located at 0.9 m from the ground surface since there is a reduction in value for the particular points from points 2 and 5. However, the fill is

compacted to the specification in accordance to PWD except for point 2 where the readings are medium dense to dense.

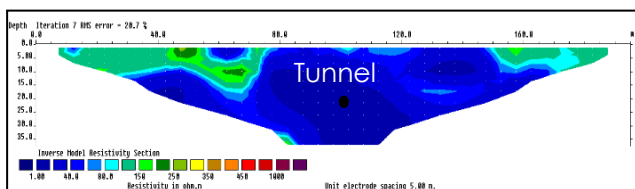
Figure-14. Electrical resistivity image for Line 1.

According to the image given in Figure-14, it clearly showed that 1 m below the ground surface, the soil is fully saturated and loose. However, below the tunnel, since the sandy SILT and silty CLAY layer is an impermeable boundary with water flow restriction, it retains its moisture capacity and could easily cause consolidation settlement if the excess pore water pressure is present due to the loading capacity from the traffic above. The tunnel above may experience changes due to these conditions and if the settlement is huge enough, it would realign the tunnel vertical alignment and could cause leaking to the tunnel. In fact, from the probe data observed, the layer below the tunnel at this section is weak and loose which could cause probable settlement issues to the tunnel, hence the ground above. This is also proof of internal erosion occurring below the tunnel section due to the saturated condition of the silt or clay layers. Based on visual inspection, the settlement occurred at about the tunnel crest, slightly eccentric from the alignment at about 90 m from the left end.

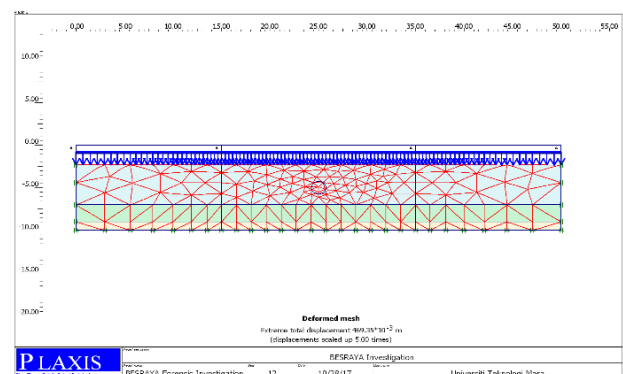
Figure-18. Deformation of the ground due to existing traffic load.

Based on the image shown in Figure-18, this is the most critical line where the settlement occurred excessively eccentrically from the tunnel crest. The resistivity image even showed that the ground is fully saturated approximately 1.2 m below the surface and there is water pocket on the left side of the diagram. Moreover, below the tunnel, since the sandy SILT and silty CLAY layer is an impermeable boundary with water flow restriction, it retains its moisture capacity and could easily cause consolidation settlement if the excess pore water pressure is present due to the loading capacity from the traffic above. However, the hard layer is encountered below the level which provides additional resistance to settlement. From the probe data observed, the layer below the tunnel at this section is dense to very dense hence could restrain the ground from excessive settlement.

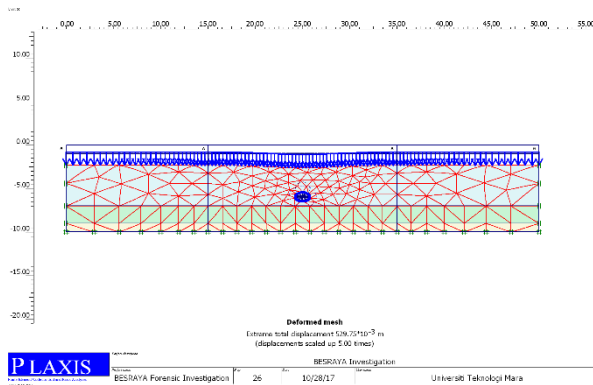
Figure-19. Deformation of the ground surface due to pipe jacking work.

Figure-19 provides the deformation of the ground due to pipe jacking work. It is observed that the settlement is 529 mm at the crest of the tunnel from the ground surface. The deformation pattern followed the expected settlement trough due to micro tunneling work executed underneath and existing road structure. Figure-20 shows the settlement trough which, provided discomfort to the traffic users. Figure-21 shows the development of excess pore water pressures during the pipe jacking work which triggered settlement at the crest of the tunnel. Hence, due to the dissipation of the excess pore water pressure, the

pavement structure could have experienced settlement during the pipe jacking work if temporary support work was not planned.

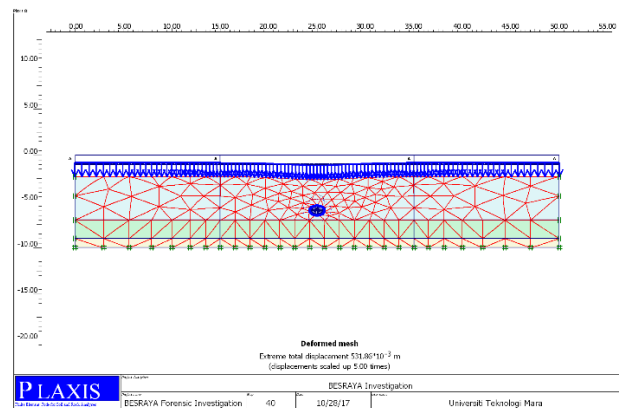
Figure-21. Deformation of the ground surface two (2) years post construction.

Figure-21 shows the deformation of the ground surface after two (2) years of construction. Due to continuous traffic load, the ground has settled about 531 mm at the crest of the tunnel from the ground surface. This deformation does not include settlement due to erosion within the soil layer due to the presence of the water pockets and seepage. Integrating ERI and JKR probe, the settlement of the ground becomes excessive as the excess pore pressure dissipated, washed away all of the fines in the sand layer, introducing cavity and voids underneath the pavement structure. There are evidences that showed the presence of cavities and voids due to inundation, seepage and dissipation. Figure-22 illustrates the settlement through two (2) years post construction causing riding discomfort to the traffic users. Hence, if remediation work is not proposed, there is a possibility that the cavities and voids would reappear and cause more problems.

- For stabilization of the loose ground, it is suggested to inject polyurethane (PU) foam/resin providing buoyancy and stability of the loose deposit. In addition, the impermeable characteristic of the PU foam/resin will divert water from flowing underneath the ground surface, reducing the seepage. Moreover, subsoil drainage is to be provided, to reduce the internal erosion occurring in the water pocket and providing better flow of water in the ground. Using polyurethane foam injection method, no excavation is required and small diameter holes are drilled to perform the work. The setting and curing time for PU foam is very fast, whereby it takes only 24 hrs. for the foam to harden. In addition, since PU foam is an expansive material and lightweight, the volume of liquid material before mix is less and acts as a buoyant layer for soil stabilization.

- Another solution is by lightweight cementitious grout into the weak layer, to improve the density and bearing capacity of the weak layer. Cement increases the strength and durability of the platform, however increases the weight of the ground providing additional overburden for the underlain layer. The time of curing and hardening is approximately three (3) days but the volume of cement use varies, depending on the ground conditions. Subsoil drains are to be installed as well for providing better flow of water in the ground, reducing internal erosion and wash away of fines.

c) The final solution is excavating and replacing the fill with lightweight material i.e. Expanded Polystyrene System (EPS) of polyurethane (PU) flatbed to reinstate the ground and reduce the effect of settlement. This method is not recommended since the traffic closure would be massive and time consuming whereby, the pavement structure is to be demolished, excavate the weak layer, replacing partly with the light weight material, then the suitable compacted fill and reconstructing the pavement structure. Subsoil drains are to be installed as well for providing better flow of water in the ground, reducing internal erosion and wash away of fines.

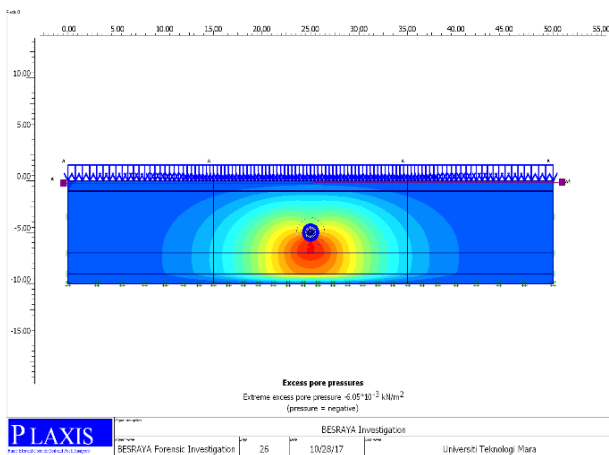
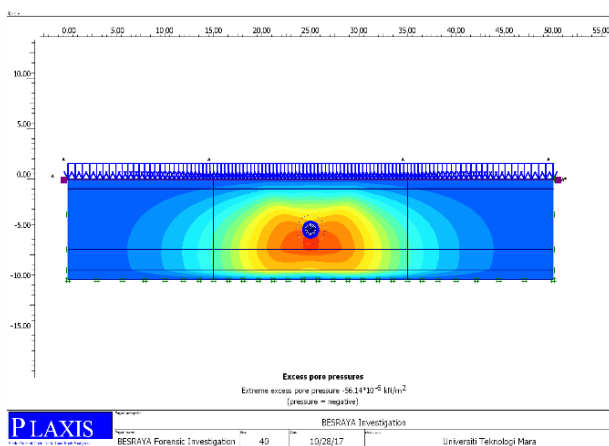
Figures 23 and 24 provide the development of excess pore water pressures during the pipe jacking work and two (2) years post construction. It is observed that the excess pore water pressure developed underneath the tunnel which could cause settlement as it dissipates. In fact, as the excess pore water dissipated two (2) years post construction, the pressure around the tunnel reduced; hence the deformation of the tunnel is less. Integrating ERI and JKR probe data, this showed significantly that the dissipation would trigger seepage and washed away of fines within the silty SAND layer. The issue caused the development of cavities and voids underneath the pavement structure as observed on site.
