INSPECTION AND EVALUATION OF DAMAGE MECHANISMS IN TWO-PHASES VERTICAL SEPARATOR

Daniel Nayib Lissa Cure, Gonzalo Moreno Contreras and Rafael Bolivar León

Mechanical Engineering Program, Faculty of Engineering and Architecture, Pamplona University, Pamplona, Colombia

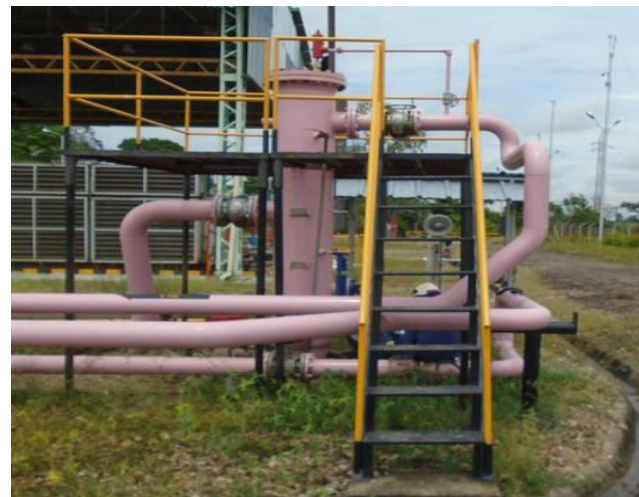
**Figure-1.** Vertical two-phase separator inspected.

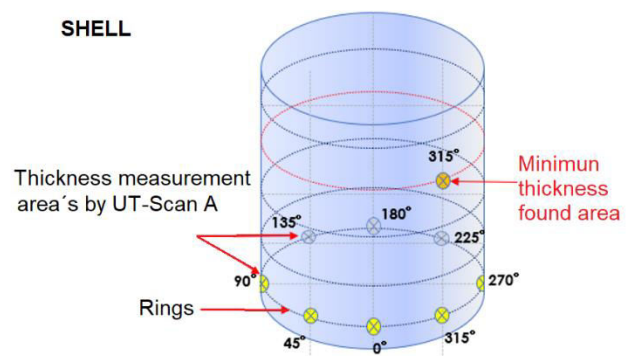
Figure-2. Diagram of rings and areas of the shell for thickness measurement.

The corresponding measurements were analyzed and the minimum thickness was determined, resulting in a tmin = 0.322 [in] located in ring 4, at the bottom of the

shell. Design thickness at this point was $t_{nom}=0.375$ [in] according to the plans.

Using equation 1, a material loss was 14%, a value considered significant by the API inspector because the bottom area of the shell is where the liquid phase of the system is collected. As a result, a more detailed segmentation was carried out in that area to perform thickness measurements and determine if there were higher loss percentages. A grid was drawn on the shell at a distance of one inch [1 in], with 25 axes numbered from 1 to 25 and 9 points per axis denoted alphabetically (Figure-3).

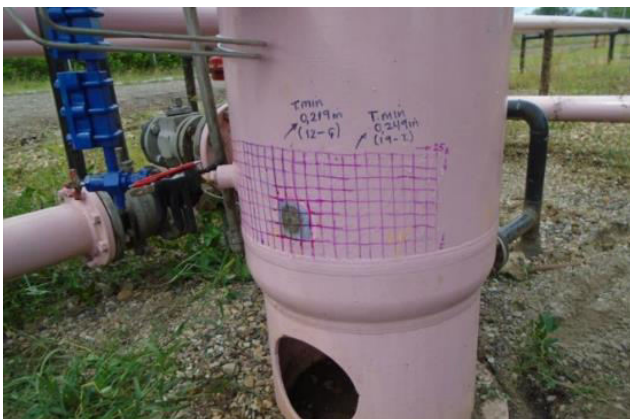
Figure-3. Verify minimum thickness in the lower zone of the separator's shell.

The procedure to determine the minimum thickness was the same as mentioned above, and a $t_{min} = 0.219$ [in] was obtained at axis 12, ring G, with a severe material loss of 42%. The data obtained for this and the other sections forward were used to determine the corrosion rate and remaining equipment life in the mechanical integrity assessment according to API 510 standards and ASME Section VIII Division 1 calculation, which will be shown in another paper.

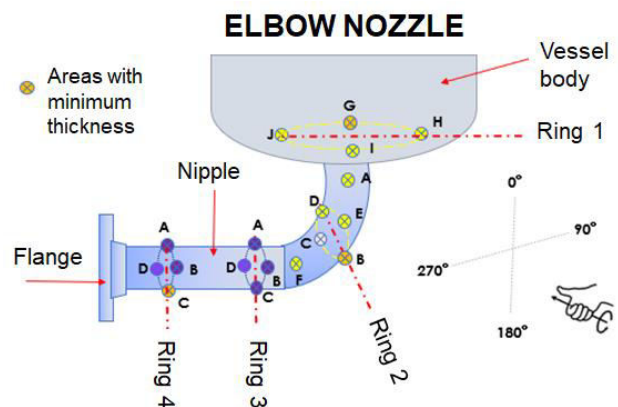
In Table-4 and Figure-4 highlighted in orange, it can be observed that the highest percentages of material loss were found in the center of the elbow with a 23% material loss in ring 2, area B; in the helmet with a 28% material loss in ring 1, area G; and in the nipple connecting to the flange with a 25% material loss in ring 4, area C.

Figure-4. Division of elbow nozzle in rings and areas for thickness measurement.

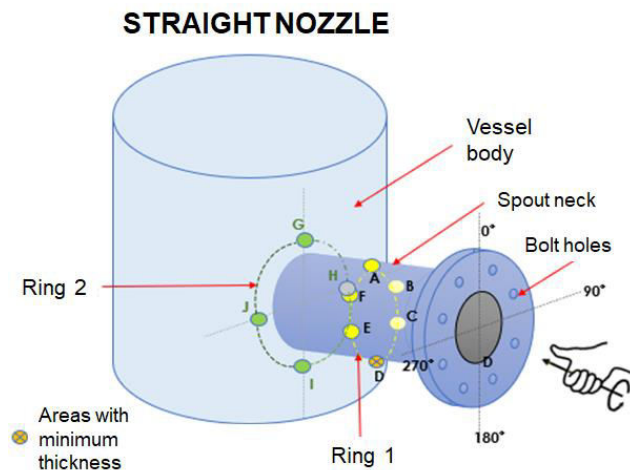
Table-5 shows that the highest percentage of material loss occurred in the neck of nozzle 3 (N3) with 16%, tmin= 0.283" in ring 1, area D, as illustrated in Figure-5 in orange. The percentages of losses obtained in the helmet measurements were negligible, ranging from 0% to 2% as shown in Table-10.

Figure-5. Area with minimum thickness found in the straight nozzle of the separator.

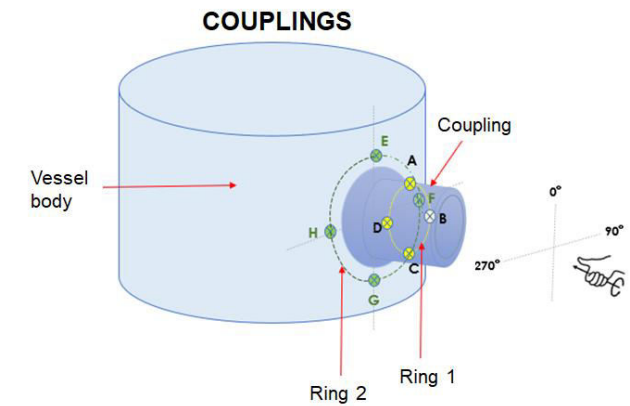
Figure-6. Diagram of rings and areas performed in the field for thickness measurement in the separator couplings.

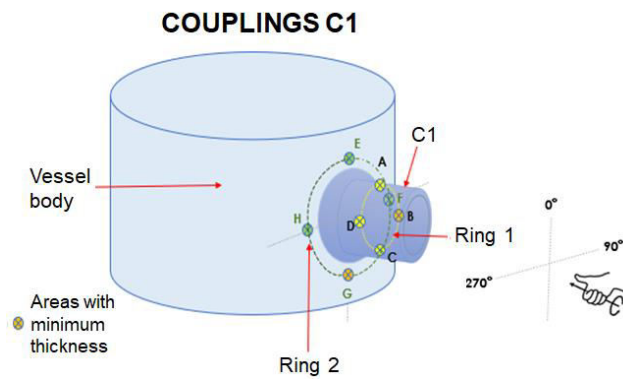
In Table-6, it can be observed that the coupling with the highest percentage of thickness loss is coupling 1 (C1), located in the lower cap of the equipment, with a 14% loss in the neck (tmin= 0.133 inches) in ring 1, area B, and also a 14% material loss in the separator's helmet (tmin=0.323 inches) in ring 2, area G, as illustrated in Figure-7 in orange.

Figure-7. Minimum thickness found in coupling 1.

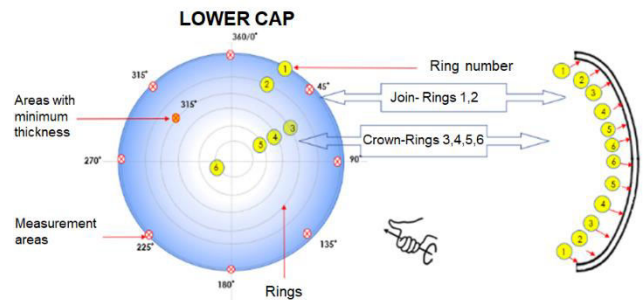
Figure-8. Diagram of rings and areas performed in the field for thickness measurement A in the lower cap of the separator.

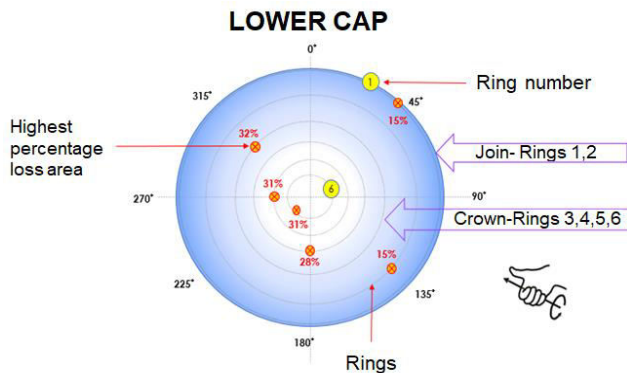
It can be observed in Table-7 that the crown of the lower cap has significant percentage losses, but the highest percentage was found in ring 3, area 8 (315°) with tmin=0.254 inches, as illustrated in Figure-9.

Figure-9. Percentage of material loss in the lower cap.

Due to this finding, the API inspector decided to perform a thickness verification in the area with the highest material loss to assess the mechanical condition of the initially uninspected parts in the crown of the lower cap. For this reason, measurements were retaken using UT Scan A, creating 4 rings in a clockwise direction around the affected area, with a distance of 1 inch between each ring, and 8 measuring areas at a 45° interval. Two rings

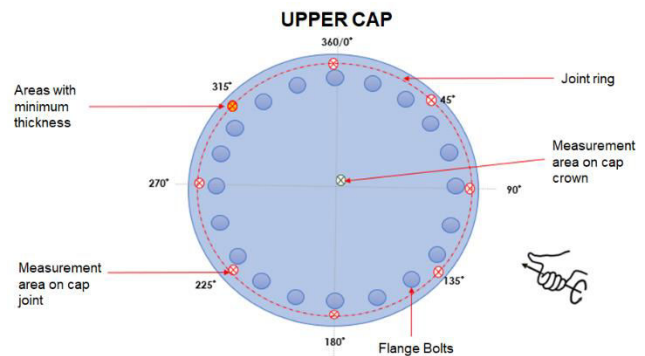
Figure-10. Thickness verification in the upper cap using UT Scan A.

The upper cap crown does not exhibit significant material loss percentages, as seen in Table-14. The UT Scan A revealed a t_{min} of 1.51 inches with a 7% loss in the cap's knuckles in Area 8 (315°), as shown in Figure 10. Additionally, a 1% material loss was found in the crown, as indicated in Table-9.

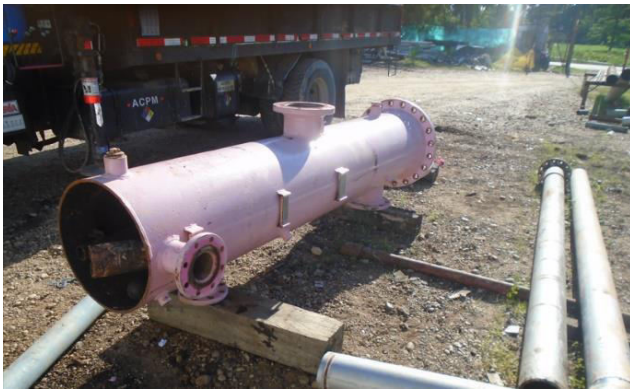
Figure-11. Disassembled TEA vertical two-phase separator for internal inspection.

Internally, a deficient cleaning was observed (which should have been entirely carried out during the previous inspection), with product deposits that hindered proper inspection. However, the damage mechanisms in the equipment's internal components were successfully identified, including the mist extractor box, the associated condensate pipe, the impact tray of the separator, and the surfaces of the vessel, caps, and nozzles. Following the internal inspection, the opportunity was taken to replace the lower cap per the previous year's inspection recommendations. Finally, with the collected data, a general diagnosis of the equipment's condition was conducted under the existing regulations - ASME Section VIII Division I Code and API-510.

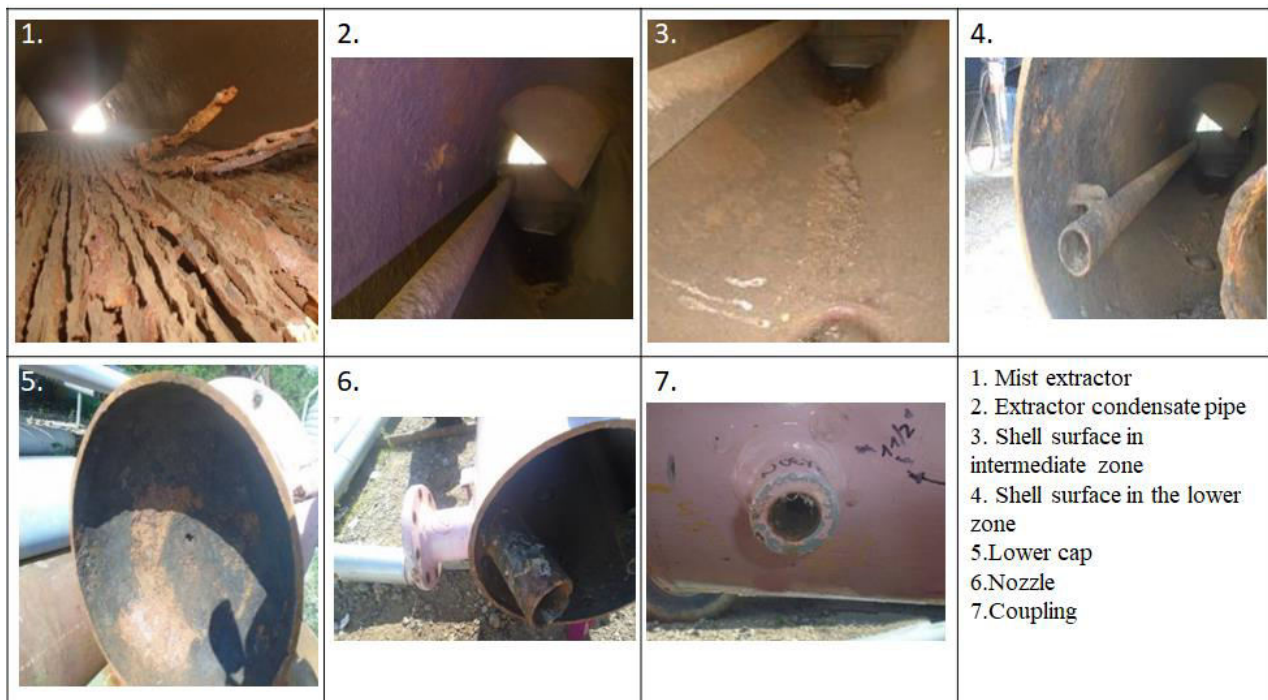
Figure-12. Photos of damage mechanisms in the internal part of the separator.

During the VT internal inspection, material thinning was found in the lower zone of the shell, along with moderate to severe corrosion in the lower shell head, confirming the findings from the previous inspection and the results obtained from the UT Scan An external inspection regarding the significant material loss in this area of the equipment. In the intermediate zone of the shell, mild to moderate uniform general corrosion was observed, with a rough orange-peel-like surface and no internal coating.

As observed in Table-14 and Figure-12, only CO₂ corrosion was identified as the damage mechanism in the equipment's internal components, resulting from the gas condensation occurring within the separator in the liquid phase
