THE SURFACE WATER STORAGE PROBLEM IN ARID REGIONS: A CASE STUDY OF THE GARGAR DAM, ALGERIA

Hassen Benfetta¹ and Abid Ouadja²

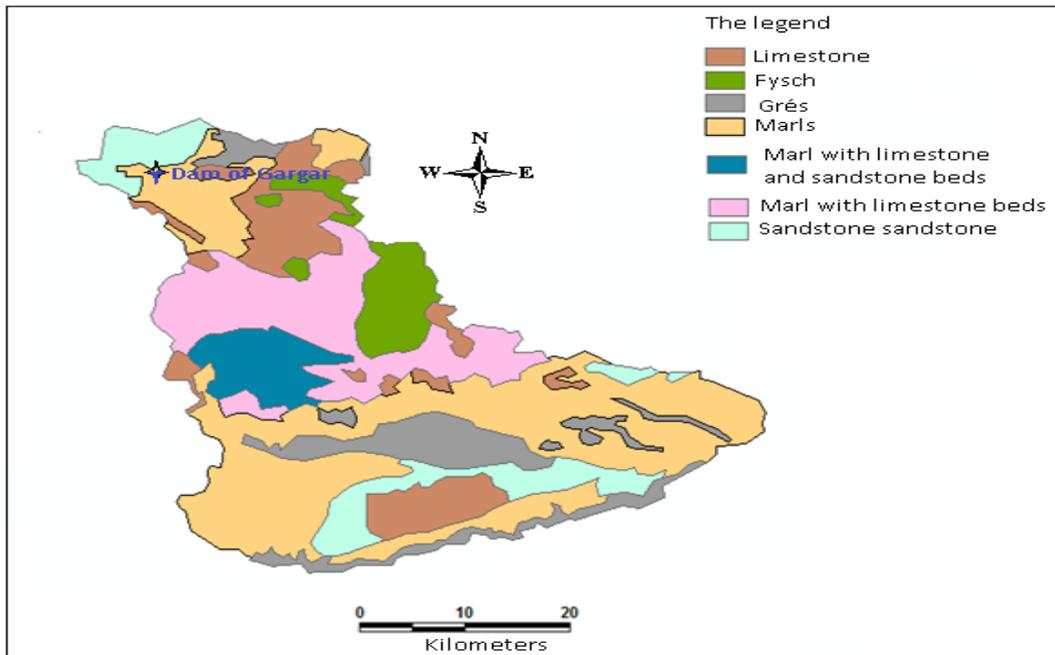
Figure-5. Geology of the site of Gargar dam: source: own elaboration.

The reservoir basin is mostly composed of relatively impermeable marls, which form a natural curtain that prevents percolation losses. Limestone outcrops are found over a considerable distance on both sides of the dam's supports. Many Lugeon limestone tests were carried out, and all found low numbers (maximum 15) despite fractures, faults and micro karst features in some areas. This impermeability and the length of flow paths suggest low seepage losses (ANDT 2010). Although the groundwater level is lower, it barely rises above the level of the river. A certain volume of water was absorbed into the soil during the establishment of the new groundwater regime. While there are no geologic structures that could cause large-scale leaks, several minor karst features characterized by secondary porosity are observed, which are probably close to vertical cracks. It was therefore considered prudent to extend the grout curtain to approximately 150 m on each wing to help to locate any other karst areas that could potentially cause leakage. The grout curtain was continuous in order to limit permeability to below 5 Lugeon. The risk of leakage through the karst is also present in areas below the dam's wings. However, early surveys suggested that the extension of the injection program to more than 150 m beyond the dam was unwarranted, unless exceptional features appeared during the injection. It was thought that if percolation areas subsequently developed along pathways in downstream areas, additional injections could be needed (Figures 5, 6 and 7) (Therond 1973; WS Atkins 1982).

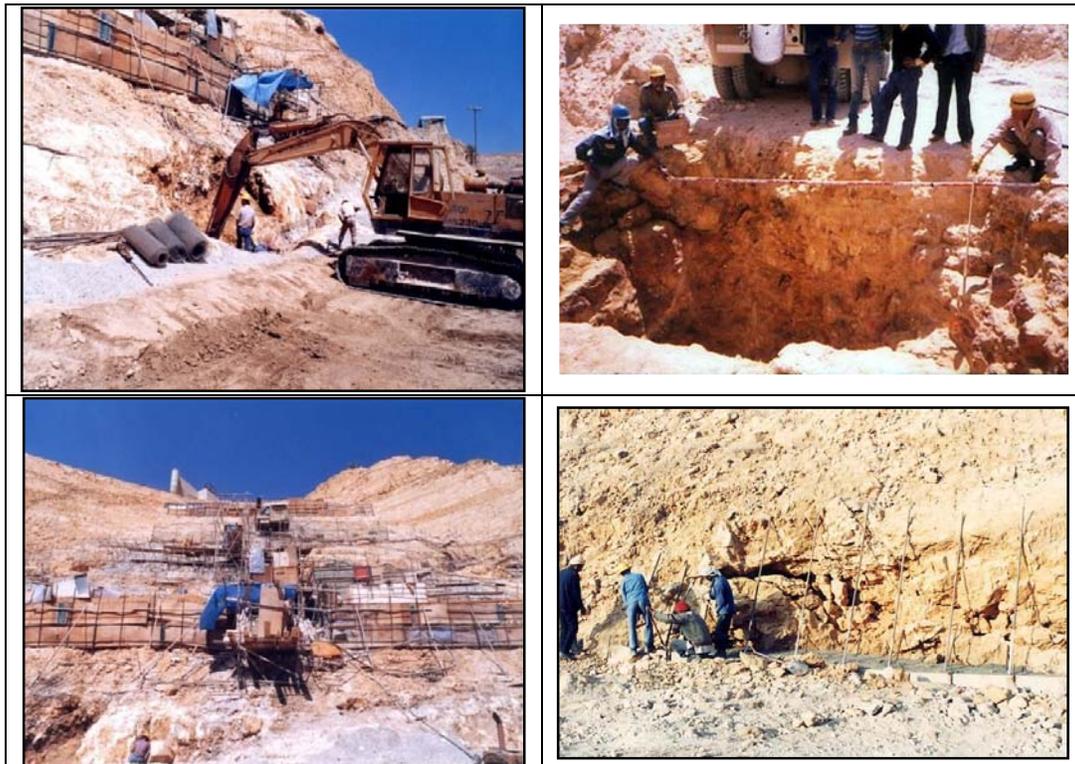
Figure-6. Geological survey (source: ANDT 2003).

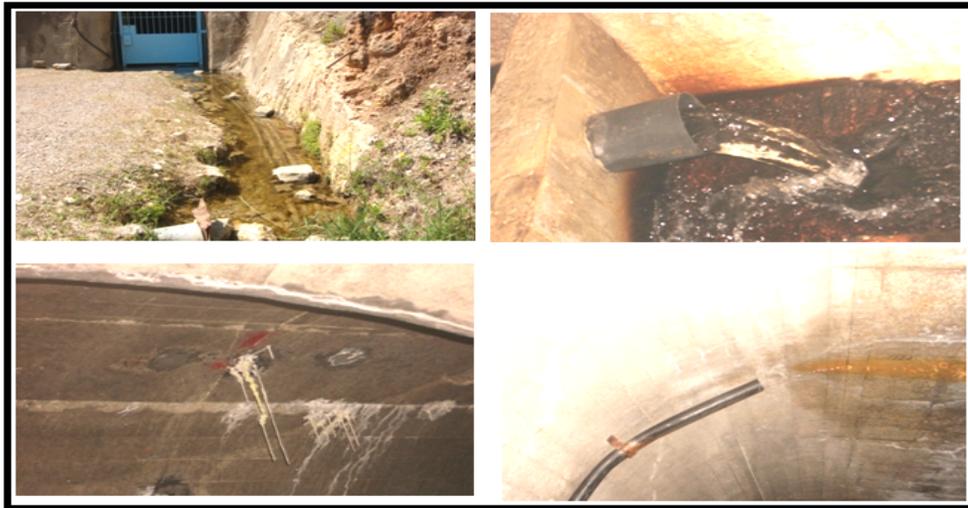
Figure-7. Leaks in the banks of the Gargar dam (Source: Benfetta & Rezik; 2008).

Figure-7 shows leakages. The upstream body of water at the foot of the dam is separated from the basin by a batardeau. Although leaks are observed in the joints of the injection and drainage galleries of both banks, they are much more significant in right bank. This is because the right bank is in contact with the reservoir, while the left bank is in contact with the body of water located upstream of the dam. Leakage in the two galleries increases as a function of rises in the reservoir level and decreases due to sealing after a long period (ANDT 1988-2015b; Toumi & Remini 2004). Some leaks are sealed by the adhesion of molten limestone. The initial design of the dam did not include any devices to measure such leakage. These leakages are also due to the presence of a strong hydraulic gradient. However, the increase of this rate in time and for the same water level of the lake indicates deterioration of the rock mass forming the support of the dam. The rate of leakages was almost on the increase in time and especially when the water level in the reservoir is above the coast 98 m. This could be explained by the fact that the increased hydrostatic pressure resulted in a deterioration of the

bedrock by the appearance of large cracks. It's due to the degraded state of the geological layers. The current solution is to record the flow rate at the exit points of galleries in the right and left bank. Additional test points would enhance the reliability of measures and make it possible to differentiate leaks in the various galleries (injection, drainage and access). It is also important to observe the progress of cracks, which can expand if the reservoir level rises (due to increased water pressure) (ANDT 1988–2015b).

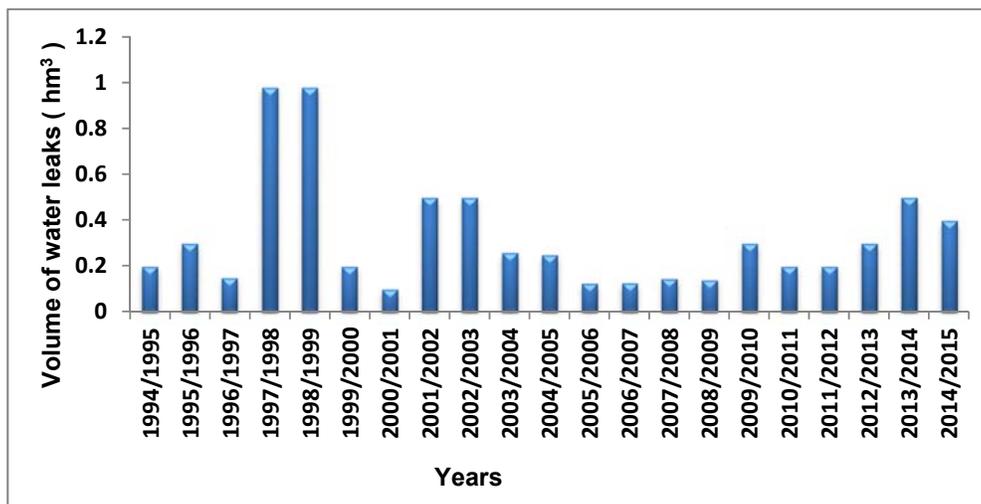
Figure-8. Leakage (hm^3) 1994–2015: Source: own elaboration.

The first analysis concerned the volume of leakage through a study of variations overtime and as a function of the reservoir level. Figure-8 shows leakage estimated by the ANDT for the period 1994-2015 and highlights significant variation. Average annual loss is $0.3 \text{ hm}^3/\text{year}$. The problem is ongoing, and changes from one year to another. Figure-9 shows variation in leakage as a function of the reservoir level, and highlights the close correlation ($R^2 = 0.98$). The second part of the study analyzed leakage flow rates (l/s) for 2004-2008 (fig 10, 11 and 12) and as a function of the reservoir level (fig 13). Figures 10 and 11 show data for the hydrological years 2005-2006. Figures 10, 11 and 12 are discussed in more detail below.

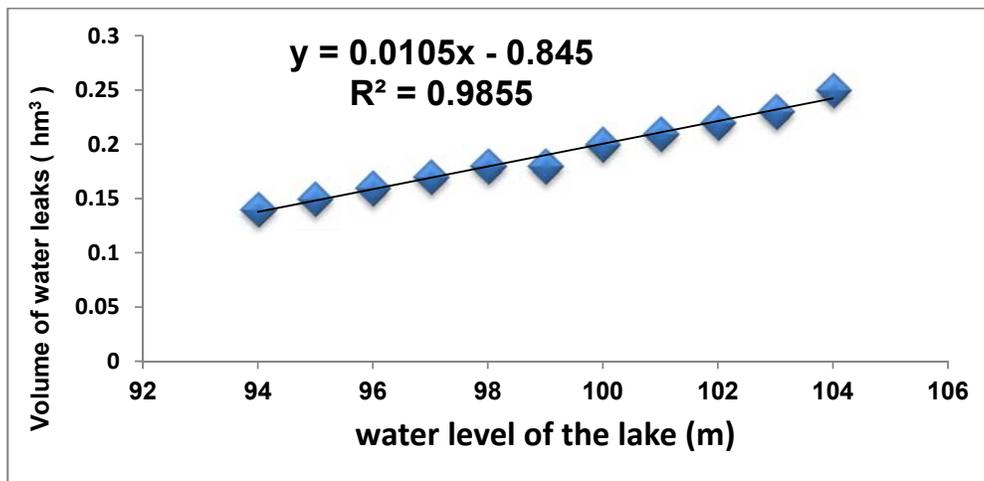
Figure-9. Leakage (hm³) as a function of the reservoir level (m): Source: own elaboration

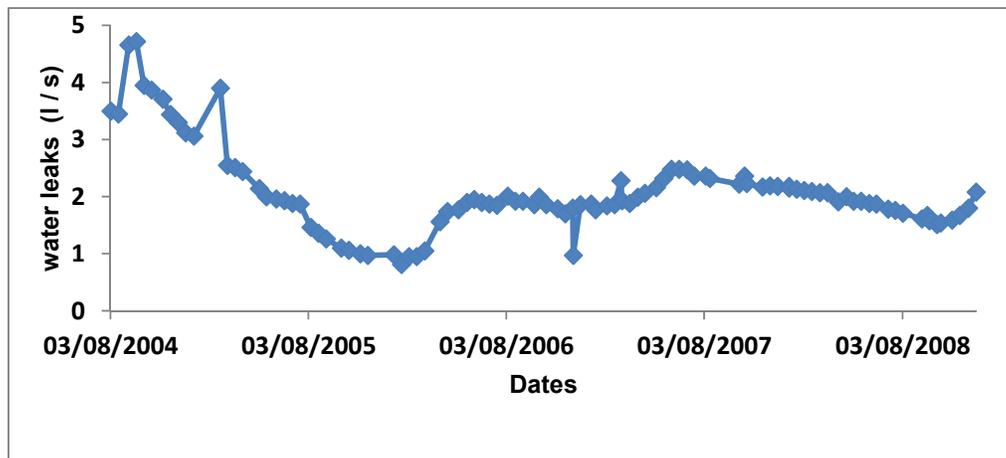
Figure-10. Left bank leakage flow rate (litres/ second) 2004-2008: source: own elaboration.

Figure-10 shows that the flow rate through the left bank exceeded 4.3 l/s in February 2004, reaching 5.98 l/s in May 2004. The flow rate subsequently fell, due to the reduction in the volume of water in the reservoir, reaching 0.81 l/s in January 2006. Figure-11 shows that the flow rate through the right bank exceeded 4.6 l/s in February 2004, reaching 5.98 l/s in May 2004. Like the left bank, the reduction in the volume of water in the

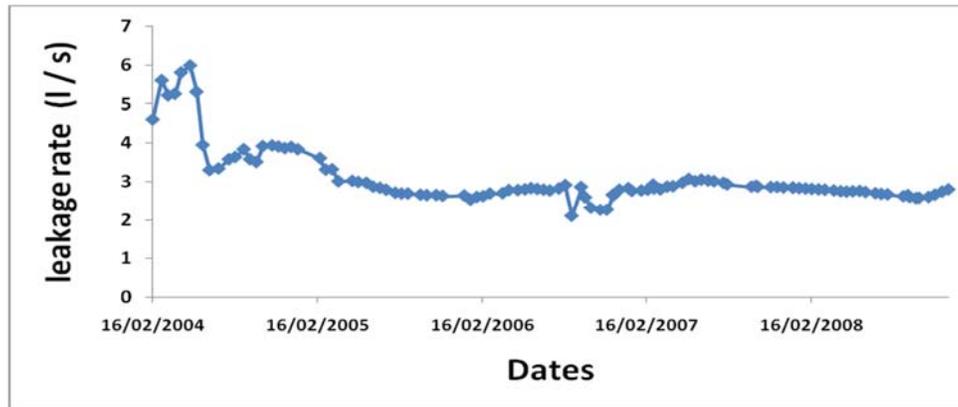
Figure-11. Right bank leakage flow rate (litres/ second) 2004–2008: Source: Own elaboration.

reservoir led to a significant fall in the flow rate, reaching 2.25 l/s in November 2006. Figure-12 shows total leakage flow rates. This follows trends for each bank. A minimum value 8.5 l/s was recorded in February 2004, reaching 12 l/s in May 2004. Like the two banks, levels subsequently fell due to falling water levels in the reservoir, reaching 2.18 l/s in January 2008.

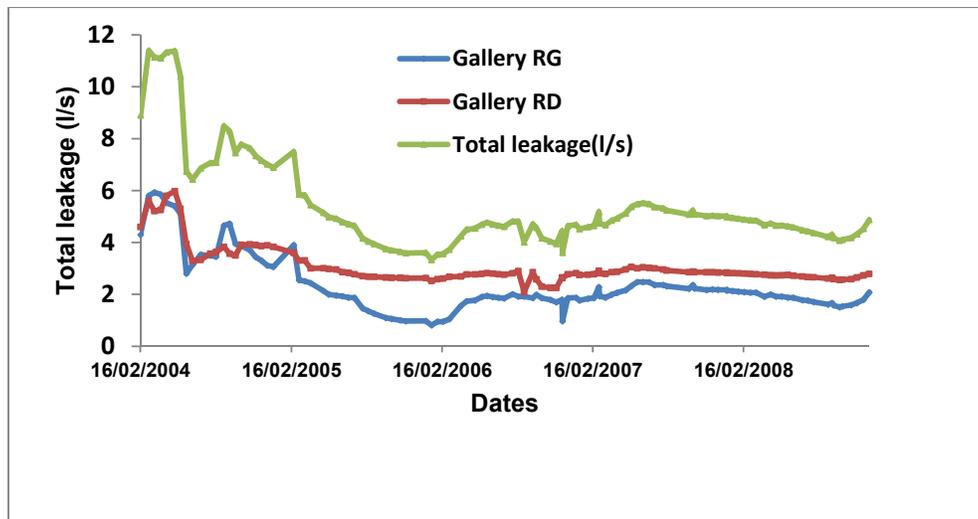
Figure-12. Total leakage flow rate (litres/ second) 2004-2008: Source: Own elaboration.

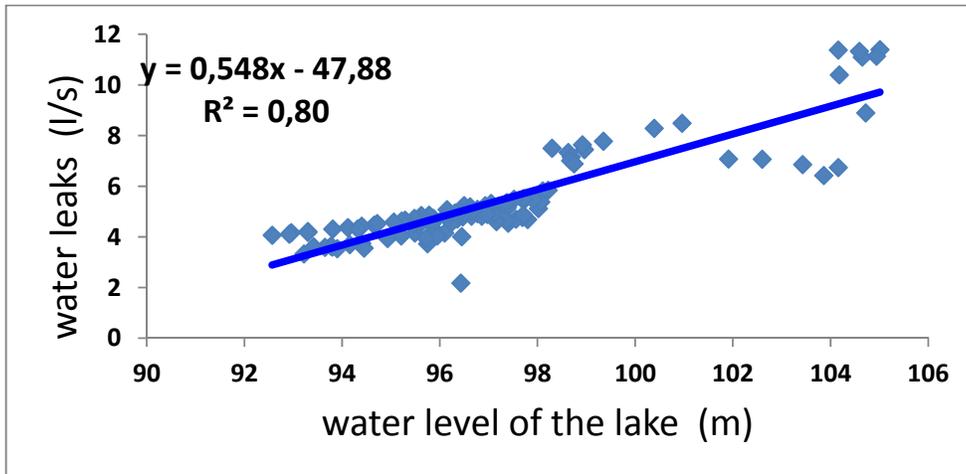
Figure-13. Leakage (litres/ second) as a function of reservoir level (metres): source: Own elaboration.

Figure-13 shows variation in flow rate as a function of the reservoir level for all hydrological years. Flow increases linearly with the water level. The two highest correlation coefficients (0.80 and 0.90) were calculated for the hydrological years 2004-2005 and 2005-2006 (Figures 14 and 15). Figure-13 shows that flow rates increase consistently up to a reservoir level of 98 m, beyond which there is a more rapid increase. This could be explained by the fact that up to 98 m, flow is governed by Darcy's law and depends on the permeability of the

massif. Above 98 m, underground flows no longer follow this law and instead pass through highly permeable layers or faults. This increase was particularly remarkable for the hydrological years 2004-2005 and 2005-2006. Increasing hydrostatic pressure, due to the progressive increase in the reservoir level resulted in a notable decrease in load. This resulted in the deterioration of the rock massif at the dam site, which translated into significant cracks (Benfetta 2007 and 2008; ANDT 1988-2015b).

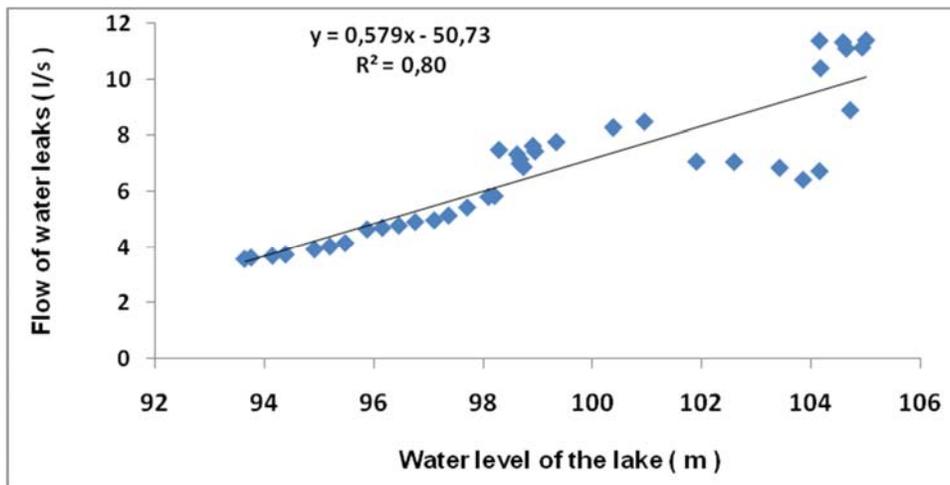
Figure-14. Leakage (litres/ second) as a function of reservoir level (m) 2004–2005: source: own elaboration.

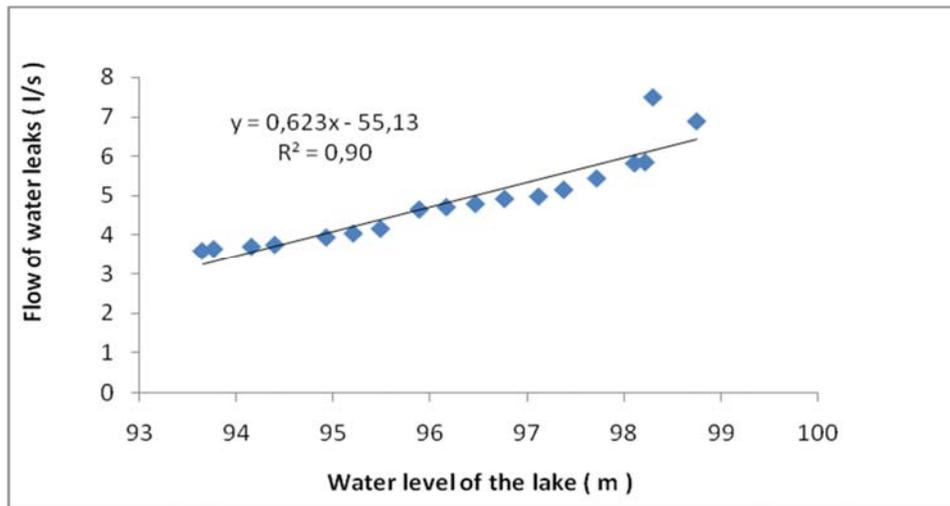
Figure-15. Leakage (litres/ second) as a function of reservoir level (m) 2005–2006 source: own elaboration.

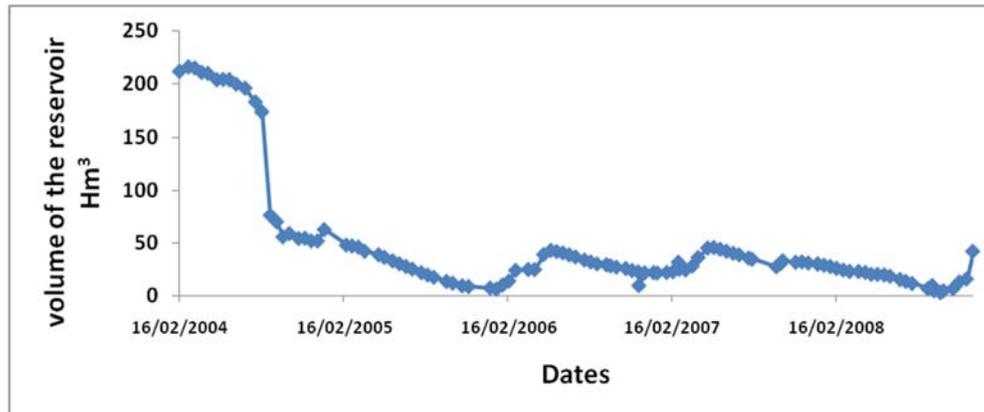
Figure-16. Reservoir volume (hm^3) 2004-2008: Source: Own elaboration.

Figure-16 shows the variation of the volume of the reservoir from 2004-2008. Overall, the volume falls to drought conditions. Furthermore, Figure-17 shows how

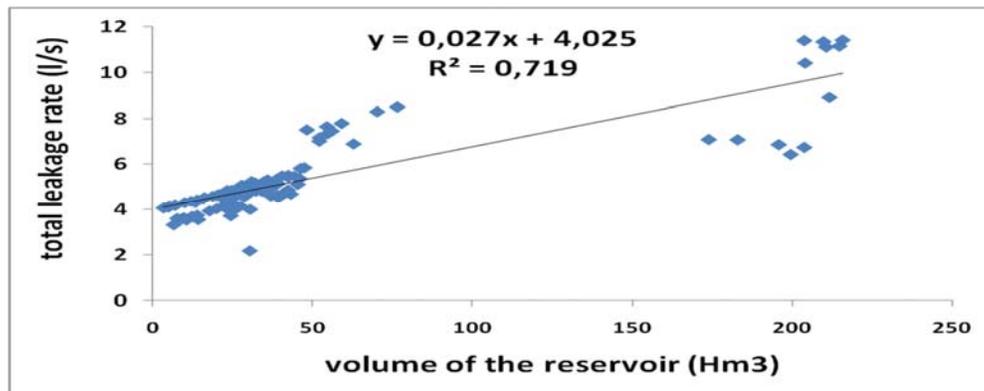
Figure-17. Leakage (litres/ second) as a function of reservoir volume (hm^3): Source: Own elaboration.

leakage falls as a function of the reservoir's volume and shows that low rates are closely correlated ($R^2 = 0.72$).

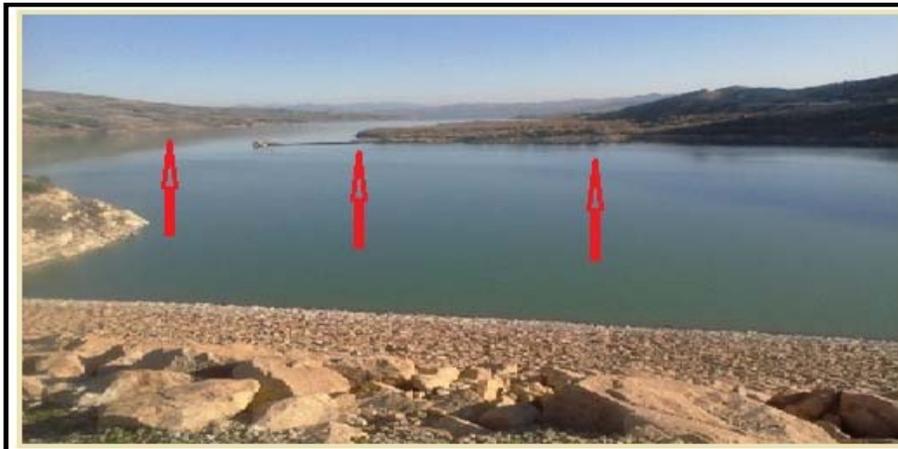
Figure-18. Evaporation at the Gargar dam: source: Benfetta, 2008.

The analyses presented here are based on operational data provided by the ADNT for the period 1989–2015 (ANDT 1988–2015b). Figures 18 and 19 show losses due to evaporation. These range from 5–32.2 hm^3 /year, with an annual average of 21.6 hm^3 /year. Figure 20 shows evaporation as a percentage of total water losses. Total losses range from 9.9–37.1 hm^3 /year, with an annual average of 26.50 hm^3 /year and there is a very close correlation with evaporation ($R^2 = 1$).

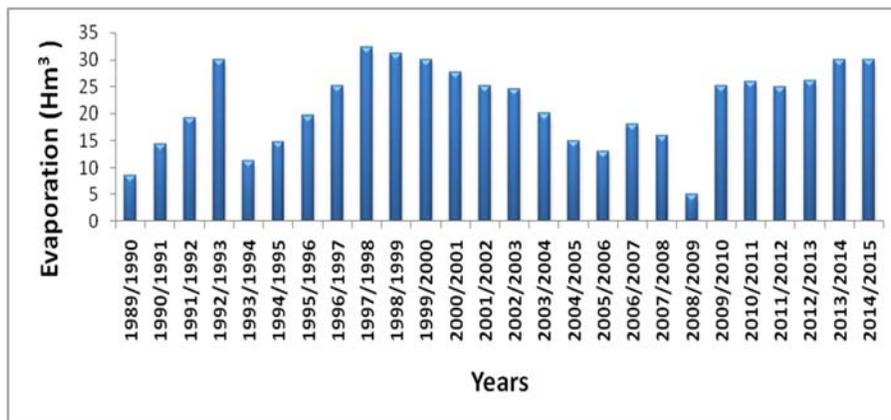
Figure-19. Evaporation (hm³)1989-2015: Source: Own elaboration.

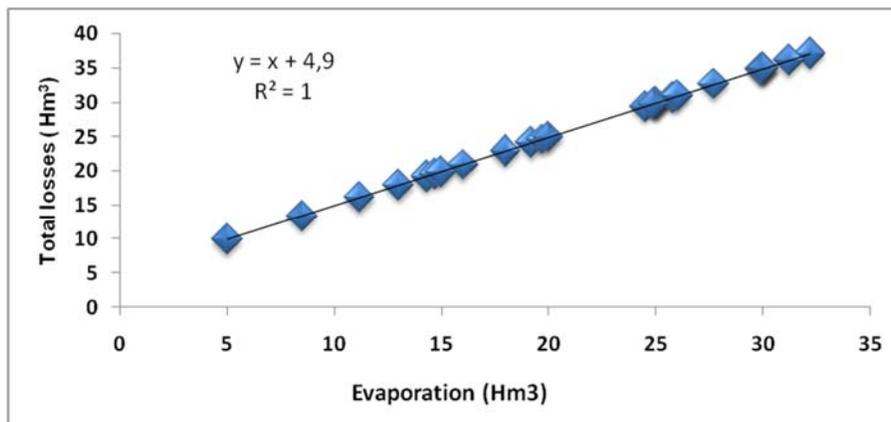
Figure-20. Evaporation (hm³) as a function of total losses (hm³): Source: own elaboration.

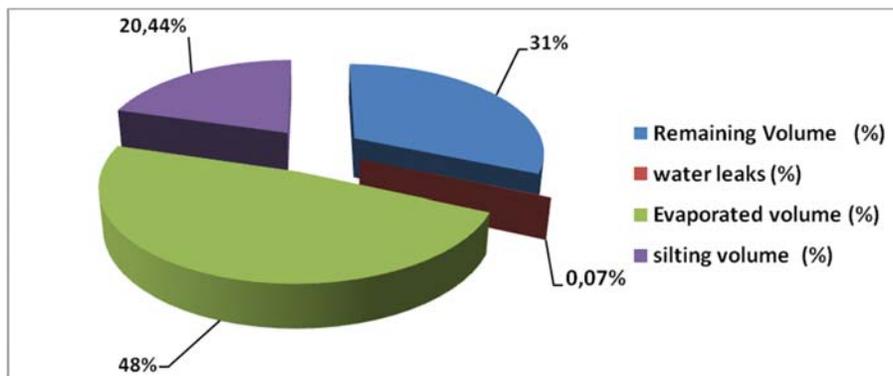
Figure-21. Sources of water loss 1998–2004: source: own elaboration.

Based on data from the bathymetric survey conducted in 2004, the dam has lost 92 million m³ of water over a period of 15 years. This is due to excessive sedimentation, leakage (annual average 0.3 hm³) and evaporation (annual average 21.6 hm³). Total losses for 2004 are estimated at 113.9 hm³, which represents about 25.31% of total capacity (fig 21, 22 and 23). Taking 2015 as the baseline, current losses are estimated as:

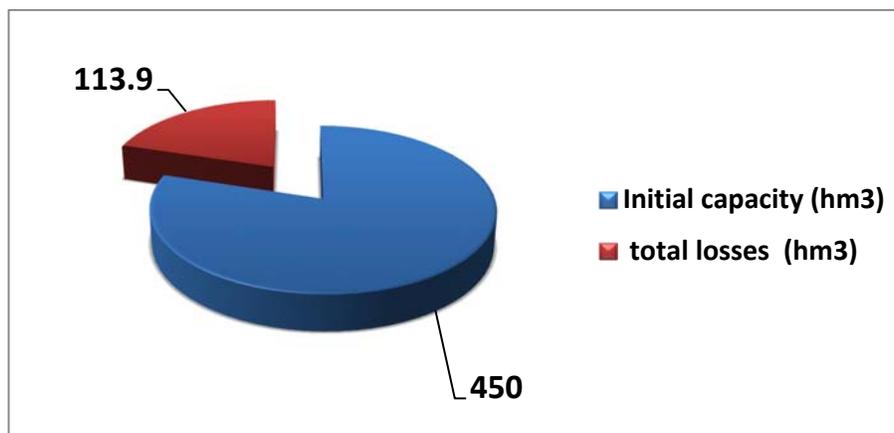
Figure-22. Total water losses (hm³)1998–2004: source: own elaboration.

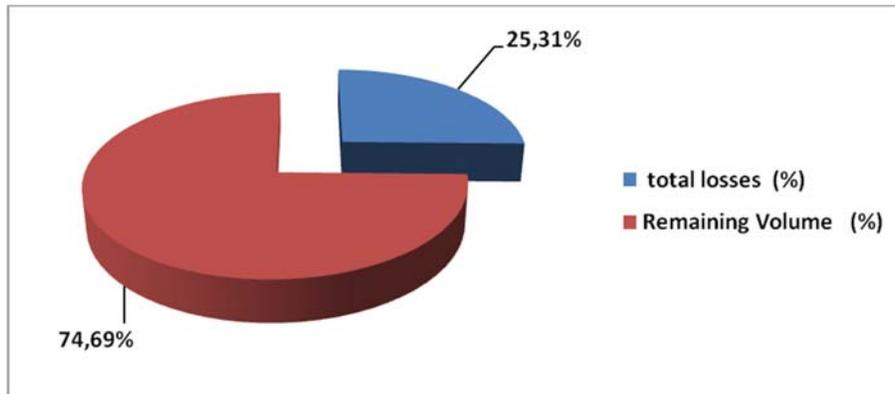
Figure-23. Total water losses (%) 1998–2004: source: own elaboration.

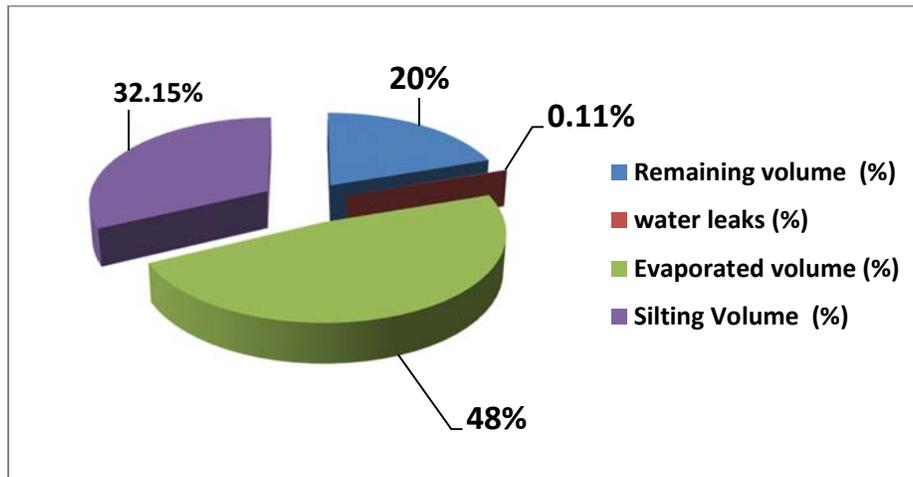
Figure-24. Percentage water losses by sector 1988–2015: source: own elaboration.

This makes a total loss of 166.8 hm³, representing about 37% of total capacity (Figures 24, 25 and 26). The most important factors are leakage and sedimentation,

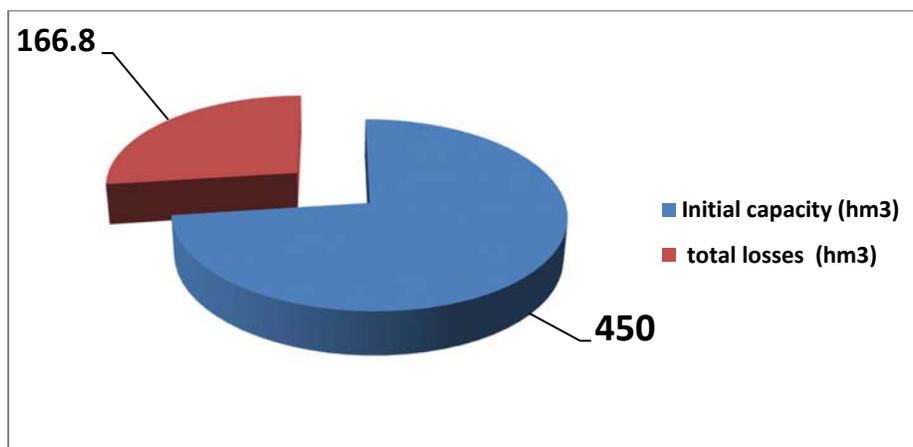
Figure-25. Total water losses (hm³)1988-2015: source: Own elaboration.

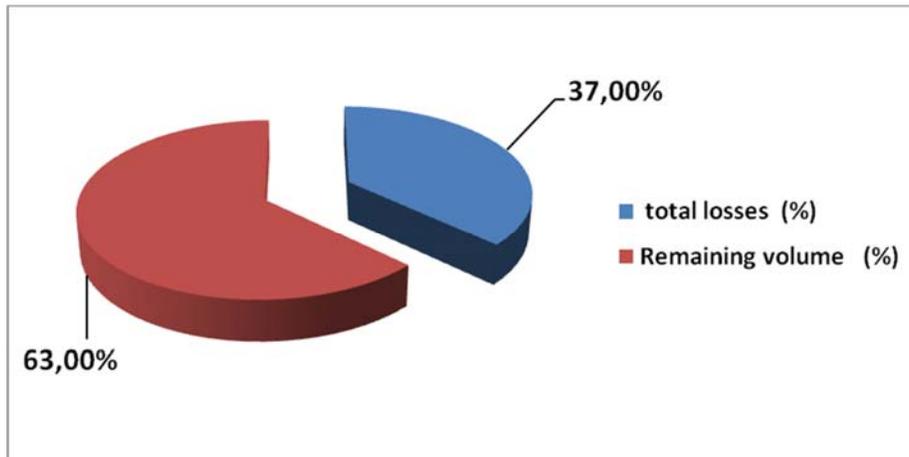
Figure-26. Total water losses (%) 1988-2015: source: own elaboration.
