ANALYSIS OF THE CAUSES OF DISTRESSES IN A PRE-STRESSED CONCRETE BRIDGE

In recent years, distress has been observed in several PSC structures, which had a latent weakness due to lack of good detailing, improper design, adverse climate, and absence of skilled work man to manufacture and place good quality concrete. In some cases there would be multiple interacting events to cause distress. Common interactive causes are corrosion combined with poor quality of construction or improper design with heavy load etc. This paper describes a PSC bridge of balance cantilever-cum-suspended span type, distressed due to improper design and poor quality of construction. Stresses at cracked section have been calculated. The nature of the failure, location of crack and cause of distress has been discussed.

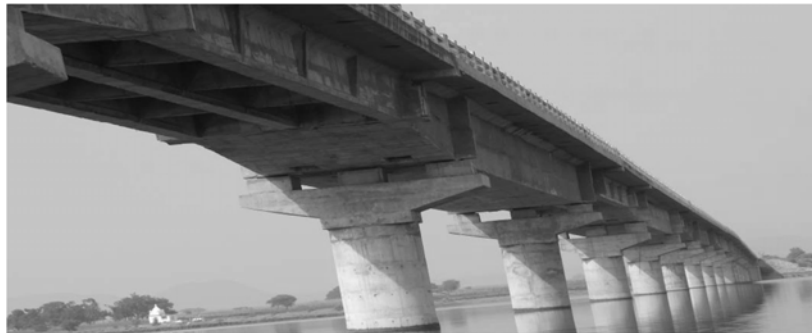
Figure-1. General view of the bridge.

The bridge is a high level, balance cantilever-cum-suspended span deck Type Bridge with sixteen spans resting on hollow circular piers, supported on well and open type foundations. A common structural unit consists of 44.5m pre-stressed concrete box with 12.5m cantilever on one side and 9.5m cantilever on the other side. A suspended span of 26.7 m in length resting on the tip of cantilevers from both sides. The suspended span has pre-stressed concrete three girder system. Some supported spans are larger than 44.5m Figure-1.

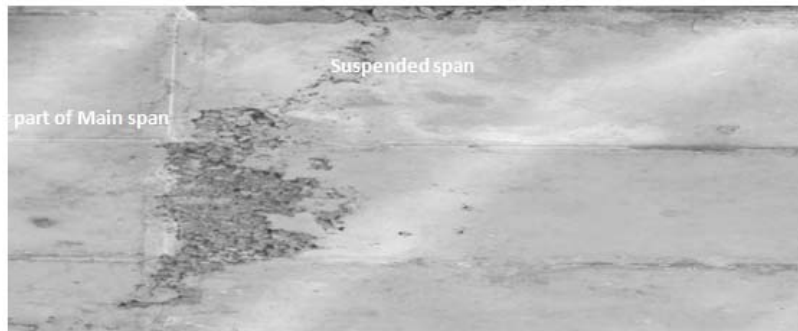
Figure-4. Honey combing at soffit level.

- Cross girders of other suspended span are damaged and steel is exposed. The sides of box deck appear to have been honeycombed, and are repaired. At many other locations also honeycombing is observed (Figure-4).

Small damages/ honeycombing within the structural elements reflect badly on the quality of structural elements and workmanship.

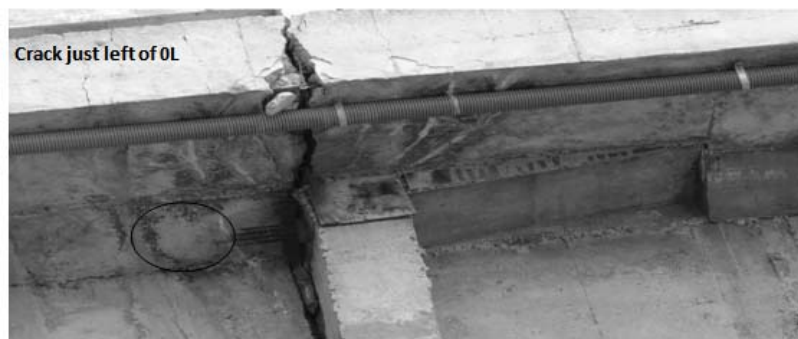
Figure-6. Location of crack and curtailment of cable number VIII view from bottom.

- The deck is supported on 2 Piers and cantilevered on both sides with a suspended span supported on cantilever Figure-2.
- Supported deck on piers is 44.5m (main span) and cantilever is 12.5m on abutment side and 9.0m on other side Figure-10.
- Suspended span has 3 pre-stressed girders and deck slab above Figure-3.
- Depth of water is 20m at present. Maximum water level is 2m above the present water level.
- The cantilever on pier P10 towards P11 has sagged, therefore the suspended span has also deflected at that end. Figure-10.
- There was a wide through crack in the main span supported between pier P9 and P10 just left side (Jigna side) of pier P10. Because of this cantilever on Barhi side has sagged Figures 2, 6 and 7.

At this section (at the face of the cantilever near pier P10) cable number VIII (4x8= 32 strands) has been curtailed without bothering about the section just left of it Figure-6 and Figures 8 and 9. Now considering the section just left of the above section i.e. 0L. Stresses Produced by dead load and live load moments at the top and bottom will nearly be equal to the same as at 0L i.e. -65.3 kg/cm² and 83.9 kg/cm² respectively. But now only 200 strands are available, i.e. there is a deficiency of 32 strands. External Stresses induced by Pre-stressing force after considering all losses at top and bottom will be reduced to 58.9 kg/cm² and 6.46 kg/cm² respectively. Final stress at

top is -6.42 kg/cm², which is negative, hence unsafe as no tension is allowed in service condition clause 7.2.2 of IRC18 2000. Final stress at the bottom is 90.39 kg/cm², which is less than the allowable stress in flexure compression for M35 grade of concrete (118.96 kg/cm² as per clause 7.2.1 of IRC18 2000). The moment due to DL and LL just left of this section will not reduce sharply and the number of strands required, will be the same, but there is a sudden deficiency of 32 strands Figures 8 and 9. Hence, there is a shortfall in the pre-stressing, and it is reflected by the structure as the crack is just left of the section.
