REPAIRED OF FIRE-DAMAGED CONCRETE-FILLED DOUBLE SKIN STEEL TUBULAR (CFDST) COLUMNS WITH FIBER REINFORCED POLYMER (FRP)

ABSTRACT

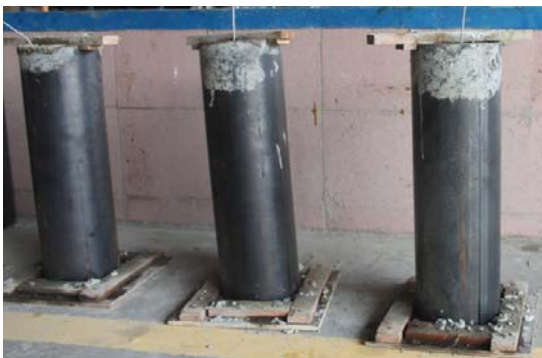
a) Unheated specimens

Physically, there is no changes can be seen from before (

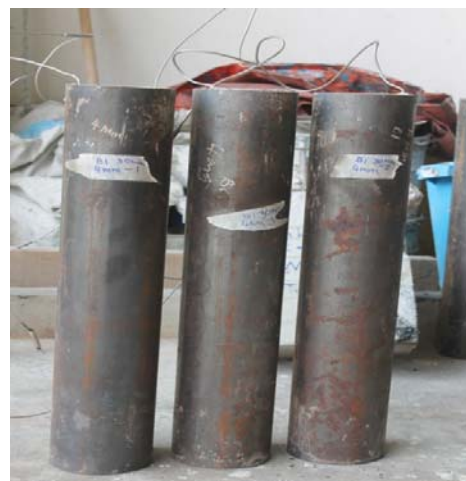
c) Heated specimens

Figure-1(c)) the specimens being exposed to fire. Besides, the appearances of outer steel tube of specimens exposed to 60 and 90 minutes of fire were similar to each other. However, once the outer steel tube was removed, the color of concrete changed from grey to whitish grey indicating that the maximum temperature of concrete exceeding 300°C. Similar finding was reported by other researcher such as (Short *et al.* 2001). The changes in concrete color are shown in Figure-4. Furthermore, the concrete was still intact when the outer steel tube was removed for control and specimen with fire exposure of 60 minutes (Figure-4(a) (b)). However, concrete in specimen

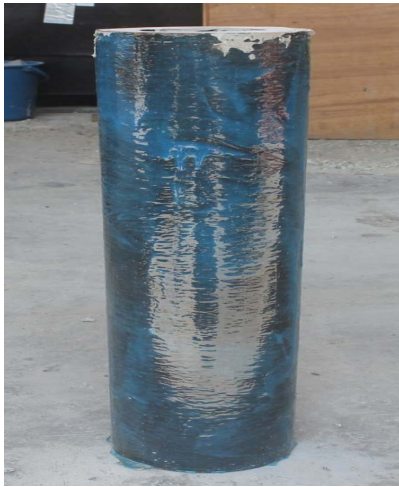
d) Heated and repaired specimen

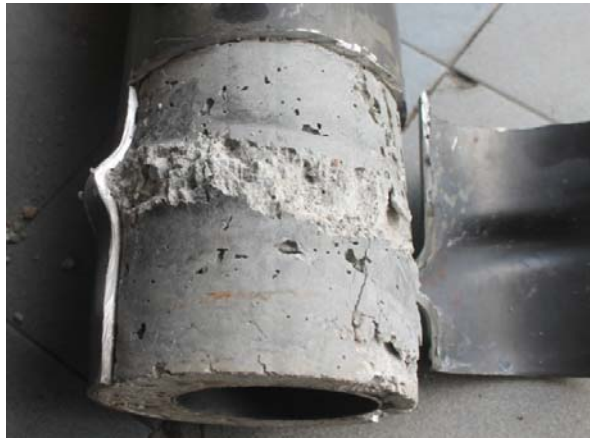
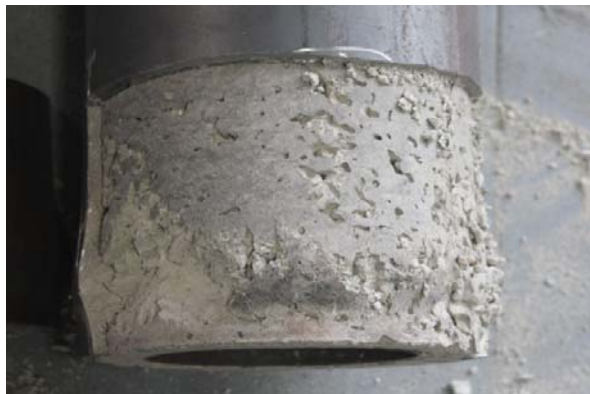
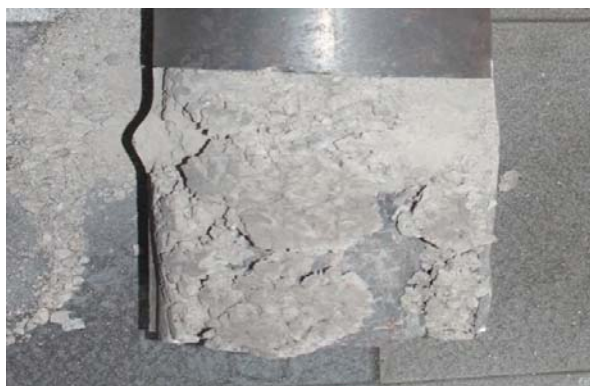
Figure-4. Condition of concrete before and after fire exposure.

(a) Control specimen

(b) Specimen exposed to 60 minutes of fire

(c) Specimen exposed to 90 minutes of fire

exposed to 90 minutes of fire was very brittle and crumble to touch (Figure-4(c)).

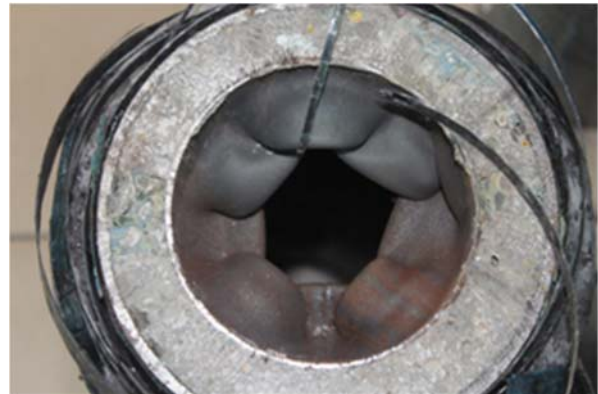
Figure-5. Failure pattern of inner steel tube.

buckling of inner steel tube is shown in Figure-6(a), Figure-4 and

Figure-5, respectively. However, local buckling of specimens exposed to 90 minutes of fire was more severe than control and specimens exposed to 60 minutes of fire. Position of local buckling of both steel tubes was found to be corresponded with crushing of concrete. Repaired fire-damaged specimens failed by explosive rupture of FRP followed by failure similar to control and unrepaired specimens either at mid-height or near to or bottom end of the specimens (Figure-6(b)). However, the explosive rupture of FRP was more violent in single layer than Hybrid FRP. Rupture of FRP occurred outside overlap region indicating that 100 mm of overlapping is sufficient to avoid premature failure due to poor installation of FRP. Prior to rupture of FRP, loud cracking sound can be heard from the tested specimen. This can be associated with FRP being fully activated.

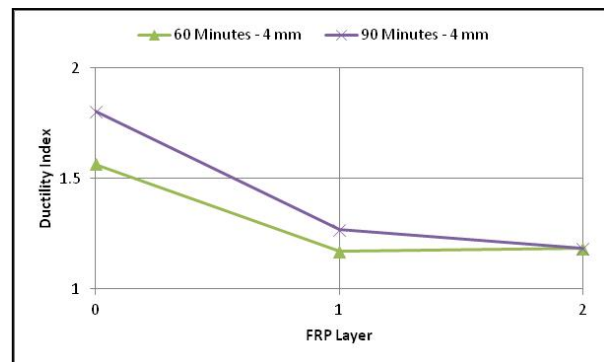
Figure-12. Effect of FRP on ductility index.

Figure-11, DI of fire exposed specimens increased with increasing fire exposure time. In other words, the specimens became more ductile after fire. However, this phenomenon diminished after the specimens being repaired. Therefore, no enhancement in DI can be expected for repaired specimens due to previous increment of DI after fire. On the other hand, repairing the fire-damaged specimens with Hybrid FRP enhanced the DI of specimens exposed to 60 minutes of fire. Nevertheless, DI of specimens exposed to 90 minutes of fire remains almost similar to single FRP. This can clearly be seen in
