## IMPACT OF IMPROPER LANDUSE CHANGES ON FLASH FLOOD AND RIVER SYSTEM-A CASE OF SG PUSU

The impact of landuses can cause significant changes in the hydrological regime of a river basin. Sg. Pusu is a recent example in Malaysia, which is going through indiscriminate changes in the landuses. This study was conducted in response to the recent severe flash flood occurred on 4<sup>th</sup> June, 2014 due to high rainfall intensity of 82.4 mm/hr which lasted about 2 hours. The flooding depth varied from 0.3 to 1.0 m and the flash flood duration was about 1.5 hours. Although the duration was short but it damaged 12 cars, inundated 2 blocks of the hostels (Mahallah) and caused inconvenience to the staff and students of the campus. The drainage and river systems of the campus was functioning properly as the seven ponds and lakes constructed along the rivers and tributaries could reduce the peak flows coming from the upstream areas. However, due to improper land clearing from 2009 and onwards, the peak flows during the rain events have increased significantly, the lakes and ponds constructed by IIUM has silted up and lost their flow reduction ability. As a result the flash flood incidents h

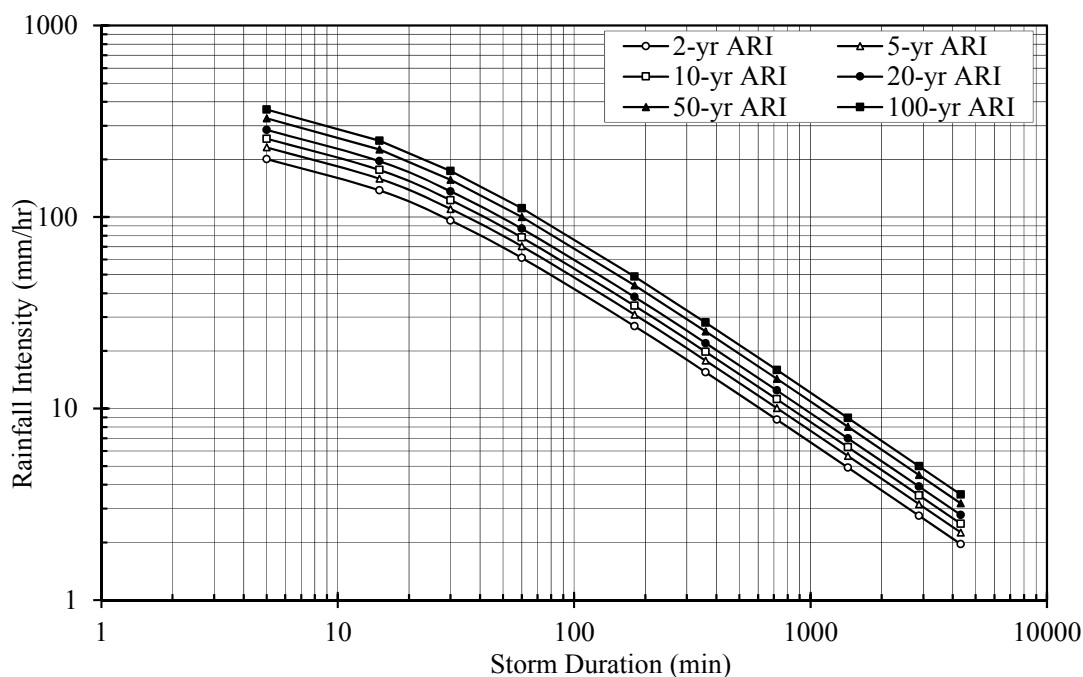
Figure-4. Mean I-D-F curves for Sg. Pusu.

The design rainfall intensity-duration-frequency (I-D-F) curves of various return periods (Figure) were calculated based on the revised Hydrological Procedure (HP) of DID, Malaysia. The I-D-F values were calculated based on the regression coefficients proposed for the five automatic rainfall stations around Sg. Pusu (Table-2). The coefficients of Table 2 was used to produce the I-D-F curves (Figure-4) to calculate the return period of the rainfall intensity occurred on 4<sup>th</sup> June, 2014.

Based on the rainfall recorded at the surrounding stations (Figure 3 and Table 1), the mean highest hourly rainfall on 4<sup>th</sup> June was 79.1 mm/hr. Compared to the I-D-F curves given in Figure the rainfall was equivalent to 11-year return period. This indicates that due to significant change in the upstream catchment landcover and hydrology rainfall intensity of small return period also can cause flood in the downstream areas of Sg. Pusu including the IIUM Campus.

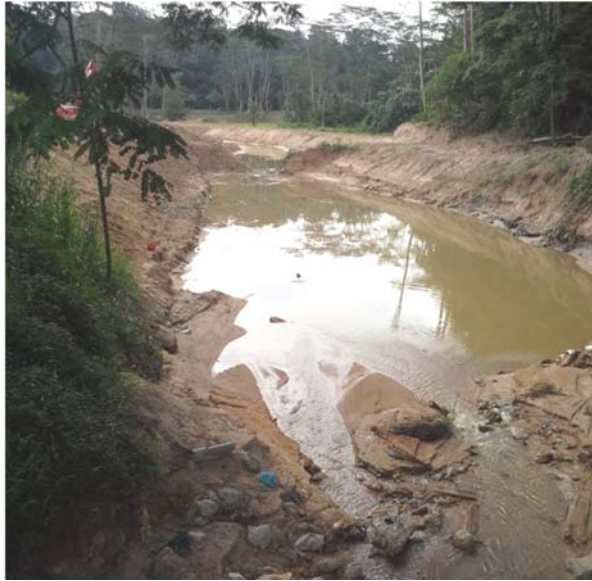
**Plate-1.** Re-excavation of pond 5 at IIUM.

Prompt actions were taken by the University Management to clear the campus of flood debris. The Star on-line news media praised the action taken by the university and reported on 7 June, 2014 that mess caused by the flood at the International Islamic University Malaysia's (IIUM) campus in Gombak has been cleared quickly. The IIUM also has taken initiative to remove the sediments from the lakes and ponds to regain the storage capacity of the facilities (Plate 1), which will help reduce the peak flow in the rivers passing through the campus. However, the lakes will be quickly filled up during the next heavy rainfall if the upstream developing areas do not

have proper sediment traps as required by MSMA and other Authorities.
