A STUDY ON DAMAGE ASSESSMENT OF RC BEAM WRAPPED WITH CARBON FIBRE SHEETS USING PARAMETERS OF ACOUSTIC EMISSION SIGNAL

Keywords: acoustic emission, carbon fibre sheet, signal strength, static load test.

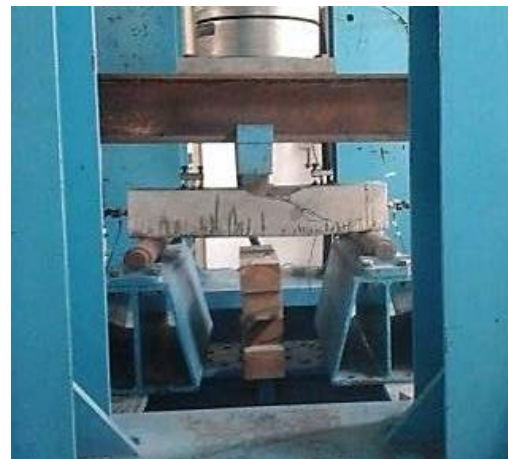
Figure-4. Three point of bending load of RC beam specimens in conjunction with AE technique.

The RC beam specimens were prepared with concrete strength grade C40. The RC beams specimens were designed as a singly reinforced with 2T16 to strengthen the tension part and 2R8 to act as hanger bars. Each bar was bent at both end to form a standard hook of 30 mm at compression part and 60 mm at tension part. A total nine RC beam specimens of 150 mm x 150 mm x 750 mm and 20 cubes of 150 mm x 150 mm x 150 mm were prepared. The RC specimens were cured in curing tank for 7 and 28 days. The average compressive strength for 7 days was found to be 33.87 N/mm² meanwhile for 28 days was 43 N/mm². CFS with required length was bonded on the RC beam using epoxy resin adhesive on the soffit. Then, the wrapped beam kept in room temperature for more than one week (Takeda *et al.*, 1996). The steel plates with the required length were installed on selected location on the beam surfaces. Three point bending using a servo-controlled Universal Testing Machine (UTM) was used in conjunction with AE testing. It was performed under constant load rate of 0.02 mm/s. Figure-4 shows the bending test were setup. Four AE sensors R61 - resonant 75 kHz were attached on the specimens. The sensors were placed with high-vacuum silicon grease as couplant to the beam surface. The visual inspection was also carried out to compare with the AE signals strength data in data acquired system. For the analysis using AE signal strength, it based on the collected data at Channel 4. The signal strength was measured in nano-volt-sec (nVs).

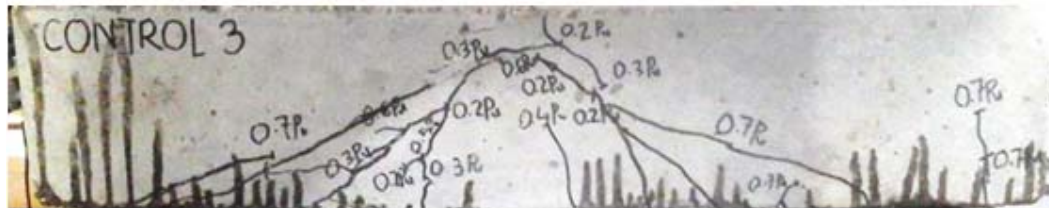
Figure-5. Visual observations on control 3 specimen.

Figure-5 shows the cracks patterns of the plain RC beam under seven phases of increasing static load test. The phase from number 1 until seven tells the progression

of crack pattern corresponding to Phase 1 to Phase 7 of loading.

It is found that there was no crack detected by visual inspection for phase 1 when maximum loading (Pmax) of 11.5 kN was applied. This indicates that the

Therefore, it is found that the result obtained from visual observation was compatible with the graph signal strength against X-location. Then, in phase 3, the initial development of shear crack was clearly seen by naked eyes. The highest value of signal strength here identified was 11400 nVs at at distance 0.4 m from the edge of beam specimen.

This result tells that in this phases, as cracks propagated and developed the signal strength can maintain the energy to 11400 nVs. Meanwhile when the testing reach to phase 7, it is found that the shear cracks was aggressively growth beyond the midspan beam surface when the load reach failure as shown in Figure 4.3. Therefore, based on the results obtained from visual inspection and relationship of signal strength against X-locations, it was clearly shown that the small increment of cracks progression can produce high energy value of

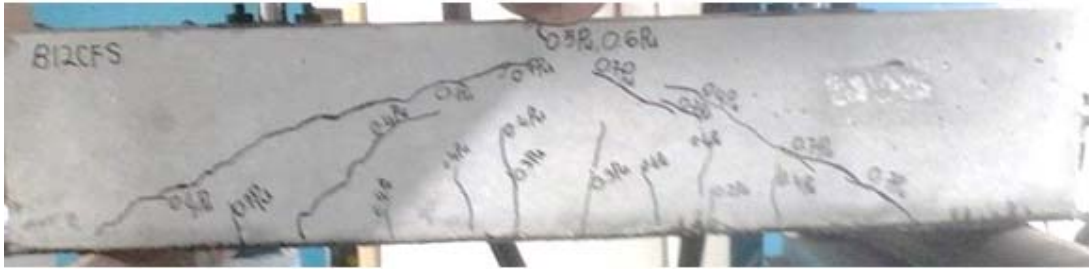
Figure-9. Visual observations on B2 2CFS specimen.

Under loading value of 15.3 kN of phase 1, there was no crack occurred. However, the crack was firstly visible at the midspan of the beam specimen as shown in Figure-9. It was shear cracks growths at distance 0.37 m from the edge of beam specimen. The highest energy of signal strength produced in this phases identified was 1350 nVs.

In phase 4, there are too much tensile cracks developed in this moment. But, the CFS layer is still in a
