TANGENT DELTA LOW VOLTAGE HIGH FREQUENCY AC METHOD TO MEASURE HV UNDERGROUND XLPE CABLES

A. R. Avinash, Chandan Kumar Chakrabarty, Navitharshaani Permal and Agileswari
College of Engineering, University Tenaga Nasional, Kajang, Selangor, Malaysia

Keywords: 132 kV cables, dissipation factor, HFAC, high frequency, tangent delta, XLPE.

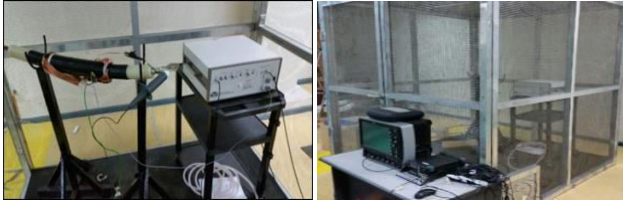
Figure-9. Laboratory setup for HF tan delta measurement system.

The laboratory test was carried out using the newly developed tan delta measurement method. The setup is shown in Figure-9 below.

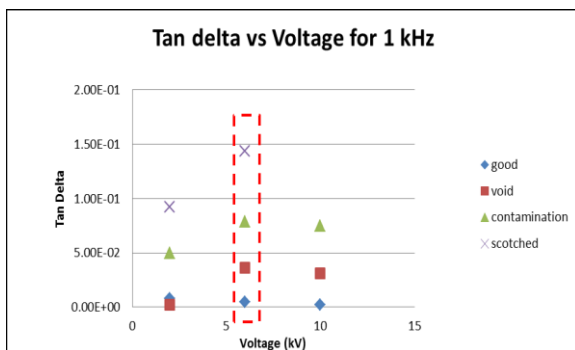
Figure-10. Tan delta vs. voltage at 1 kHz.

The tan delta measurement method is able to discriminate better at 6kV and 10 kV. The best resolution of tan delta between all the cables is clearly seen at 6kV at 1 kHz as shown in Figure-10 above.

A linear trend line equation is observed from the plot as follows [2]:

$$y = 0.3668x + 0.6190 \quad (1)$$

Calibration curve obtained is with 90.17% confidence level. All HF tan delta value obtained in the future will divide with base value and substituted as x value into equation. After obtaining the y value using linear equation above, it has to be multiplied with base of 50 Hz. The result will be HF tan delta value that is converted to 50 Hz.

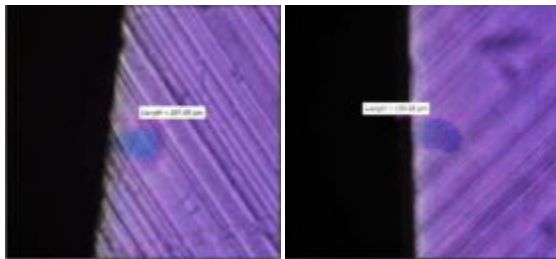
2. Vented Tree from Screen

**Figure-14.** Examples of vented tree.

- Measurement of voids, contaminants (power utility company specification)
 - Max void size: 0.05mm
 - Max contaminant size: 0.125mm
- Measured water tree size
 - Max: 0.646mm

Remarks - Water tree's were observed from the affected cable sample (A).

Water trees are well known to cause reduction in the breakdown strength of the cable by increasing the electrical stress in the cable. Both bow tie and vented trees are common water trees detected when a breakdown occurs. Bow-tie trees are related to impurities and they grow in the opposite direction along the electric field lines [5]. Vented tree are mostly related to the mechanical damage of the cable insulation and irregularity in the semiconducting screen that cause contact issues with the insulation. [6].

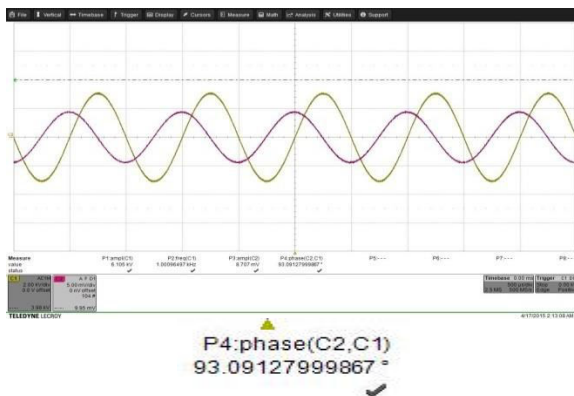
Figure-17. Signal traces for cable 2 at 6kV.

Figure-15 to Figure-18 displays the traces for both the cables at 6 and 10 kV each. Signals were averaged to 1000 samples to display a clearer and more reliable result. No distortion were observed from the traces thus proving a reliable tangent delta result.

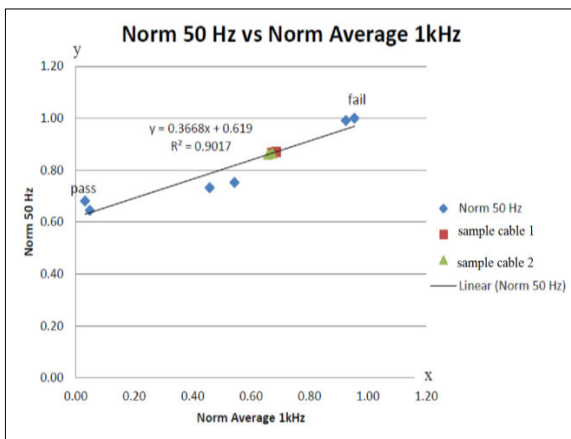
Figure-19. Calibration curve of normalized 1 kHz.

Calibration curve obtained is with 90.17% confidence level. The HF tan delta value obtained is divided with base value and substituted as x value into equation to get y value using linear equation above. Tangent delta for both cables is very close based on the calibration curve in Figure-19 above.

A linear trend line equation is used to plot the normalized values of cable 1 and 2 [2]:

The sample 1 and 2 correlates to the calibration curve and is very close to the high severity range of the cables. This shows that cables 20 meters away are also affected and may breakdown if used continuously. This results had been feedback to the power utility company and the cables has been excavated and removed.
