## EFFECT OF CUTTING SPEED ON BIO-CORROSION OF AISI 316L STAINLESS STEEL

### ABSTRACT

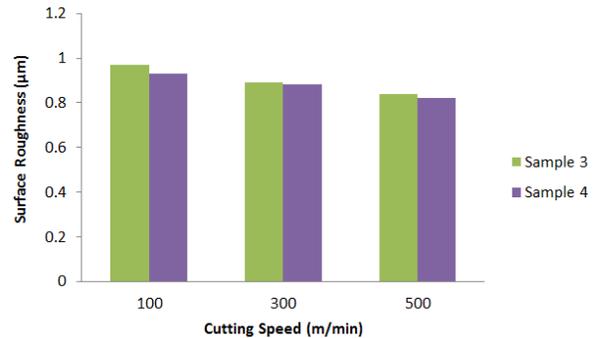
Considering the face milling was done at the same feed rate and using the same type of cutting tool, it was expected that the surface roughness to be similar, within the value of Ra between 0.8 and 1.2  $\mu\text{m}$ . The results as shown in Figure-1 showed that the surface roughness values were within the expected range. However, it was found that there is tendency that the increase in cutting speed reduces the surface roughness.

**Figure-1.** Surface roughness versus cutting speed for two selected samples

Although not as expected, the trend that the surface roughness is inversely proportional to cutting speed is in agreement with previous work [9]. However, in the reference, there was no satisfactory explanation on why the phenomenon occurred.

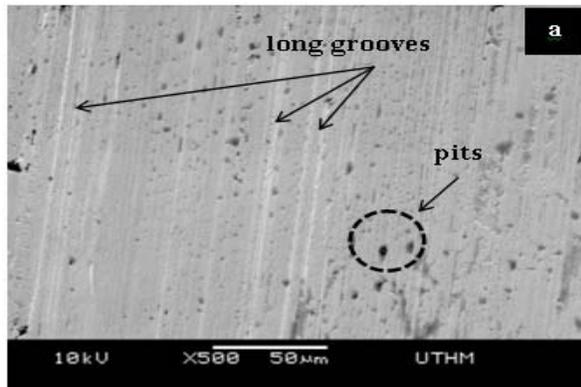
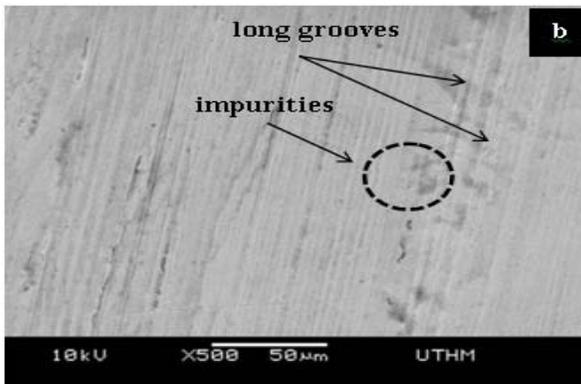
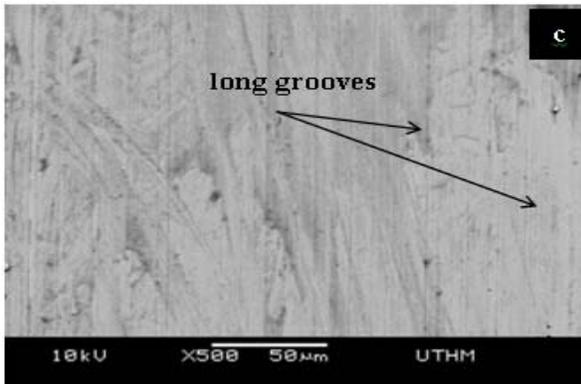
Figure-2 represents the surface of machined samples under observation using Scanning Electron Microscopy (SEM) with 500x magnification to assess the surface morphology. The machined surface consists of long straight grooves as the feed marks and of ridges in between the grooves from the tool's rubbing action. This is typical on surface of machined steel [9]. The machined surface produced at cutting speed of 100 m/min shows pits. For surface produced at higher cutting speeds, the presence of pits was fewer. There was less clear differentiation between feed marks and ridges at surfaces produced by high cutting speeds. From these, the finer surface produced at higher cutting speed was likely due to less defects on the machined surface. Such fewer defects might be the result of machining at higher temperature induced by higher cutting speed.

**Figure-2.** The surface microstructure examined by SEM with cutting speed: (a) 100m/min, (b) 300m/min, (c) 500m/min.

The results showed that there is apparent difference in corrosion rate for the AISI 316L stainless steels machined at different cutting speeds. Generally, corrosion rate is lower for samples produced at higher cutting speeds. Possible reasons for this include the less surface area for samples produced at higher cutting speeds. Referring to the morphology, pits were more in existence for samples machined at low cutting speed. Also, referring to the surface roughness, there is good chance that lower surface roughness (which is produced at high cutting speed) means less surface area. Another possible reason is there were less peaks on the surface of the samples produced at higher cutting speeds. It is known that peaks are the sites prone to corrosion attacks. The higher the cutting speed, the less obvious the difference between feed marks and ridges, which means the peaks (and also the valleys) were less in sharpness and/or fewer in number.

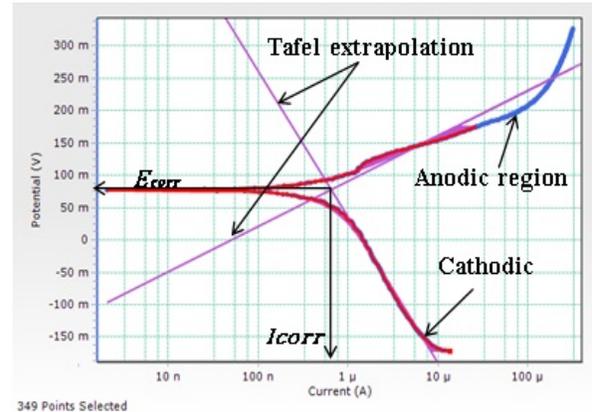
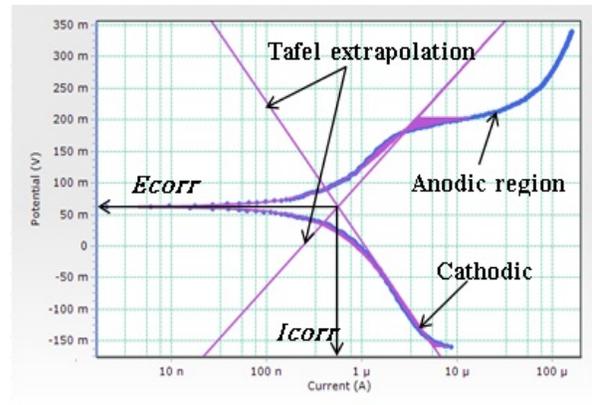
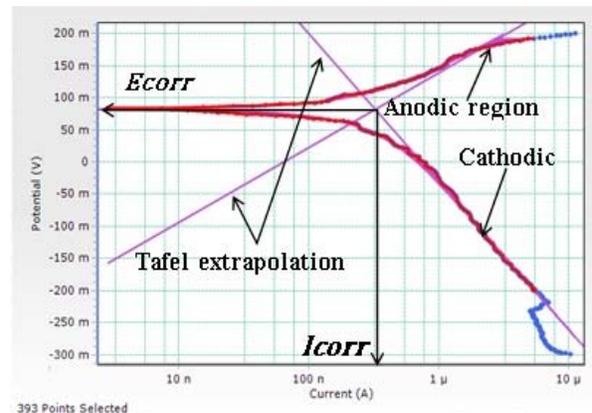
Bio-corrosion test in order to observe the corrosion behavior on the AISI 316L stainless steel using Potentiodynamic Polarization Test resulted in polarization curves as shown in Figure 3. The curves could then be processed to extract the corrosion potential, corrosion current density, and corrosion rate, as shown in Table 1.

**Figure-3.** Tafel extrapolation at polarization curves of three cutting speed: (a) 100 m/min, (b) 300 m/min, (c) 500m/min.

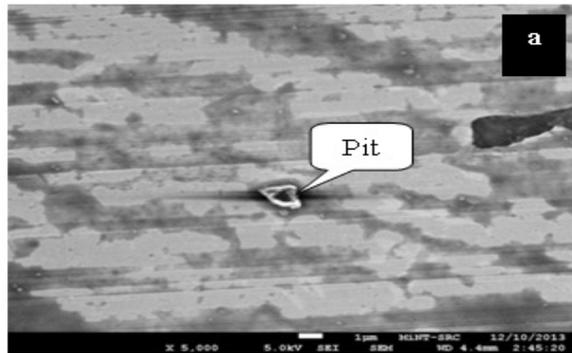
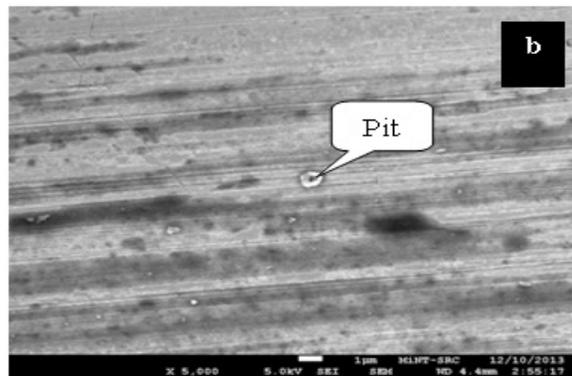
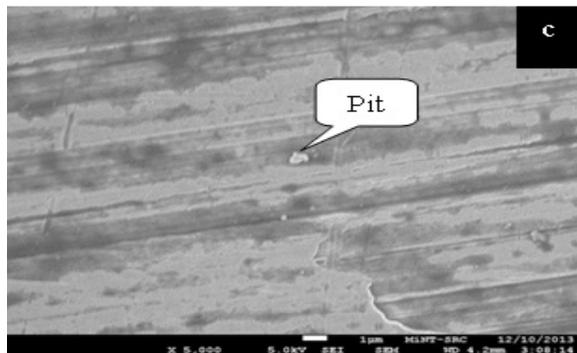
From Figure-4 which shows the surface morphology after the potentiodynamic polarization test, the corrosion product on the surface was not apparent. It was as expected considering the high corrosion resistance nature of stainless steel.

**Figure-4.** The surface microstructure examined by SEM after potentiodynamic polarization test. The mark area was the pit initiations occur at the surface with cutting speed at (a) 100 m/min, (b) 300 m/min and (c) 500 m/min.
