## CRITICALITY OF CONDUCTOR/CASING INTEGRITY FOR AGEING OFFSHORE WELL LIFE EXTENSION

Ramesh Ramasamy, Zainah Ibrahim and Meldi Suhatri

Department of Civil Engineering, Faculty of Engineering, University of Malaya, Kuala Lumpur, Malaysia

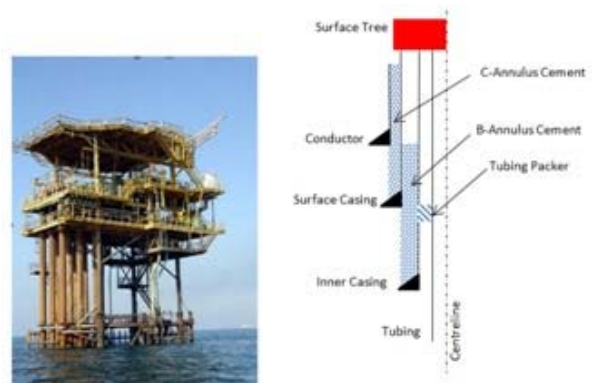
In order to keep up with energy demands and the volatility of the oil price, operators have been looking to extend the service life of their offshore wells. A significant number of the offshore wells located in the areas such as the Persian Gulf and the North Sea are operating beyond their intended design life. A good maintenance program put in-place can ensure safe operation and continued fitness-for-purpose of these wells and their structural components. In the absence of this, and combined with demanding operating and environmental conditions, these wells can experience severe degradation and may result in catastrophic failures. An effective integrity program is expected to achieve complete zonal isolation throughout its service life, although not necessarily the case in reality. An ageing wellhead platform tower (WHPT), shown in

**Figure-1**[1], consists of conductors and wellheads to support the production or injection operations, accompanied by the typical well construction schematics. The wellhead, designed to be supported by the surface casing during installation is shielded from the environment by the larger diameter conductor pipe. In this essence, the surface casing is designed to resist the wellhead weight, and partial weights of the consecutive casing and tubing strings inside the wellbore, depending on the quality of the cement job. Several factors are identified as playing major roles in ageing offshore well integrity. The contributing factors, in order of criticality are corrosion of the conductor and casing outer/inner walls, cement shortfall inside annuli B and C, increased

**Figure-1.** WHPT and well construction in a shallow water region [1].

**Figure-1**), ranging from completely un-cemented annuli (upper bound) and fully cemented annuli (lower bound) with several intermediate TOC combinations. This will result in a series of conductor/casing pipe axial loads or preloads for each TOC scenario, and for a typical shallow water system consisting of 30in (762mm) conductor, 13-3/8in (340mm) surface casing, 9-5/8in (245mm) intermediate casing and 3-1/2in (89mm) tubing, the maximum compressions on the 13-3/8in surface casing pipe can be conservatively estimated in equation (1), considering the wellhead and tree weight to be:

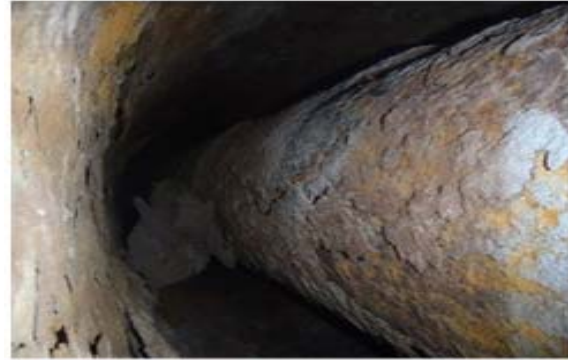
In a poorly maintained WHPT, the shortfall of annular cement (Figure-2) inside the conductor can present the risk of surface casing sinusoidally or helically coiling/buckling inside the wellbore, based on similar behaviours encountered during coiled tubing operations [5]. The coiling of surface casing inside the wellbore can result in the vertical settlement or drop of the wellhead onto the platform deck or directly onto the top of the conductor, thus exposing the heavily corroded conductor pipe to excessive compression, and under cement shortfall, this can result in a catastrophic failure of the well. The proceeding section will focus on establishing the

**Figure-2.** Cement shortfall inside ageing well [1].

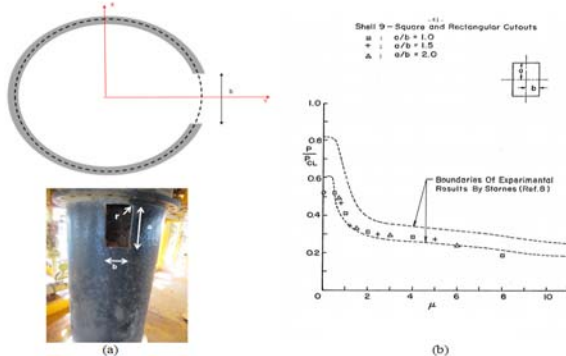
The accurate computation of the corroded conductor section property is deemed crucial in establishing the remaining sectional stiffness of the conductor and is carried out by means of discretization. The conductor circumference is sub-divided into  $0.5^\circ$  sectors and the sectional properties such as cross sectional area and area moments are integrated across these sectors. Any damage or presence of pitting on the conductor can be approximated as a rectangular cut-out and assessed for buckling as per experimental findings in [7], and are shown in

Figure-3. (a) Typical section damage, and (b) Collapse capacity [7]

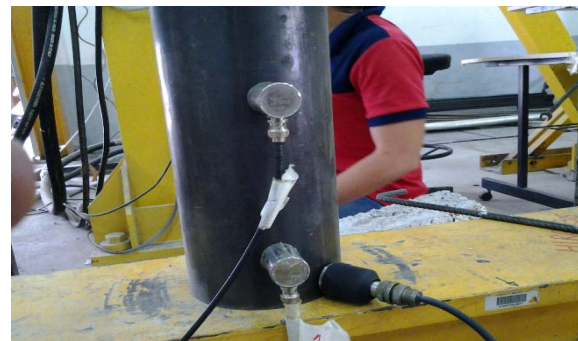
The well preload on ageing wells, is affected by the well construction sequence and quality of the cement job which contributes towards the inherent axial compression at the top of the surface casing, or at the top of the conductor in the event of vertical settlement of the wellhead which may be resting on top of the conductor. Analytical calculations, similar to that shown in equation **Error! Reference source not found.** can be used to estimate the preload, but over-conservatism are eminent, and can cause unnecessary remedial work and cost implications. Therefore, a specialised inspection technique consisting of non-destructive technique (NDT) is developed in this work. This method of measuring the material hardness using the rebound technique has been successfully used in [10], by calibrating the measured hardness of the specimen to an empirical relationship. Several variations of this philosophy has been carried out in the Heavy Structures Lab at the University of Malaya, consisting of different sensors, as shown in

Figure-4. Use of acoustic sensors for measuring pipe preload.

use of acoustical sensor and accelerometer to detect the vibrations produced by the rebounding Leeb hardness system is based on the theory that the elastic waves generated by the impact of the device is dependent upon the elastic stress field present in the specimen, caused by the preload. The uniqueness of the well system is that they are in fully compressive field. The laboratory calibration for a specimen of the same material grade as well strings (Grade-B with yield strength of 244MPa/35.5ksi) are shown for impact energy picked up by the acoustical emission (AE) transducers in Figure-6, the varying hardness and acceleration with preload in Figure-7.

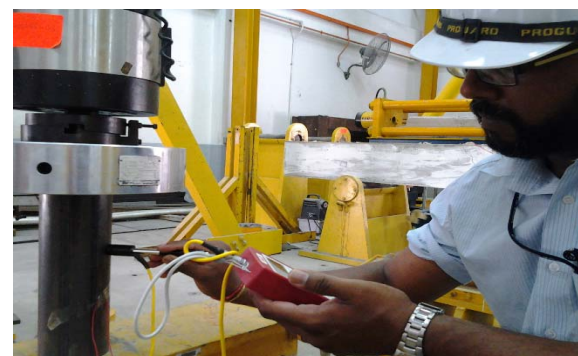
**Figure-5.** Leeb hardness measurement for predicting pipe preload.

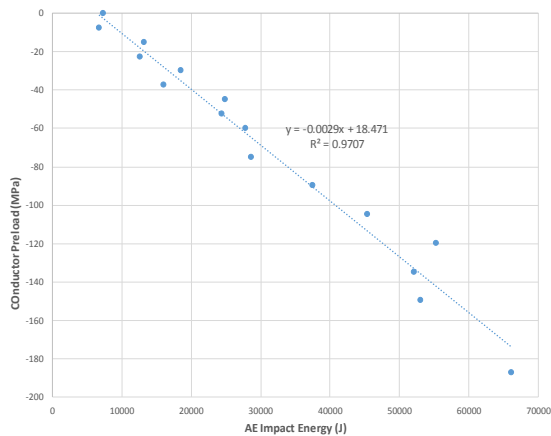
**Figure-6.** Calibration of preload to impact energy from AE transducers.

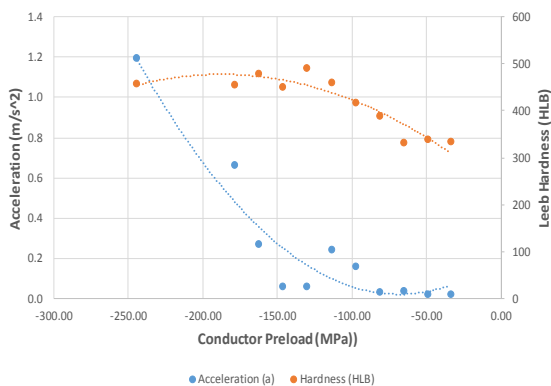
**Figure-7.** Measurement of hardness and accelerometer readings to varying preloads.

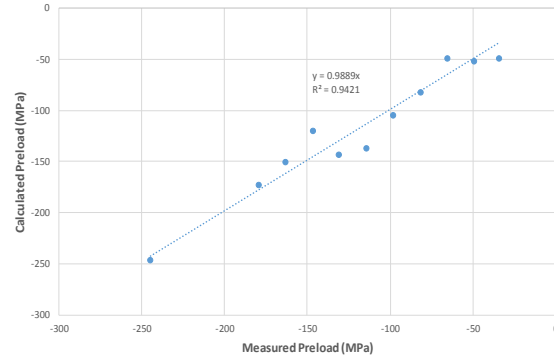
An empirical relation can be derived based on the vibration recording and the material hardness, and is presented in equation (4) **Error! Reference source not found.**, and Figure-8 as follows:

**Figure-8.** Preload comparison with empirical predictions.

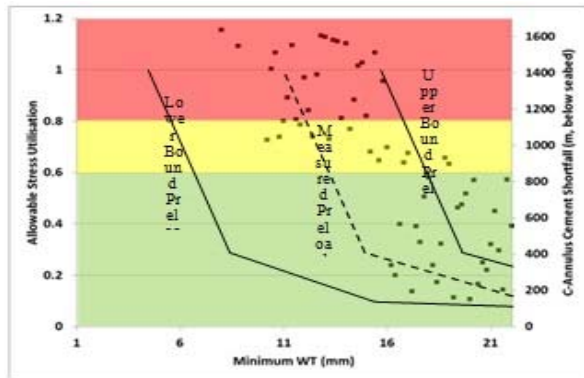
**Figure-9**, indicating the required WT for the upper and lower bounds of the existing well preloads resulting from the two extreme TOC levels. The risk categorisation scheme is adapted into this plot to highlight the remedial action on conductors (or casings) based on the available WT and the corresponding stresses. The measured preload, abased on earlier presentation of various field/lab based methods can prove to be very useful in precisely determining the well integrity state, whilst reducing any over-conservatism.

Figure-9. Operability guideline plot.

The operability plot functions on the basis of minimum and average WT of the pipes recoded during inspection, on the basis of mean area resisting axial compression and minimum area resisting the environmental bending. The criteria set forward to categorise wells for remedial actions must relate to these parameters also.

The most important factor in the remedial action for the conductor and casing is the magnitude of the compression from the well axial loads. Although conservative estimates can be derived in predicting the well axial loads, the residual measurement techniques proposed in this paper, or by ASTM [9] is effective in streamlining the wells for rehabilitation, especially if faced with hundreds of ageing well needing repairs by identifying the exact operability status in
