ANALYSIS OF HIGH FREQUENCY OSCILLATIONS IN SURFACE DISCHARGE FORMATION ON OIL IMPREGNATED PRESSBOARD

Palanki Pattabhi Saikumar and Mohamed Ghouse S

Department of Electrical Engineering Shanmugha Arts, Science, Technology and Research Academy University, India

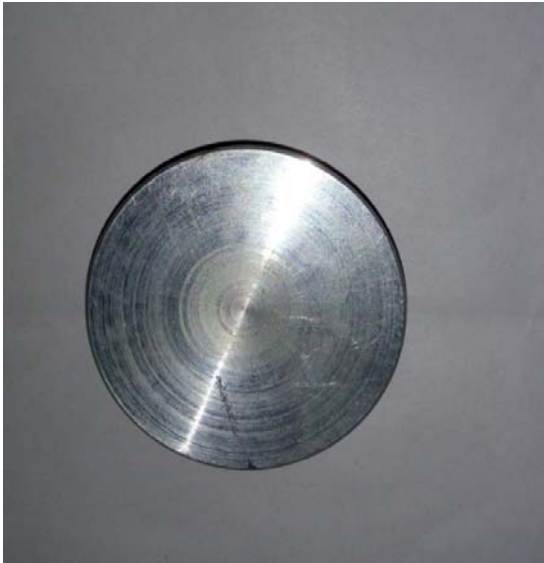
The test Set up consists of two electrodes. The upper electrode is made in the IEC(b) electrode configuration. The test is fabricated in rod to plane electrode configuration. One electrode is set in the bottom which is shown in Figure-2 and called as bottom electrode and the other situated at the top is called top electrode. The bottom electrode is made up of aluminum and the top electrodes are of copper, brass and aluminum. The bottom electrode is of 5mm thickness and 5cm in diameter. The upper electrode is 6mm in diameter. Teflon rods are used as insulation as well as support for the test cell. Teflon is the strongest material which is fire resistant and acts as an insulator for electrical and thermal purposes. Pressboard material, on which the test is being conducted, comes in between the two electrodes. It is cut in the exact dimension of the bottom electrode. It is seated on the bottom electrode. Pressboard is used fresh for every set of experiment. The test cell is as show in the Figure-3.

Figure-2. Bottom view.

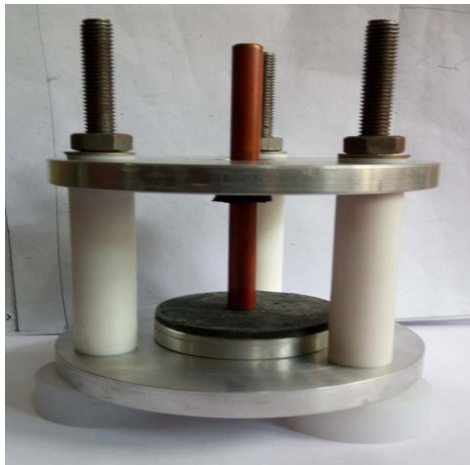
Figure-3. Test cell.

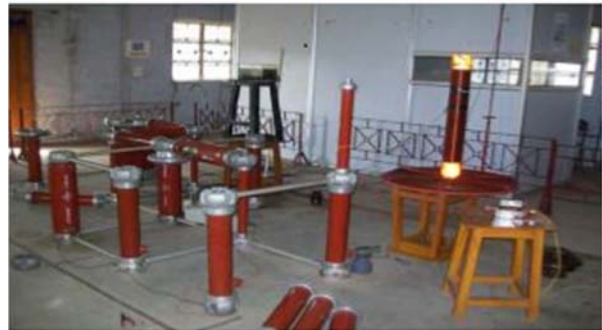
Figure-4. Laboratory setup for HFHV tracking test.

Figures 4 and 5 shows experimental setup and circuit diagram for surface degradation studies. A rod-plane electrode configuration was used the pressboard is inserted between the two electrodes. The supply voltage is maintained by at 6 kV (HVAC voltage). Fresh pressboard is shown in Figure-6. The degraded pressboard used for tracking studies is shown in the Figures 7 & 8. The test is done on pressboard of same material for different frequencies to understand the nature of the pressboard in the HFHV oscillations and the waveforms are observed and the pressboard is analyzed with ATR-FTIR. The degradation of pressboard and waveforms obtained after testing at 85 KHz and 113.6 KHz are shown below. The

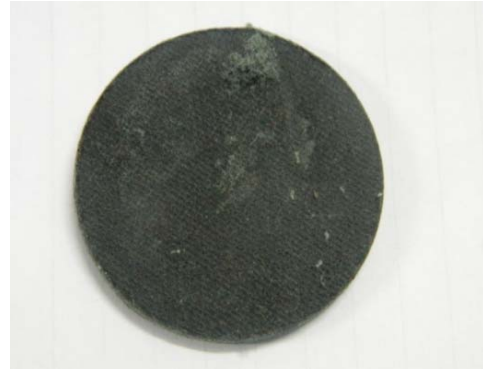
Figure-7. Degraded pressboard at 85Khz.

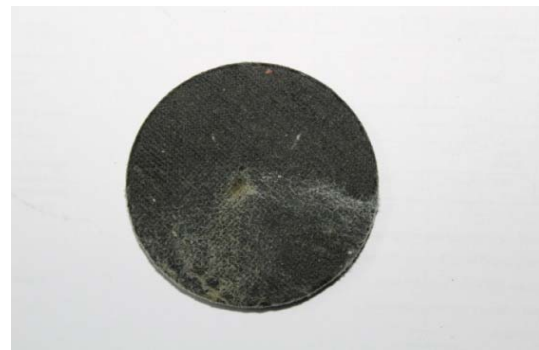
Figure-8. Degraded pressboard at 85Khz.
