# MORPHOLOGICAL STUDIES OF ELECTRICAL TREE DUE TO HIGH ALTERNATING ELECTRIC FIELDS IN EPOXY SOLID DIELECTRICS

S. Natarajan, M. Balasubramanian, S. Mohamed Ghouse and R. Rajesh

School of Electrical and Electronics Engineering, Shanmugha Arts, Science, Technology & Research Academy, Thanjavur, India

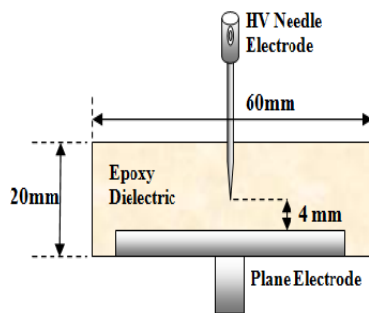
Figure-1. Sample configuration.

The epoxy resin used in this experimental study is the Araldite epoxy system consisting of epoxy resin Araldite CY 230-1 and a hardener Aradur HY 951. A proper mixture ratio of (CY 230-1) 100:10 (HY 951) parts by weight is used for the preparation of the test specimen. The resin and the hardener were mixed at a uniform rate and the mixture filtered in order to remove fine impurities. Care must be taken so that the mould is free of any void or contaminations. Pin-plane Aluminium electrode geometry is selected for the preparation of the test specimens. Plane aluminium electrodes of diameter 60mm and a thickness of 5mm were adopted. A steel needle electrode of tip radius of about 10µm is utilized in order to provide a high divergent electric field. The separation between the High voltage (HV) pin- and Ground plane electrode is maintained about 4mm during the molding process. The curing of the specimen was carried out at room temperature for 24 hours and the final specimen was taken from the mould and cleaned properly before carrying out the electrical treeing experimental study. Figure-1 and Figure-2 show the sample configuration and the prepared Epoxy Araldite dielectric specimen respectively.

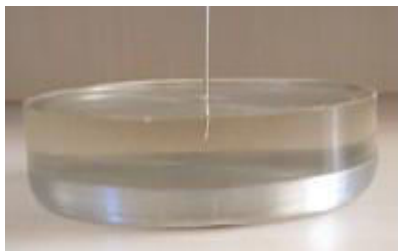
Figure-2. Epoxy dielectric specimen.

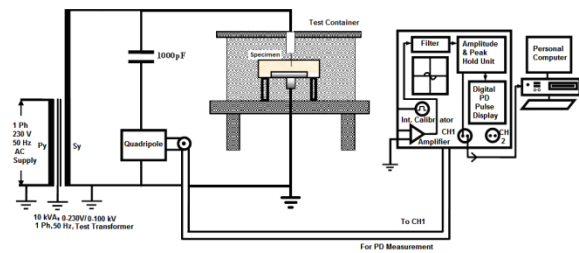
Figure-3. Experimental test setup for PD initiated electrical treeing studies.

The detailed experimentation and analysis has been performed utilizing a 10kVA, 100kV, 50Hz test transformer with a Digital PD Measurement and Acquisition System (Model No.: DTM-D ®) comprising a digital storage oscilloscope (TDS 2002B ®) and a tunable narrow-band filter (Model: DFT-1®) at a variable center frequency of range 600 kHz-2400 kHz at 9 kHz bandwidth. The direct (straight) PD detection and measurement setup as recommended in IEC 60270 is utilized in this study since the tests have been carried out in a controlled laboratory environment.

However, to ensure appropriateness in real-time studies, noise mitigation techniques are employed wherein the PD system comprises window gating facility to mask redundant background noise during measurement. A coupling capacitor (1nF) was also added to the test setup to augment the transfer characteristics and to provide an appropriate wave shape of output response. Appropriate calibration is carried out using an electronic reference calibrator (Model: PDG ®). PD Gold® package is interfaced with the PD measurement system for recoding and acquiring the PD signatures [10].

The pulses are displayed either in sinusoidal or elliptical forms selectable in auto or manual mode. The manual mode provides an option for recording and acquiring for a considerable period and hence most suited for treeing studies. Figure-3 shows the generic experimental test setup utilized for PD initiated electrical treeing studies.

The electrodes and the samples were immersed in the mineral oil to avoid potential flashovers. It also avoids the influence of any leakage current over the surface the specimen.

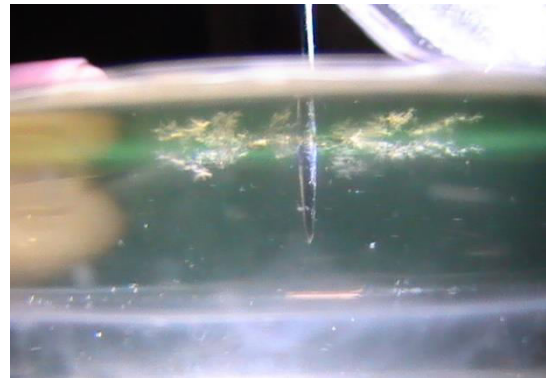
**Figure-4.** Initiation of few tree branches.

During the application of high alternating field at the pin electrode the initiation of first tree branch was observed by slowly increasing the applied voltage and inspecting the specimen. For easy detection of electrical tree a transparent test container along with transparent mineral insulating oil was chosen. The tree shapes was acquired by a high resolution digital camera at different tree growth time and at the same time partial discharge measurements were acquired by means of PD measurement system. Typical branch type tree patterns obtained during the experiment are shown in Figures 4, 5, 6 and 7.

Figure-4 shows the tree morphology during the initiation period. The voltage stress was removed and the image of the tree was photographed. Then the voltage was raised again to a higher voltage level, then it was removed after some time interval and again the image of the tree with more branches has been recorded. The experiments were carried out with a higher voltage of 28kV in order to obtain the complete images of branch type tree.

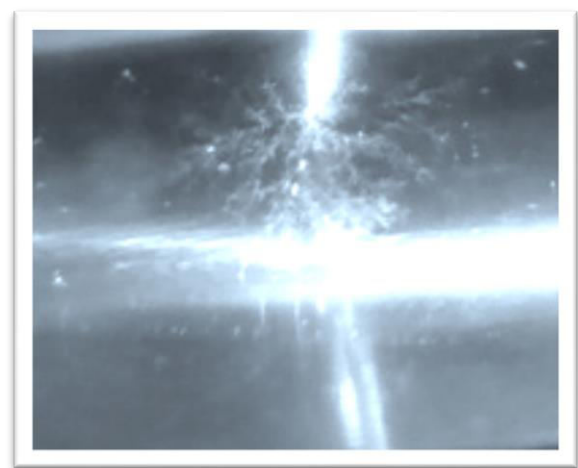
**Figure-5.** Widened tree channels.

Figure-5 shows the widened tree channels during the tree growth process. It was observed that during the growth a small branch reached the plane electrode and the breakdown of the sample did not occurred. It was assumed that the small branch with very low conductivity may have lower value of conduction current flow which is insufficient to cause the breakdown. Figure-6 shows the tree with more number of branches and hence more tree branch volume between needle tip and the plane. The small branches were widened and thick branches were created before the breakdown.

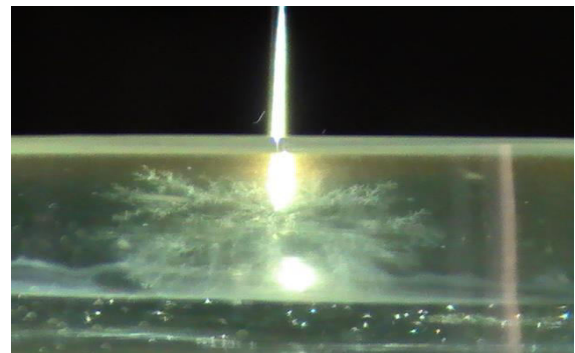
**Figure-6.** Tree pattern just before breakdown.

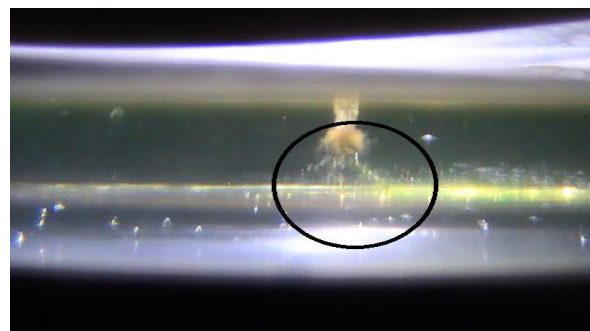
**Figure-7.** Widened pipe shaped tree channel.

The thickness of the widened branches was increasing and finally breakdown occurs and the widened branch structure changed to hollow pipe shaped channel. Figure-7 shows the thick hollow pipe shaped conducting channel formed after the breakdown of the test sample. The morphological studies carried out clearly shows the formation of the tree branches during the application of alternating fields. The tree patterns obtained was used to study the growth behavior as a function of test voltage.

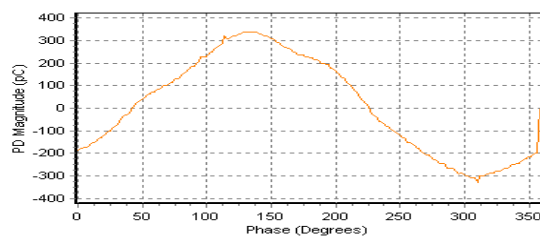
**Figure-8.** PD signature pattern at DIV of 2kV.

The PD signature obtained during the experimentation is shown in Figure-8, Figure-14. The test voltage was increased in steps of 0.5kV per minute. The discharge inception voltage was observed at 2.0kV and the corresponding PD signature was recorded and it is shown in Figure-8. The test voltage was kept at 2.0kV for 20 minutes duration. The test voltage was then increased and kept at 5kV for 20 minutes. During the application of the voltage PD signature was continuously recorded. No tree pattern was observed until 16.5kV test voltage for a cumulative duration of 60 minutes as shown in Table-1. A small tree branch initiation was observed at 85<sup>th</sup> minute and the corresponding PD signature was recorded. Figure 9 Shows the PD signature recorded at 16.5kV.

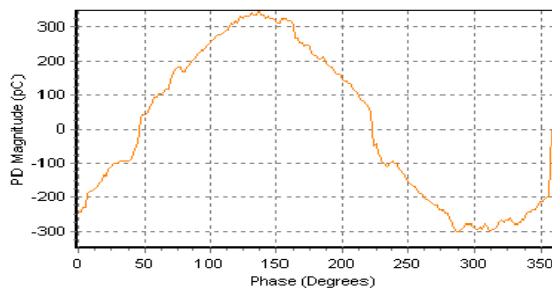
**Figure-9.** PD signature pattern during tree initiation at 16.5 kV- after 85 minutes.

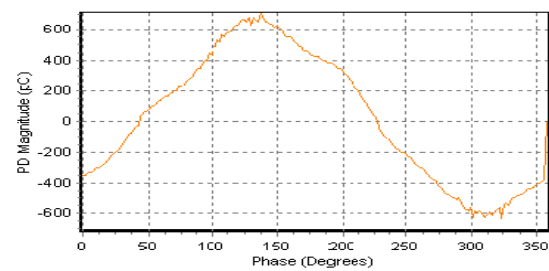
**Figure-10.** PD signature pattern during tree growth at 28kV - after 120 minutes.

The PD magnitude was increased from 350pC to 600 pC during the widening of tree branches. Figure-10 and Figure-11 clearly shows the increase in PD magnitude which was recorded at 120<sup>th</sup> and 160<sup>th</sup> minute during the treeing process. From the morphological pattern it was observed that widening of tree few tree channels were dominating during this time period.

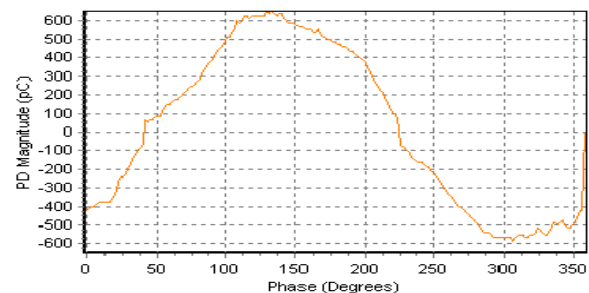
**Figure-11.** PD signature pattern during tree growth at 28 kV - after 160 minutes.

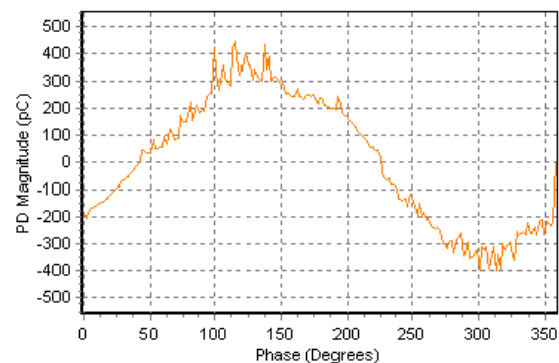
**Figure-12.** PD signature pattern during tree growth at 28 kV - after 180 minutes.

It was observed that during the time interval 160-180 minutes there was a sudden decrease in the PD magnitude from 600 pC to 400pC. The morphological study during this time period shows that the widening of tree branches ceases in this period and only the formation of small branches had been observed and the branch volumetric space between needle and the plane was increasing. It was assumed that the growth of only small branches with low conduction current might have resulted in the reduction of PD magnitude. This reduction in PD is shown in Figure-12. After 180 minutes the PD magnitude was increased to much higher value of around 1000pC and finally breakdown of the test specimen recorded at 230<sup>th</sup> minute. The PD signature obtained before breakdown at 220<sup>th</sup> minute is shown in Figure-13.

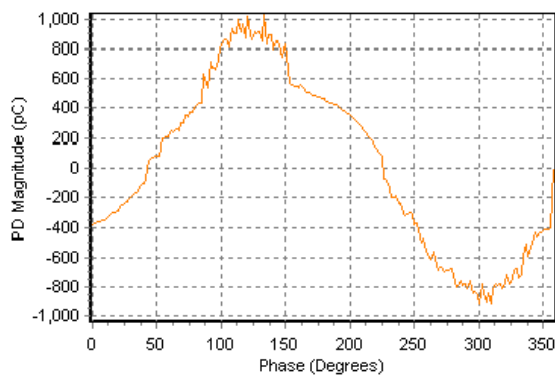
**Figure-13.** PD signature before the formation of hollow pipe shaped conducting channel - at 220 minutes.
