## RESPONSE OF WOODEN FOOTBRIDGE TO THE DYNAMIC LOAD

Lenka Ponišťová, Roman Fojtík, David Mareček, Veronika Vašková and Antonín Lokaj  
 Department of Civil Engineering, Ludvíka Podéště, VŠB - TU Ostrava, Ostrava 0 Poruba, Czech Republic  
 E-Mail: [lenka.ponistova.st@vsb.cz](mailto:lenka.ponistova.st@vsb.cz)

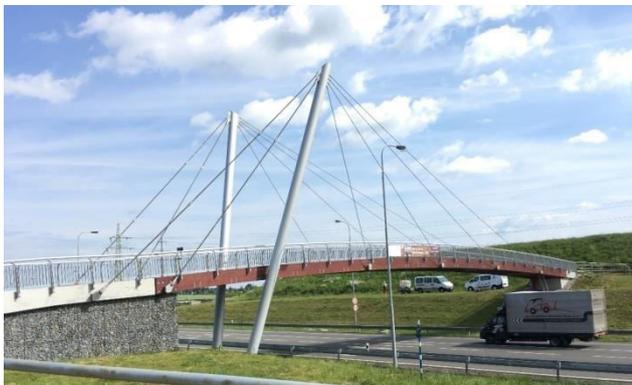
**Figure-1.** Wooden footbridge in Příbor.

The subject of this article is wooden footbridge (Figure-1) located in Příbor in Czech Republic designed as perpendicular through road I58. The footbridge is subtle so there is a high risk of presence of dynamic effects. The bridge object is exposed to dynamic load tests to verify vibrations and to investigate natural frequencies. The aim of in situ measurement is verification the equality of design response to pedestrian dynamic loads at wooden footbridge. In case of unfit response, it is necessary to design a damping correction of the structure.

footbridge over a bicycle overland communication A footbridge has two poles with intermediate bridge deck. The total bridging length is 43.0 m with span of 4.0 m and 39.0 m and free width of the footbridge is 3.0 m. A footbridge is suspended with steel rods hinges of  $\phi$  28 mm diameter and steel rods hinges of  $\phi$  40 mm diameter of steel type S 355 at a pair of steel pylons  $\phi$  457 mm diameter which is reach a height of 10.8 m above the top of the vertical alignment located into the roadway.

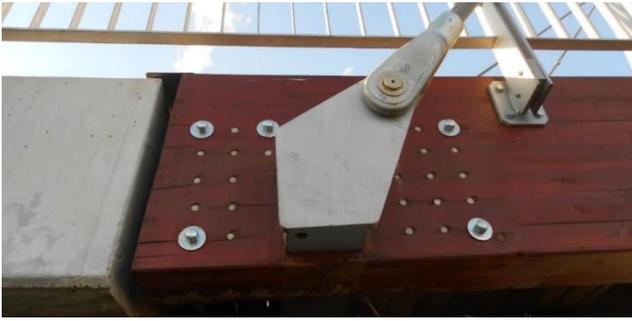
**Figure-2.** Articulated hitch connection.

The load carrying structure of wooden footbridge is formed by pair of contiguous main beams with constant height of glue laminated timber GL28h grade with dimensions 220/700 mm and with an elemental bridge deck with floor made of oak timber D35 grade with dimensions of boards 200/70 mm. Cross members are placed on the main beams, some of them are wooden and some of them are made of steel. Wooden cross members are made of glue laminated timber GL24h grade with dimensions 240/200 mm. The steel cross member's beams are located at the anchor points of steel hinges, at the place of the existing damper and at the place of the foundation of the footbridge. The steel cross members are continuous and at the point of crossing with the main beams, they cause weakening of them. Dimensions of steel cross members are the same as wooden cross members. Three wooden longitudinal beams of GL 24h grade with dimensions 120/160 mm are laid on the cross members. The space bracing of the footbridge is ensured by cross bracing with diameter 18 mm and by cross members connections. Rods are articulately connected in longitudinal direction. A damper was found on the ceiling part of the bridge deck.

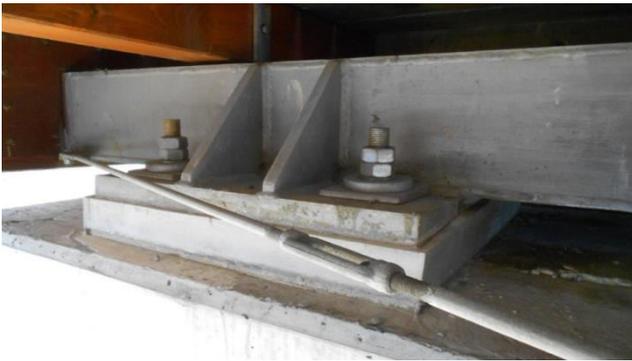
**Figure-3.** View on the footbridge bearing.

The-structure is supported using bearings which are all fixed (Figure-3) and each of them is anchored by four screws directly into structural supports. As supports, reinforced concrete angular walls with stone base are designed. A footbridge is founded by deep micropyles.

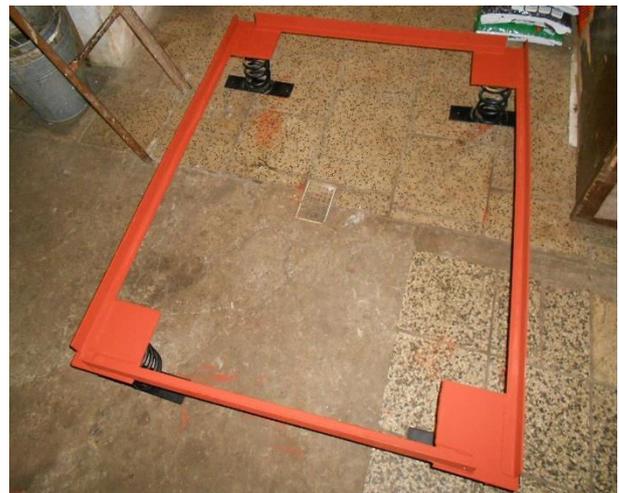
Figure-5. Experimental damper.

Experimental damper (Figure-5) is made as a steel closed frame with four welded springs from the bottom. Frame has been designed to accommodate the load object. In the experiment, static load test of damper with the load curve course under the load force  $F$  [kN] with a displacement of the beam  $U_z$  [mm] at time  $t$  [s] was made (see Figure-7). From the results of static load test stiffness of the damper  $k = 39, 25 - 44, 33$  kN/mm was determined.

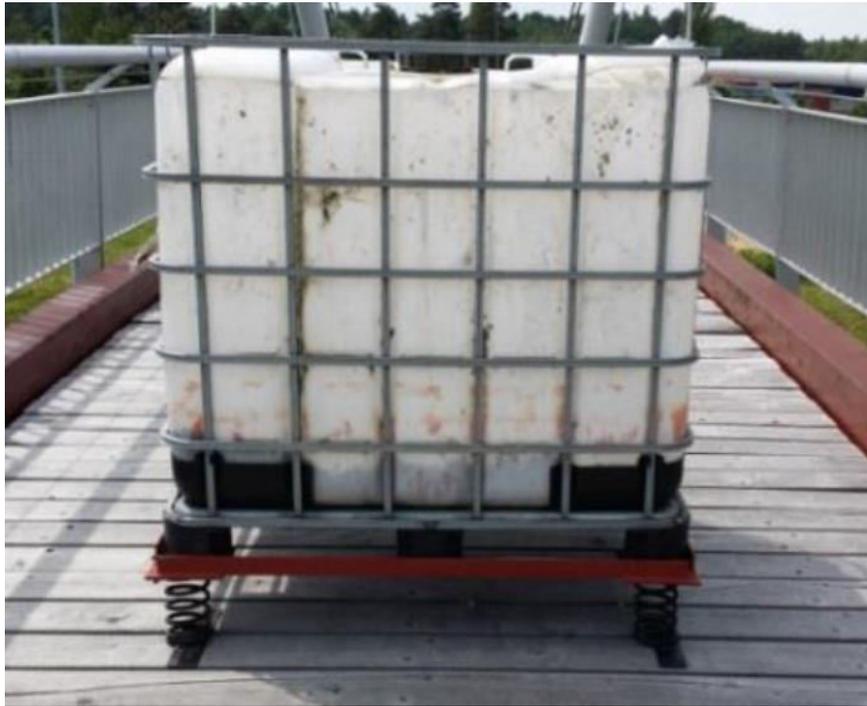
**Figure-6.** Load object with experimental damper.

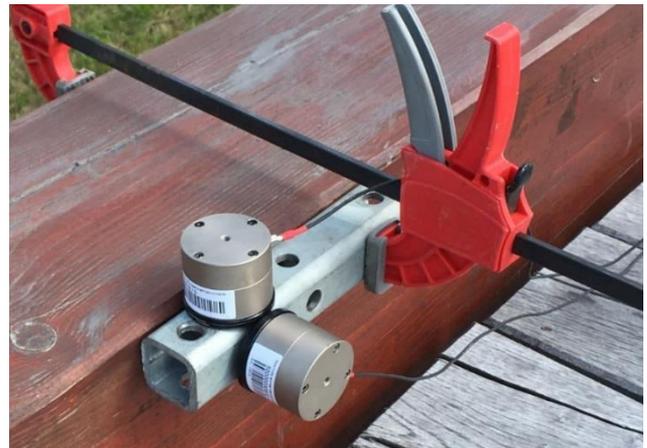
Figure-8. Seismic sensor KB12VD (horizontal, vertical).

To verify dynamic quantities, seismic sensors of acceleration KB12VD (Figure 8) were used. The record was obtained by seismic sensor on the structure in  $[m/s^2]$  which source was  $[\mu V/V]$ . Two sensors for vertical vibration amplitudes and one for horizontal vibration amplitude of this type were used for the experimental measurement.

- sensitivity 10 000 mV/g;
- range  $\pm 0,6g$ ;
- frequency  $> 0,35$  kHz.
