## CASE STUDY OF A FIRE DAMAGE ASSESSMENT OF A TWO-STORY STRUCTURE

### ABSTRACT

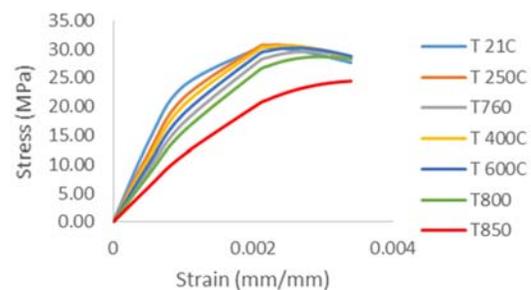
**Figure-1.** Temperature dependent concrete behavior (Knaack).

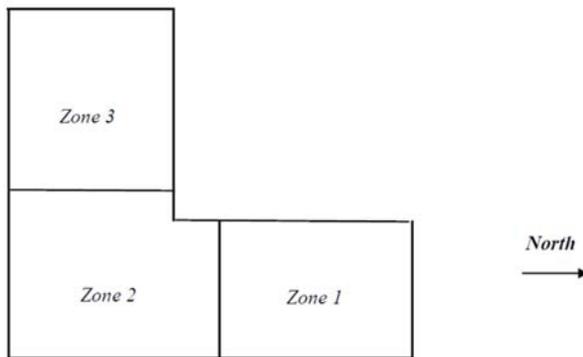
The subject site is Nahleh textile factory. It is located in Dulail region about 100 km. east of Amman city, the capital of Jordan. The building is composed of two floors. The slab units are composed of Precast Pretension concrete panels of 1.2m width, 9.2m length, and 0.2m thickness. The beams supporting the slab units are of Pre-stressed concrete. The columns and foundations are of ordinary reinforced concrete. The building total area is 9500 m<sup>2</sup>. Two expansion joints split the building into three zones as shown in Figure-2.

**Figure-2.** Schematic plan of the building.

The existence of two expansion joints that divide the whole structure into three separate buildings within three separate zones, as well as site inspection for the post fire building condition, lead to classifying the whole structure into three zones as shown in Figure-2.

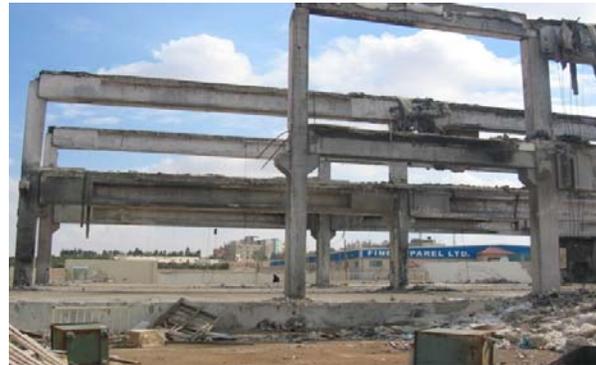
**Zone 1:** Collapse of slab panels of the ground floor and the first floor slabs. The beams and columns remained in position, but they suffered from considerable cracking, in addition to spalling of concrete at the corbels and at the column edges as illustrated in Figure-3.

**Figure-3.** Collapse of slab panels of 1<sup>st</sup> and ground floors in zone 1.

In zone 1 (Figure-3), where all slab panels of the two floors collapsed, the debris had whitish grey color. The supporting beams and columns did not collapse but had whitish grey color. In zone 2, the debris of the fallen slab panels had also whitish grey colors. The bottom slab surface in the ground floor slab had whitish grey color. In zones 2, 3 shards of glass remained in some window frames. Some of these shards had melted and were forming drips. In zone 3, the concrete surface in the 1st floor had a black color all over, as illustrated in Figure-6. This is attributed to the burning of the textiles inside the building when fire erupted. The concrete slab surface color in the ground floor was pinkish.

Comparing the colors of concrete surfaces with the color indicators and the fact that concrete surfaces suffered from spalling and cracking, it was estimated that the temperature of the concrete surfaces of slabs and columns in zone 1 and zone 2 was within the range of 550 to 650°C.

- a) The collapse of all slab units for both two floors in zone 1, (Figure-3) and of many 1<sup>st</sup> floor slab units in zone 2, (Figure-5). The collapse of such a large amount of slab units would be attributed to the followings:

- Concrete cracking and spalling when the temperatures of concrete surfaces in slabs and columns exceeded 550°C, thus loss of concrete protection bottom layer which resulted in directly exposing prestressing tendons to high temperatures and in drastic change in rate of prestress loss due to creep related relaxation being activated above 315°C.

- Substantial decrease in the ultimate tensile strength of prestressing strands at between 400°C and 500°C
  - Deterioration of mild steel modulus of elasticity ( $E_T$ ) to about  $0.5E_0$ , as estimated according to equation 2.

Therefore, it was concluded that the remaining parts of the building, in zones 1 and 2, were structurally unsafe. They ought to be demolished.

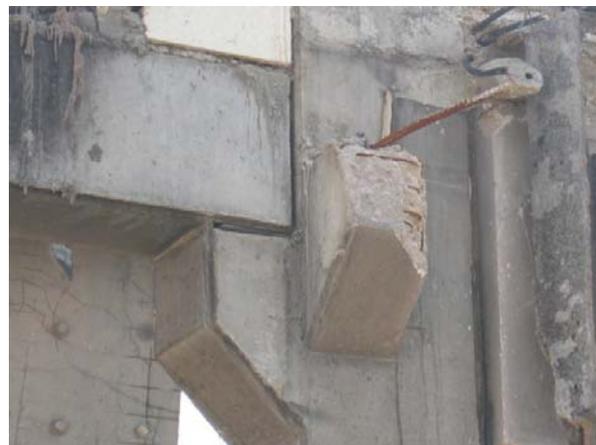
**Figure-4.** Cracks in column and spalling of corbel concrete.

- Significant decrease in the concrete compressive strength.
- b) The large amount of spalling of concrete in columns and column corbels, resulting in exposing the reinforcement, (Figure-4).

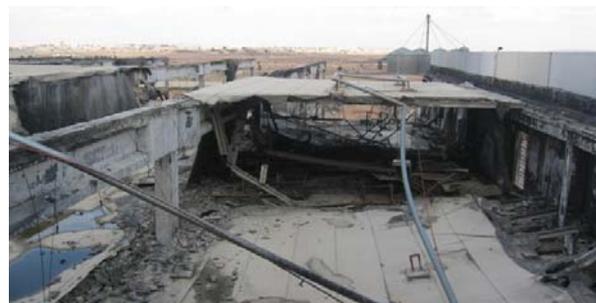
**Zone 2:** Collapse of the slab panels of the first floor within the remaining portion of the northern sector. They fell above the ground floor slab panels. Nonetheless, the ground floor slab panels were able to carry the fallen slab panels as illustrated in Figure-5.

**Figure-5.** Collapse of slab panels of 1<sup>st</sup> floor on ground floor slabs in zone 2.

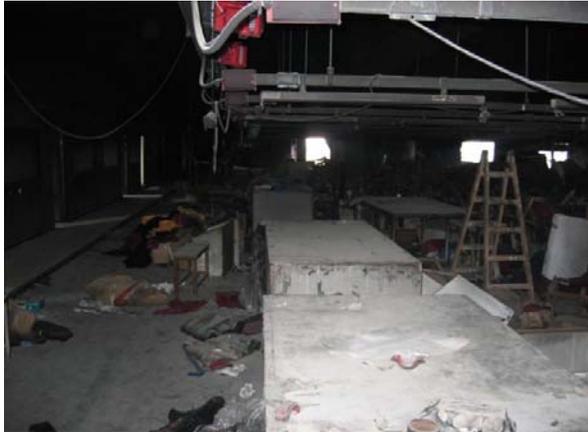
**Zone 3:** This part was exposed to fire but maintained stability and nothing collapsed, as illustrated in Figure-6.

**Figure-6.** Post fire inside view of the 1st floor within.

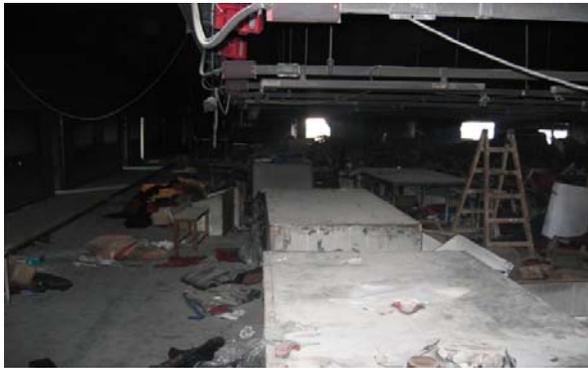
**Figure-7.** Post fire inside view of the 1st floor within zone 3

Adopting the aforementioned approach for the estimated temperatures for zone 1, and zone 2, it was concluded that the temperature in zone 3 was within 300 to 400 °C.

On the other hand, in zone 3 the temperature was estimated to have reached 300 to 400 °C. Apart from the change in color of the concrete surfaces as mentioned earlier, and other minor signs and clues, the structure in this zone seemed to be stable and safe. Thus, it was decided to carry out further field and laboratory testing to evaluate the residual strength of structural concrete in zone 3, prior to any conclusive assessment.

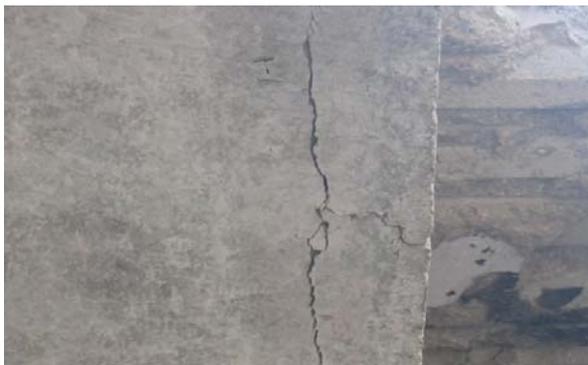
**Figure-8.** Cracks in a reinforced concrete column.

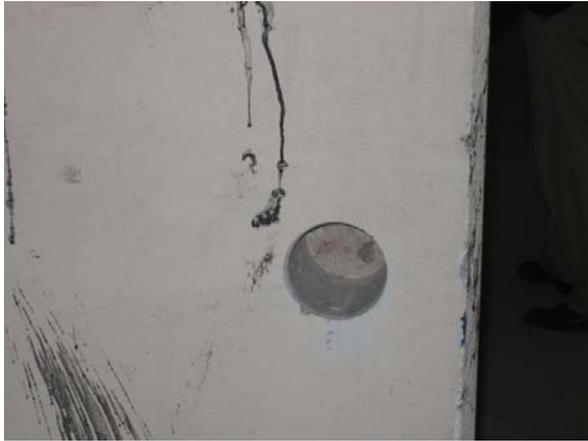
Figure-9. Core taken from a concrete column in zone.

Concrete core samples were taken for determination of compressive strength as shown in Figure-9. Such cores were taken where the concrete surface was still intact and contained the outermost layer of discolored concrete. Concrete cores taken from beams and columns were tested for compressive strength in accordance with ASTM C42 “Standard test method for obtaining and testing drilled cores”. Concrete core strength results are listed in Table-3.

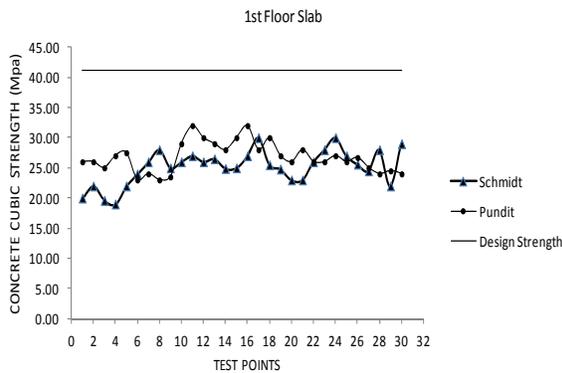
Figure-10. Comparison between Nondestructive cubic strength and Design strength at 1<sup>st</sup> Floor slab.

In general they are in agreement with the results obtained from nondestructive testing, illustrated in (Figures 10, 11, 12, 13). Concrete core strength results are close to about 50% of the concrete characteristic strength.

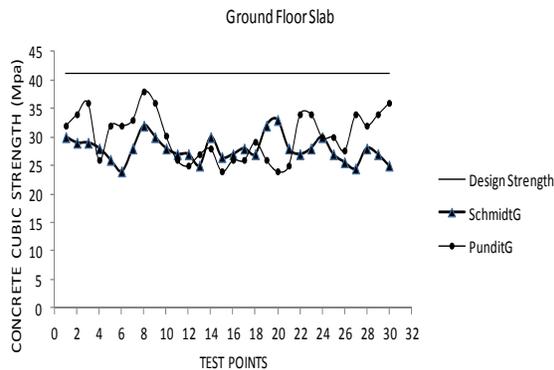
Figure-11. Comparison between nondestructive cubic strength and Design Strength at Ground Floor Slab.

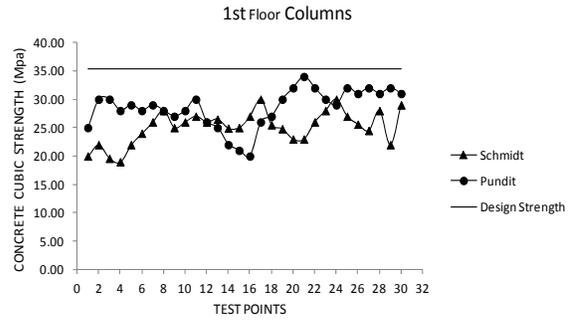
Figure-12. Comparison between Nondestructive cubic strength and Design Strength for 1<sup>st</sup> Floor Columns.

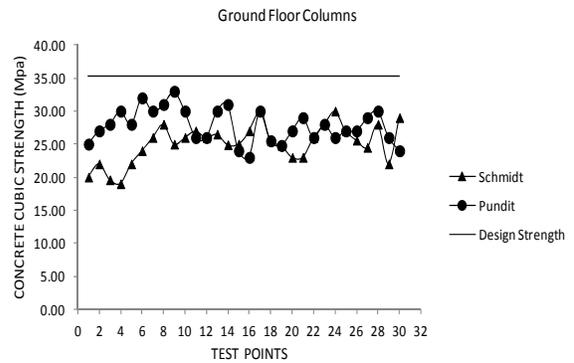
Figure-13. Comparison between Nondestructive cubic strength and Design Strength for Ground Floor Columns.
