## COMPARATIVE STUDY OF STEEL AND GLASS FIBRE REINFORCED POLYMER (GFRP) BARS IN RC MEMBERS

Rifat Resatoglu and Muhammad Sagir Muhammad

Civil Engineering Department, Near East University, Nicosia, TRNC, Mersin, Turkey

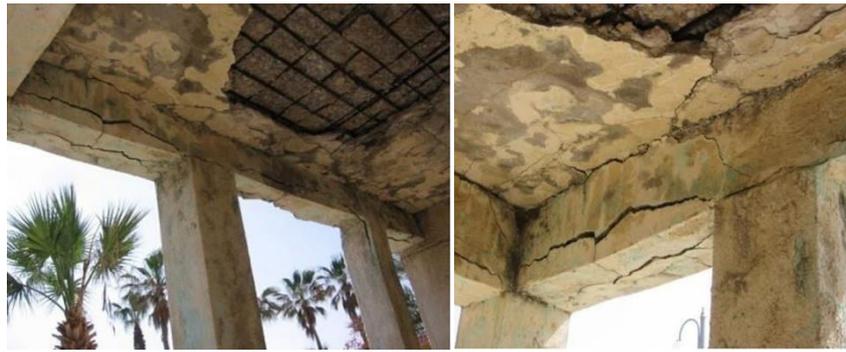
**Figure-2.** Damage of an old building due to corrosion.

It can be seen in Figure-2, an old building that was damaged as a result of corrosion; cracks and spalling of concrete can be observed, this was as a result of

aggregates used that were fetched from the seaside [3]. Figures 3 and 4 shows a structure under construction in Nicosia, North Cyprus, honeycombing and segregation problem can be observed which is due to inadequate vibration of concrete, and this easily leads to ingress of corrosive agents. Before measures were taken, quarries existed in Kumköy and Gaziveren, in Güzelyurt district, North Cyprus, which were very close to the sea shore. Aggregates for construction works were fetched from these quarries which is cheaper than crushing part of the mountains, these aggregates requires washing because of the salt deposits existing on them but that wasn't considered. These aggregates were fetched and used for construction until 1993 when the government closed down the quarries and regarded the aggregates harmful for construction [9].

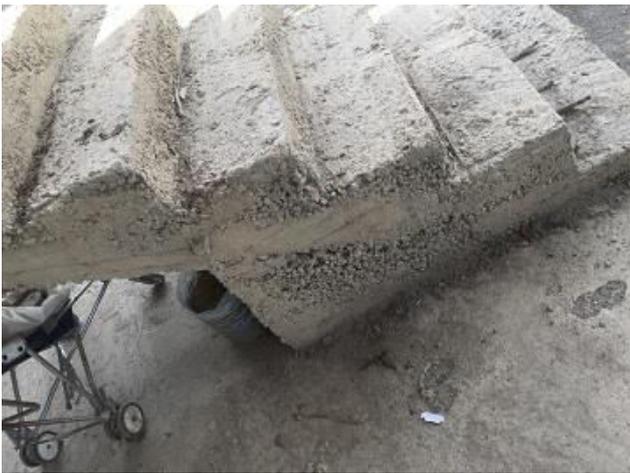
**Figure-3.** Honey combing.

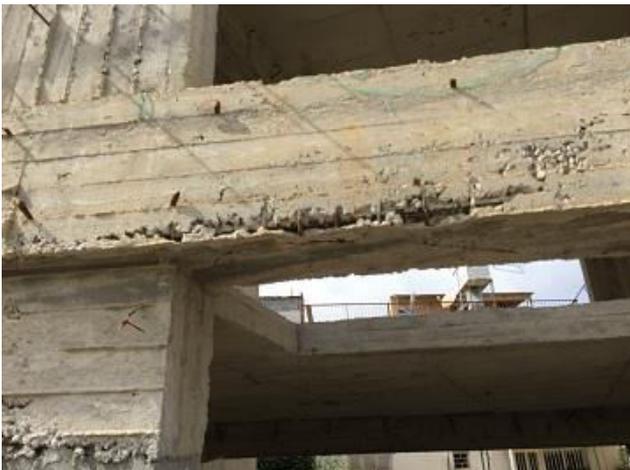
**Figure-4.** Segregation.

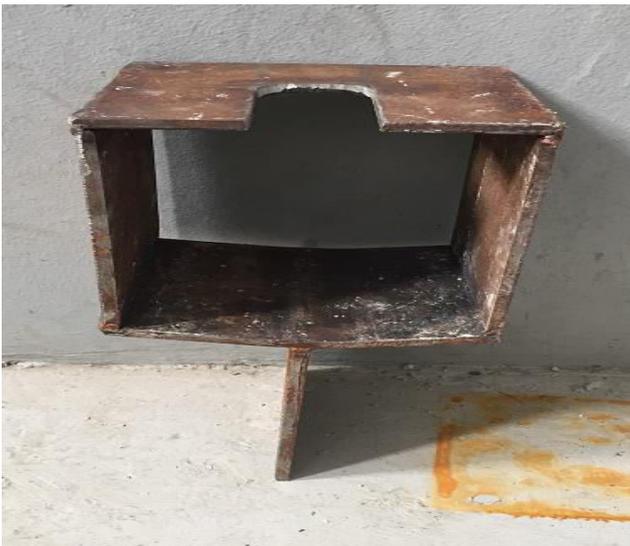
**Figure-6.** Pull-out apparatus.

An apparatus was made with 10mm thick steel and in such a way it can fit into a universal testing machine. Reinforcement bars of 300mm long were used and the schematic diagram of the pull out specimens is shown in Figure-7.

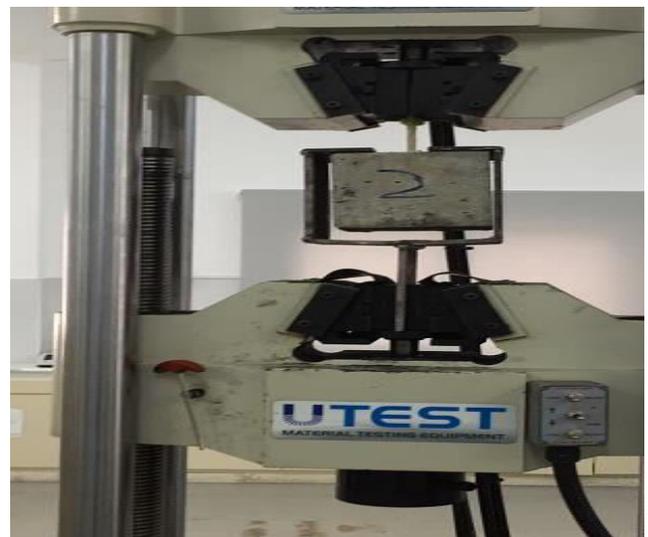
**Figure-8.** Pull-out test setup.

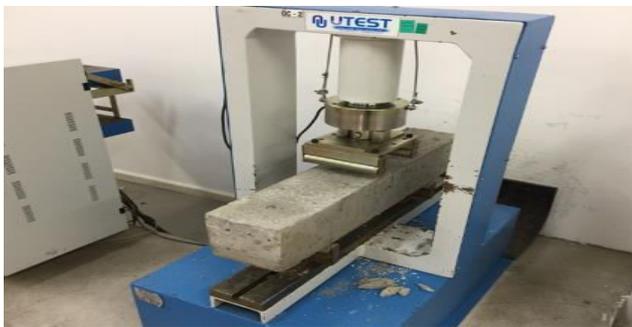
**Figure-13.** Beam flexural test setup.

The flexural testing machine has a loading capacity of 200kN. The load was applied until failure at a constant pace rate of 0.05MPa/s. Flexural strength of the beams can be computed using the equation below;

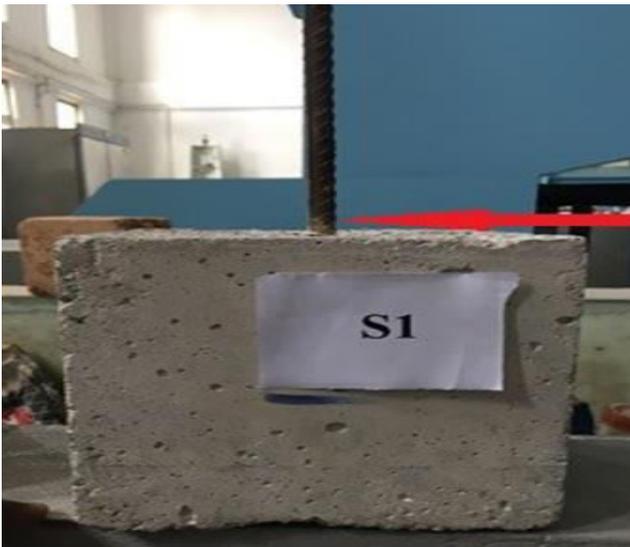
**Figure-17.** S1 & S2 Specimen Failure.

A total of 4 specimens were used for testing the bonding behaviour. Specimen S1 and S2 containing steel bars failed due to bar pull-out because of slipping of bar against the concrete, this is as a result of weak bonding. Specimen G1 and G2 containing GFRP bars failed to concrete splitting, this is because the bonding of GFRP and concrete is excellent. The average ultimate bonding strength of the G1 and G2 is 30% higher than that of S1

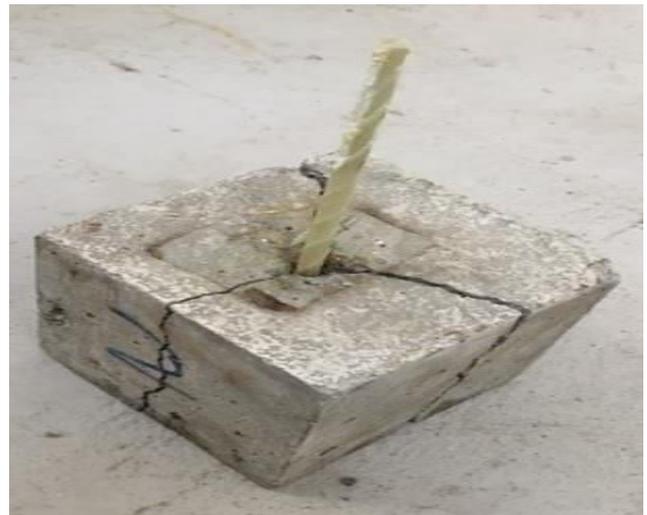
**Figure-18.** G1 & G2 Specimen Failure.
