ANALYSIS OF FITNESS FOR SERVICE IN DENTED PIPES BY MEANS OF FINITE ELEMENTS: STUDY CASE

Therefore, this investigation is intended to analyze a deformation pipeline for crude oil transport which has a 42" diameter API 5L x70 dent fault pipe, using the recommended practice API 579/ASME FFS-1 Fitness for Service, by means of finite elements, considering the definition of the mechanical and operational conditions of the deformed pipe, the establishment of boundary conditions in a CAD model and finally the calculation and analysis by means of finite elements of the behavior of the pipe in linear static regime and fatigue. SAVIDIS, et. Al, (2011) recommends the use of the finite element method to introduce a diversity of material properties and plasticity effects both in the duct and in the ground, as well as possible non-linear geometric effects. Saúl Hernández et. By (2019) simulation under adjusted parameters as experimental test, allows to see deformations graphically and facilitates engineering analysis.

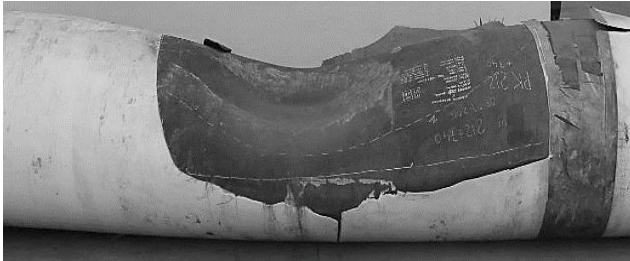
Figure-1. Pipe with buckling damage.

The section of the pipeline shows a length of 5.79 m, with a dent of approximately 200 cm and 120 cm long and wide respectively. The section has a diameter of 42 inches and a wall thickness of 17.74 mm. On the other hand, it has a 4.50 mm thick coating, which is affected by the dent generated by the explosive charge. The hourly position of the pipe is not indicated; the longitudinal welding cord is located 63 cm from shoulder 1 of the dent. The following additional data are described below in the visual inspection:

Pipe of 42" $t = 17,42$ mm buckling length = 2700 mm buckling width = 1200 mm	% buckling = 45,23% Max diameter= 1250 mm Min diameter= 530 mm depth \leq 482,26 mm
--	--

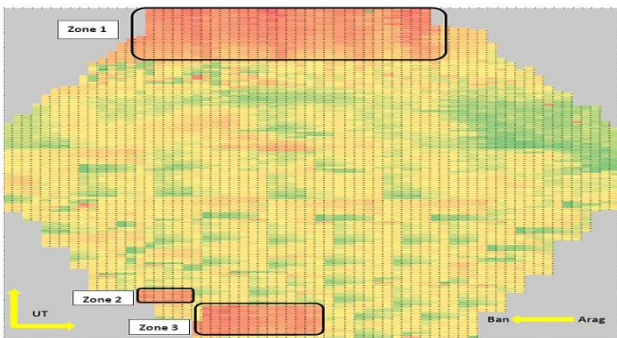
Figure-3. Ultrasonic thickness measurement results.

A minimum thickness of 16.05 mm, a maximum thickness of 17.8 mm, and an average thickness of 17.22 mm are recorded throughout the dent extension. The healthy zone thickness 17.74 mm. From the anomaly grid the thickness profile shown in Figure-4 is extracted.

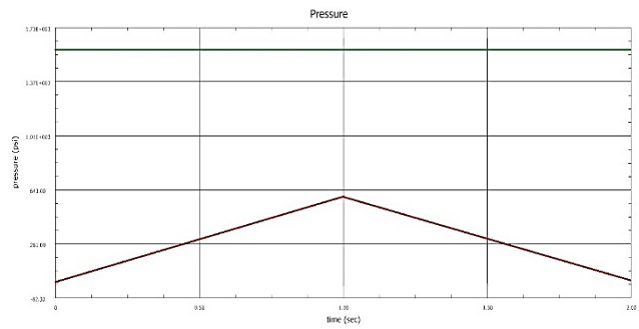
Figure-12. Load distribution in 2 sec time interval.

For the non-linear type of analysis, a time-interval analysis is taken into account, thus the conditions of the cyclic pressure applied in a time interval (t=2 s) are established as shown in Figure-13 simulating the condition of this time in a band of 50 iterations. Table-5 shows 10 simulation results showing the stress distribution of von Mises, equivalent deformation for a pressure cycle (0 to 500 psi) In time space (0 to 2 sec) (see Figures 13 and 14). The stress values are located at 356 Mpa to 697 Mpa in variation to the load, the results show a variation from elastic to plastic deformation when the pressure range exceeds 200 psi, thus continuously breaking up the material.
