THE IMPORTANCE OF FORMER QUARRY ROCK SLOPE ASSESSMENT FOR SUSTAINABLE INFRASTRUCTURE DEVELOPMENT

Hamzah Hussin^{1,2}, Tajul Anuar Jamaluddin² and Nurhazren Fauzi¹

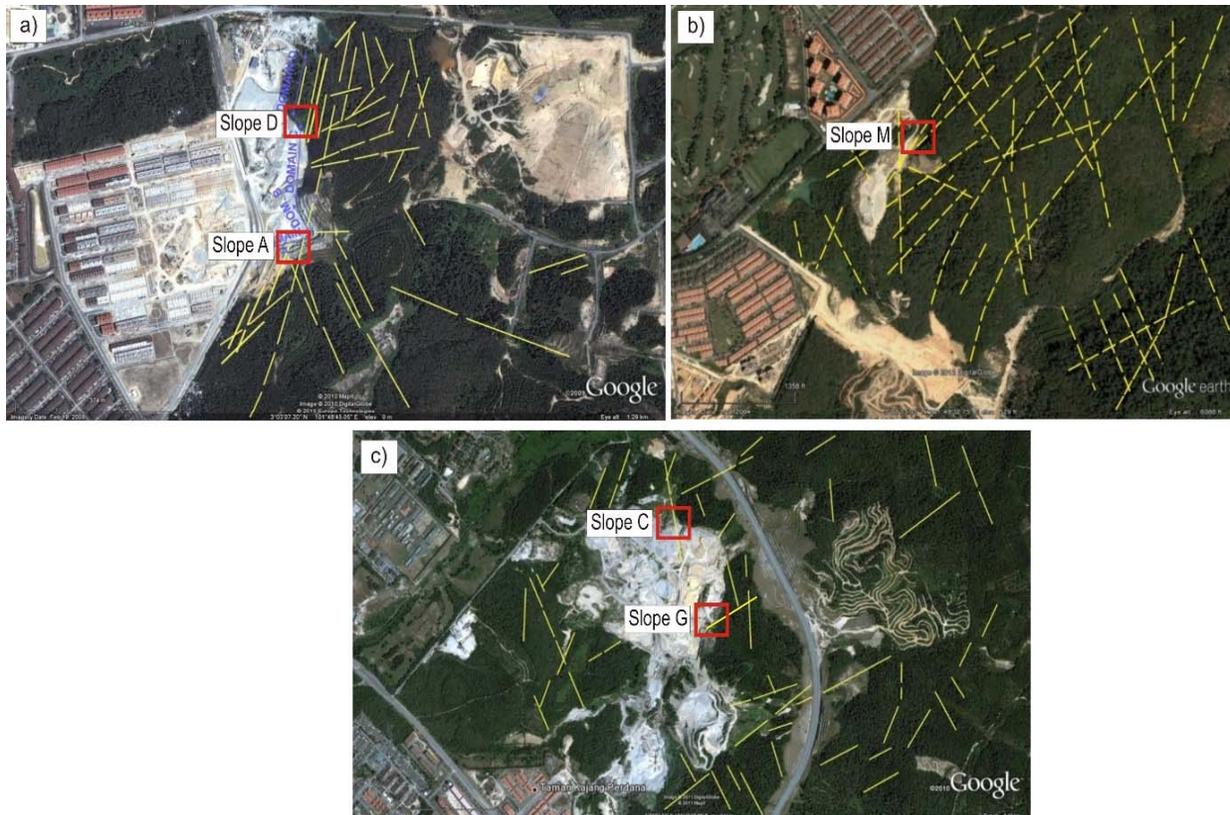
Figure-2. Location for scan line survey at three sites were conducted within the rectangular box areas; a) Palm walk, b) Mayang Kiara and c) Goodview heights

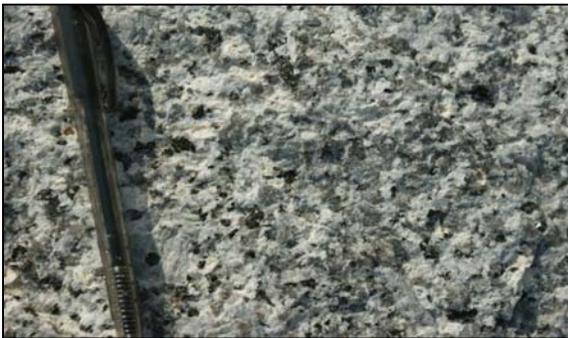
Figure-3. Close-up view of the fresh granite.
