GEOTECHNICAL INVESTIGATION OF CAVITY AND SETTLEMENT AT BESRAYA HIGHWAY, JALAN KUCHAI LAMA

Adnan D.¹, Noorasyikin M. N.², Ismacahyadi B.¹ and Samad A. R.¹

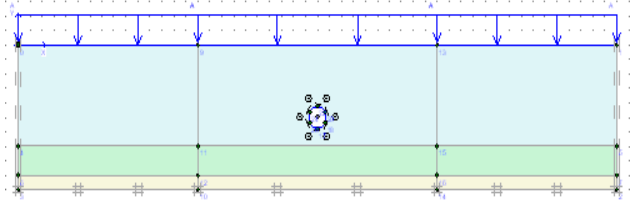
**Figure-8.** Pipe jacking procedure.

The existing road embankment was analyzed considering the traffic loads experience by the pavement during construction. At this stage, settlement during construction is also analyzed and the construction period is about one year as shown in Figure-8.

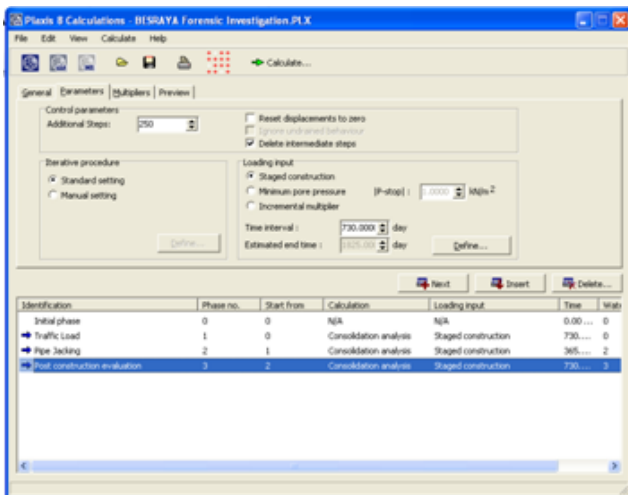
Figure-9. Construction stage.

This stage refers to the calculation of settlement about 2 years after completion of the construction. The duration taken as 2 years based on the age of the constructed structures before defects as shown in Figure-9.

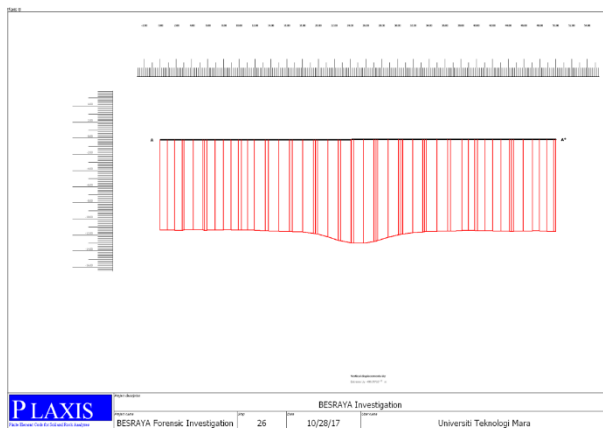
Figure-20. Settlement trough due to pipe jacking work.

Figure-19 provides the deformation of the ground due to pipe jacking work. It is observed that the settlement is 529 mm at the crest of the tunnel from the ground surface. The deformation pattern followed the expected settlement trough due to micro tunneling work executed underneath and existing road structure. Figure-20 shows the settlement trough which, provided discomfort to the traffic users. Figure-21 shows the development of excess pore water pressures during the pipe jacking work which triggered settlement at the crest of the tunnel. Hence, due to the dissipation of the excess pore water pressure, the

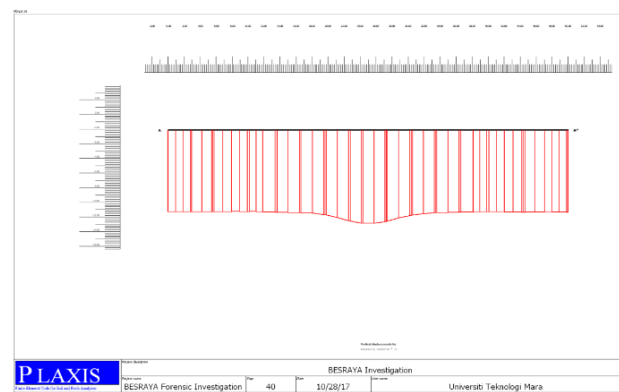
Figure-22. Settlement trough two (2) years post construction.

Figure-21 shows the deformation of the ground surface after two (2) years of construction. Due to continuous traffic load, the ground has settled about 531 mm at the crest of the tunnel from the ground surface. This deformation does not include settlement due to erosion within the soil layer due to the presence of the water pockets and seepage. Integrating ERI and JKR probe, the settlement of the ground becomes excessive as the excess pore pressure dissipated, washed away all of the fines in the sand layer, introducing cavity and voids underneath the pavement structure. There are evidences that showed the presence of cavities and voids due to inundation, seepage and dissipation. Figure-22 illustrates the settlement through two (2) years post construction causing riding discomfort to the traffic users. Hence, if remediation work is not proposed, there is a possibility that the cavities and voids would reappear and cause more problems.
