THERMOGRAPHY ANALYSIS ON WELDING DEFECTS AND INTERNAL EROSION OF CARBON STEEL PIPELINE

Maznan Ismon¹, Izzuddin Zaman^{1,2} and Ng Chee Seng¹

ABSTRACT

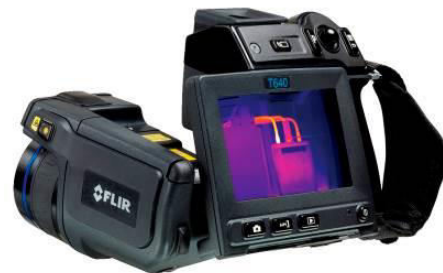
Figure-2. FLIR T640 camera.

In term of thermal imaging process, all experiments were conducted through FLIR T640 thermal imaging infrared camera. Operating temperature of the infrared camera was ranged from -40 °C to 2000 °C with thermal sensitivity less than 0.035 °C at 30 °C. In additional, the detecting wavelength of the infrared camera is 7.5 ~ 14μm. Periodic image storage processing time of the infrared camera was ranged from 14s to 24 hours per frame.

For erosion inspection, a series of different temperature energy sources were implemented. As a result, exposure of thermal gradient across the erosion defects under supplemental of different temperature energy sources were viewed and captured by FLIR T640 thermal imaging infrared camera as illustrated in Figure-2.

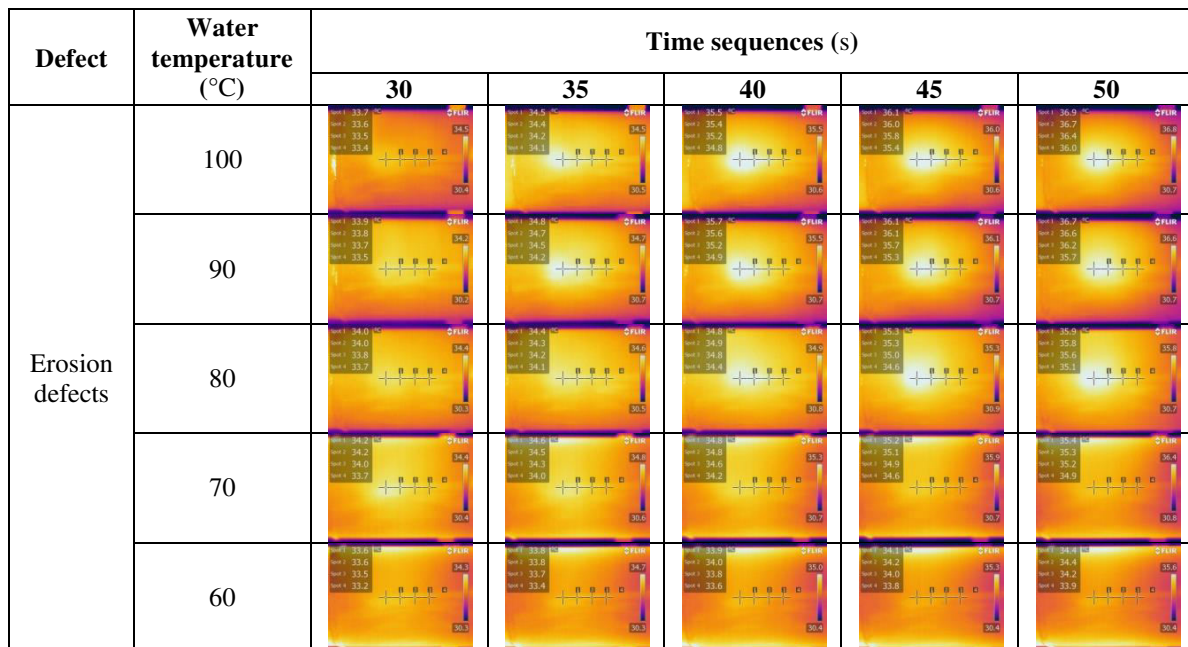
Figure-7. Surface temperature variation of erosion defects from t=30s to 50s.

From the obtained infrared thermal images, exposure of thermal gradient across the erosion defects under supplemental of different temperature energy sources began from $t=30s$ to $50s$ were constructed as shown in Figure 7. As we can see, significant reduction of thermal contrast between erosion defects and carbon steel pipe takes place when the level of implemented energy sourced is decreased constantly. From Figure-7, it is clear that the exposures of erosion defects from the obtained infrared thermal images under supplemental source of heat from $70^{\circ}C$ water or below are relatively low. Through application of FLIR Research IR software, post-processing thermal images of erosion defects under supplemental of heat from 5 different levels of energy sources was constructed as shown in Figure-8. As can be seen, exposure of thermal gradient across the erosion defects was significantly enhanced through filtering

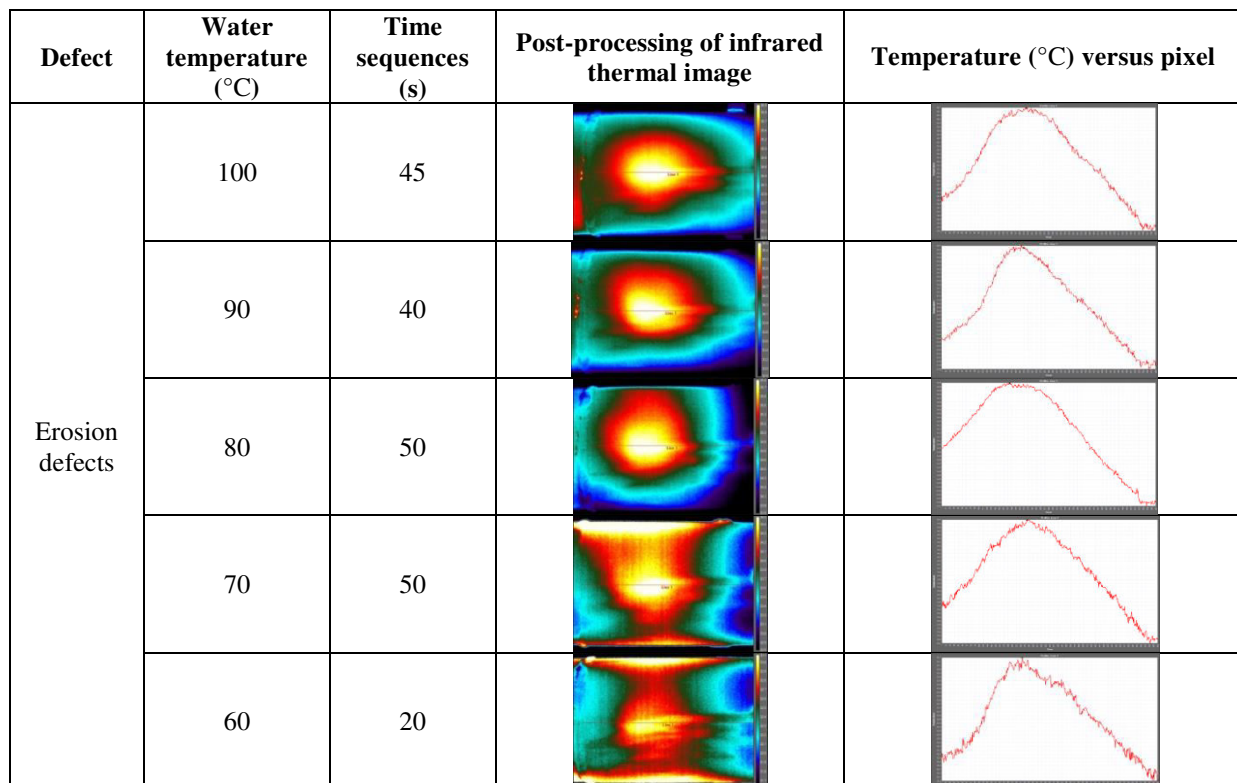
Figure-8. Comparison of post-processing infrared thermal images.

process. With application of line ROI (Region of Interest), graphs surface temperatures versus pixel were generated. As a result, variations of surface temperature across the erosion defects are similar even if the implemented energy sources are different. At this point, result verified that

significant decrement of surface temperature was present in the specimen when the depth of the depth of erosion defect was reduced constantly although exposure of erosion defects from the obtained infrared thermal images is nearly invisible for experiment under supplemental of
