A STUDY ON LEVEL OF RAILWAY ROAD DAMAGE WITH SUSTAINABLE PCI METHOD

Syaiful Syaiful and Lian Lasmana Department of Civil Engineering, Ibn Khaldun University Bogor, Indonesia E-Mail: syaiful@ft.uika-bogor.ac.id

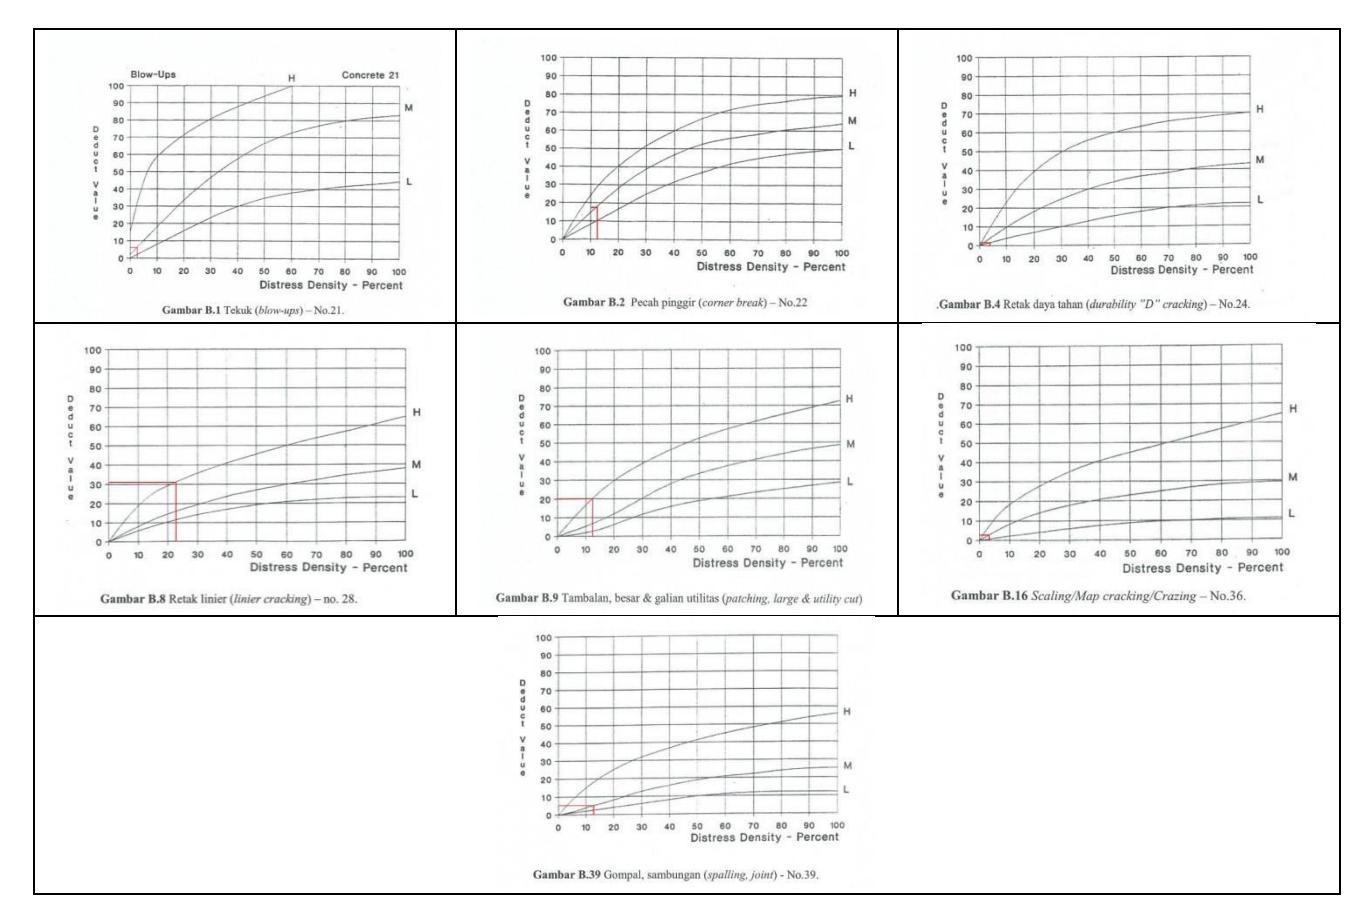
Figure-1. The graph of the deduct value used.

The basis of the calculation above table is Figure-1.

Determining the value of deduct value based on graph of density relationship with deduct value. Then the results presented in Table-3.

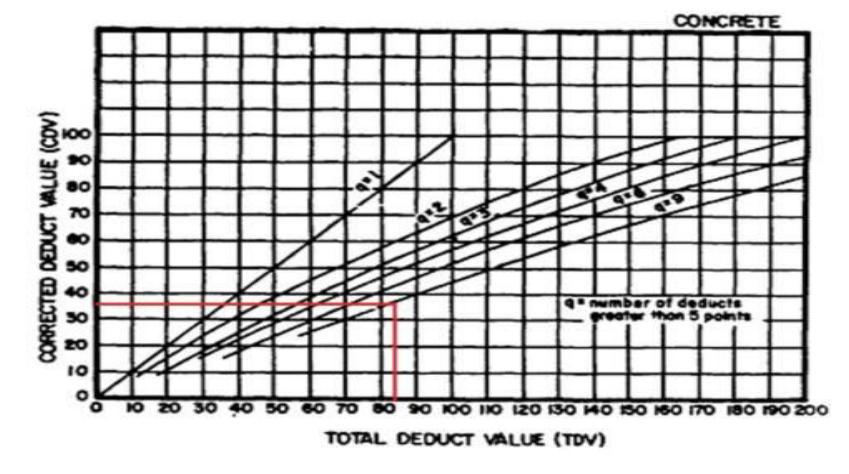
Figure-2. The graph of the deduct value used.

By obtaining the value of deduct value and summing to total deduct value (TDV) then we can find

corrected deduct value (CDV) value based on graph of TDV and CDV relationship.

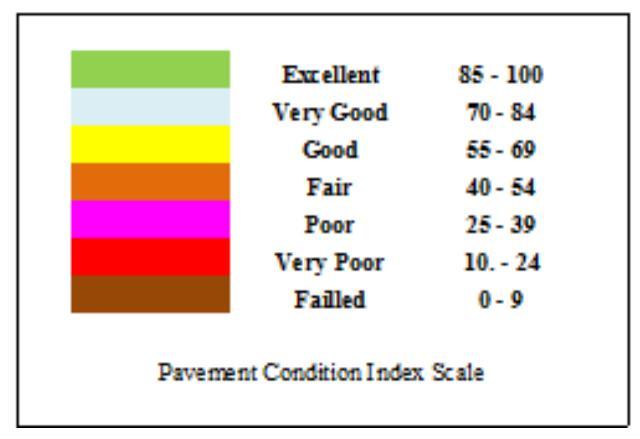
Figure-3. Qualification of PCI Value.

Figure 3 given below depicts the condition of the pavement condition index scale. There are 5 types namely, excellent, very good, good, fair, poor, very poor and failed.

PCI value for 30 sample plates on highway Mayjen H.E. Sukma Rd on STA 0 + 800 - STA 0 + 859.3 is 64, where the value is included in good category based on qualification of PCI value.
