INFLUENCE OF STEEL-CONCRETE INTERFACE AND PRE-EXISTING OXIDES LAYER ON PASSIVE REINFORCING STEEL CORROSION

A. Nasser^{1, 2}, A. Castel³ and I. Merimi^{4,5}

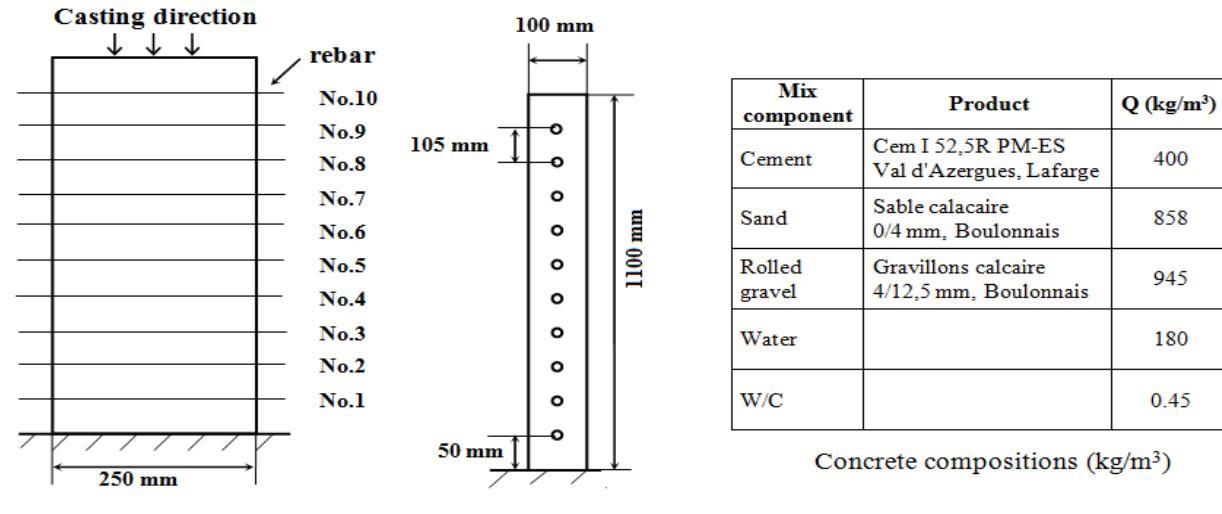
Using the concrete composition presented in Figure-1, high size concrete members were cast including horizontal the PVC-conventional ribbed reinforcing bars located at different levels in order to create the defaults at the steel-concrete interface. The steel-concrete interface defaults generated, using this method, are due to the wellknown "top-bar effect" [11], [12], leading to voids formation under the horizontal top bars regarding to the concrete casting direction. These steel bars were distributed with 105 mm spacing over the 1100 mm height of the concrete elements (Figure-1). The concrete compressive strength and elastic modulus measured after 28 days were 50 MPa and 37000 MPa respectively.

Figure-1. High size concrete elements, concrete composition, location of the steel bars and concrete casting direction.

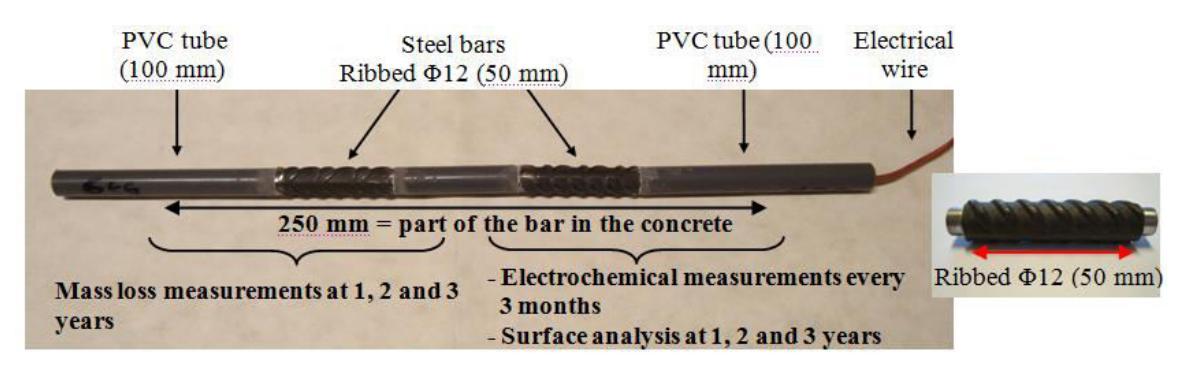
Each wall had ten reinforcing bars. Special methodology was developed to ensure that steel bars are fully embedded in the concrete. The embedded reinforcing bar was composed of two 12 mm diameter conventional ribbed steel bars, which were glued together by PVC tube as shown in Figure-2. As shown in the Figure-2, the steel bars were machined in order to ensure a sufficient strength at the connection with the PVC tubes during the concrete

casting. The steel bars were stored in the laboratory environment before to be cast in the concrete elements, then, they are affected by an initial atmospheric uniform corrosion. An electrical wire was connected with one of the ribbed steel bars to perform electrochemical measurement every three months, the second bar is used to perform destructive mass loss measurement after 1, 2 and 3 years.

Figure-2. PVC-steel rebar cast in the high concrete members.

Experimental method was developed in order to manufacture concrete specimens including steel-concrete interface default resulting from the top-bar effect. Moreover, PVC-steel bar was also developed in order to ensure that the whole steel part is inside the concrete specimens ensuring a passive state.

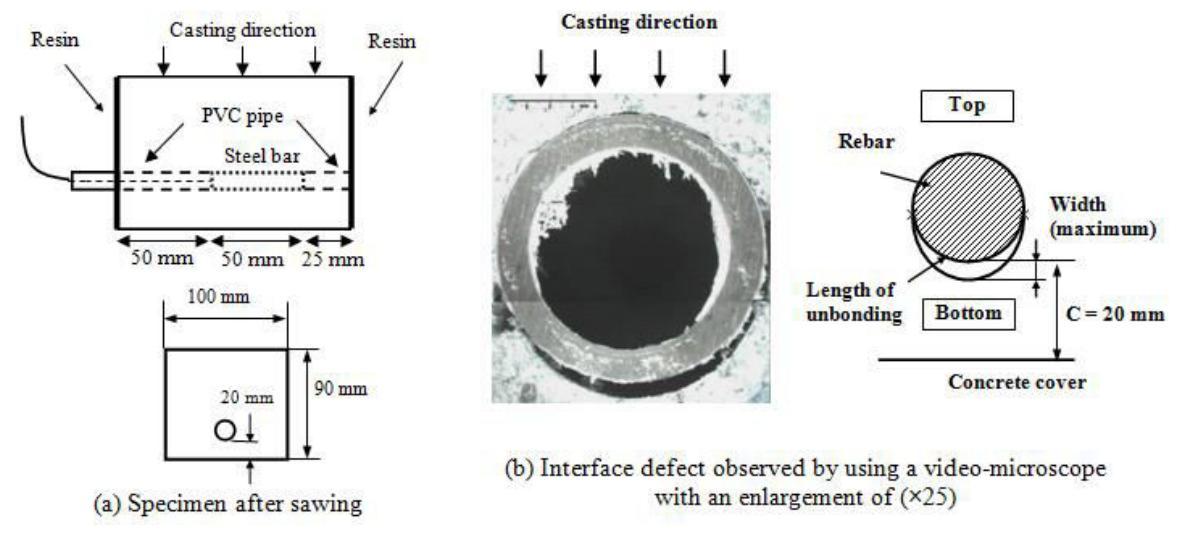
After 28 days of curing in the water (T = 20° C), the high concrete members were sawn to obtain, for each element, samples including only one steel bar. Ten horizontal sawing were performed always under the rebars in regard to concrete casting direction. One vertical sawing over the height of the high concrete elements was performed in the middle, thus through the PVC tubes. The small specimens obtained are 12,5x10x8 cm³ including only one reinforcing bar with 20 mm of concrete cover in the bottom interface side so on the side of the interfacial voids (Figure-3). The two end lateral surfaces were then coated by using a specific epoxy resin in order to prevent water and carbon dioxide penetration from these surfaces. This method ensures that the steel bars are totally embedded in the concrete and exposed to steel corrosion process in passive state.

Figure-3. Specimen after sawing and interface defect location regarding to the lower concrete cover.

Steel-concrete interface was analysed by using a video-microscope with an enlargement of 25 times. The interface quality can be characterised in terms of two parameters: the maximum width of void and the unbonding length (Figure-3(b)).

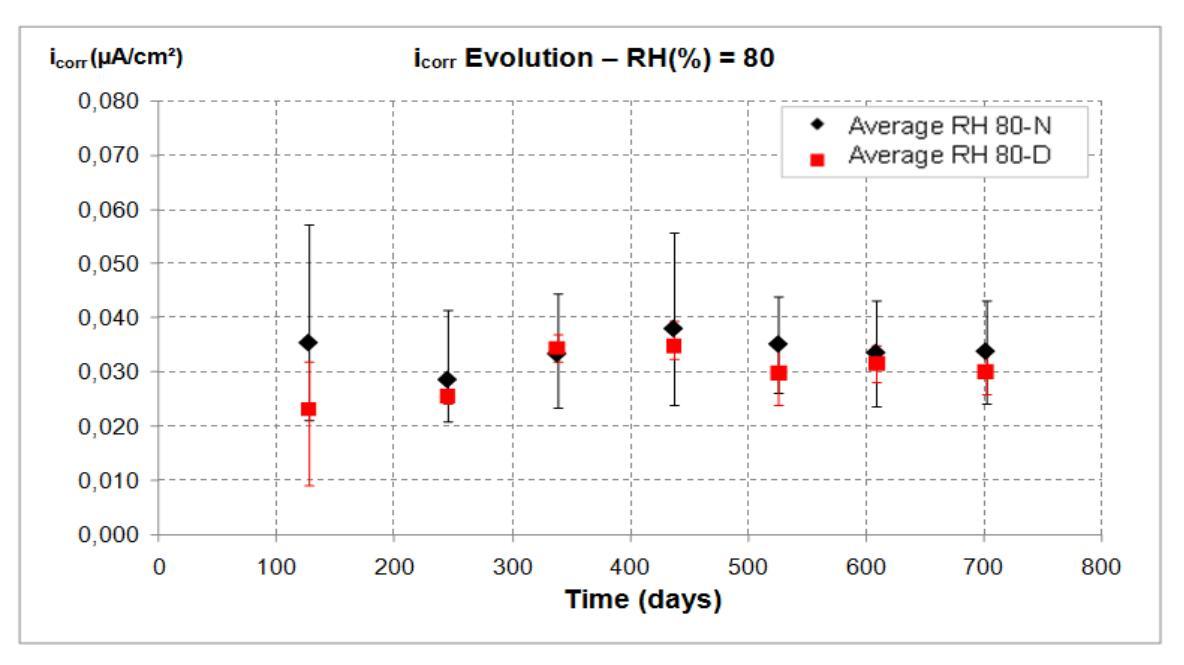
Figures 5 and 6 show the corrosion current densities evaluated on specimens stored in a ventilated

Figure-5. Corrosion current evolution – RH(%) 80.

The evolution of corrosion current densities evaluated during these first two years of conservation remains low, of the order of 0.023 ± 0.009 to $0.047 \pm 0.020 \,\mu$ A/cm. The values of the corrosion current densities correspond to corrosion of the steel in the passive state.

For these maturities and given the dispersions observed in the results, it is not possible to show an influence of the quality of the steel-concrete interface on corrosion in the passive state. Corrosion current densities of flawless samples appear to increase very slightly at 95% relative humidity. Indeed, after 2 years of storage the corrosion current density varies from 0.034 ± 0.010 to $0.047 \pm 0.017 \,\mu$ A/cm² between HR(%) 80 and HR(%) 95 for samples without interface defects. In the case of samples with interface defects the corrosion current density varies from 0.034 ± 0.009

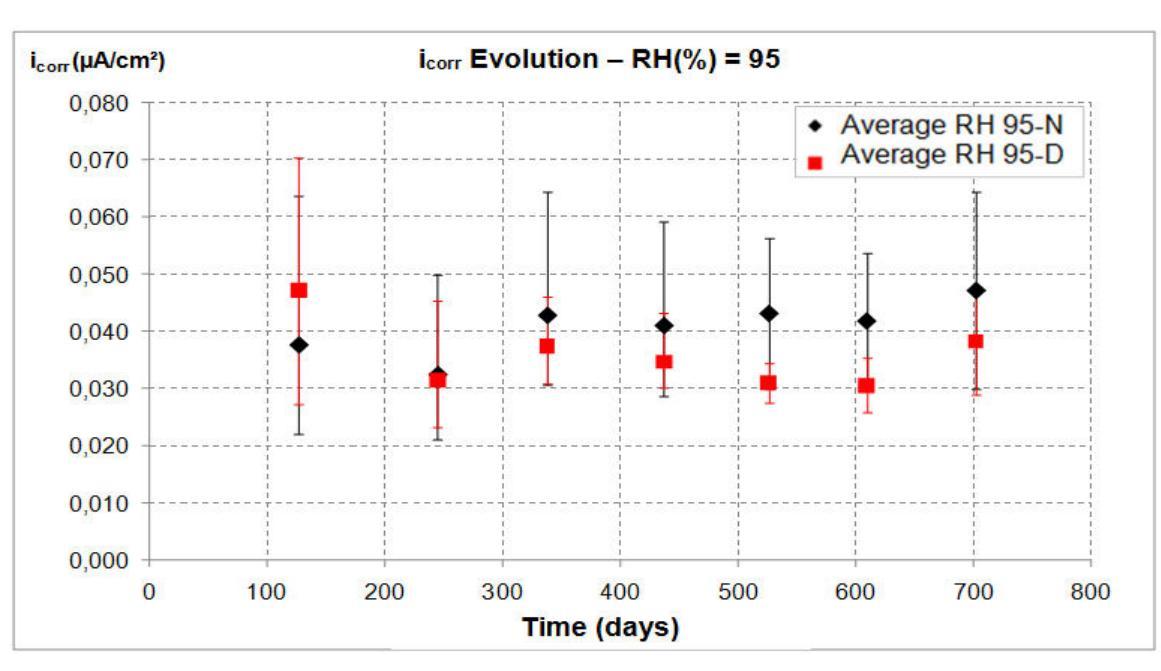
Figure-6. Corrosion current evolution – RH(%) 95.

μ A/cm² between HR(%) 80 and HR(%) 95.These values remain very insignificant given the dispersions observed.

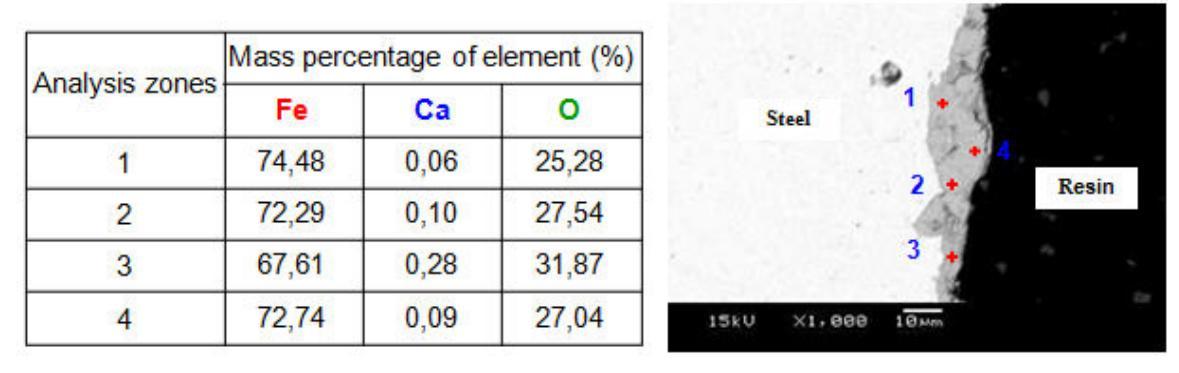
EDS analyses show that this initial layer is composed mainly of iron and oxygen, with an Fe/O ratio close to 3. (Figure-8).

Figure-8. EDS analysis of the pre-existing oxide layer before casting.

The results of SEM observations of the surface of the reinforcement in cross-section after one year of storage, in an aerated milieu at controlled RH (%). show the formation of a new oxide layer on both sides of the metal-oxide layer interface. The elemental initial characterization (EDS) shows that iron and oxygen, present in the initial oxide layer before casting, and calcium with a mass percentage ranging from 5 to 17% are present. This layer of oxides new-formed after one year of conservation was observed on all the samples analysed (stored in a aired milieu at controlled HR(%)).In the majority of cases, In most cases, this layer contains less iron, more oxygen compared to the initial oxide layer characterized before casting (Figures 5 and 6) and especially much more calcium. In the images issued from the SEM observations, these new formed oxide layers, which systematically contain calcium, differs from the initial oxide layer by its dark grey tint (presence of an element which is lighter than iron calcium.

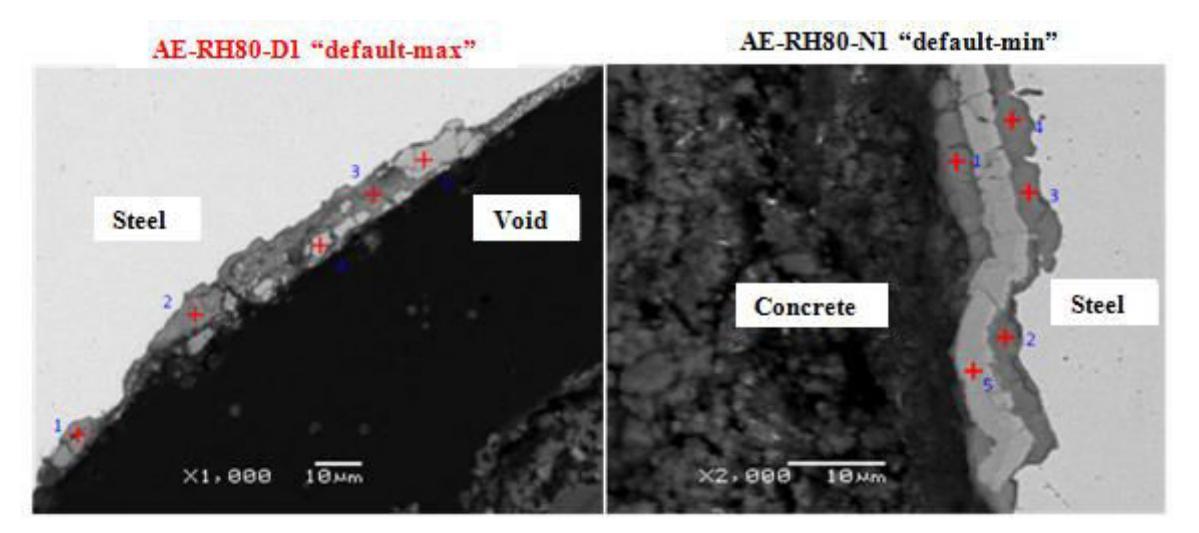
After one year's storage in an aerated environment with controlled relative humidity, the SEM-EDS observations on the samples stored under these storage conditions were carried out. For each storage condition, one specimen with a "max defect" (D1) and one specimen with a "min defect" (N1) were analysed. Figures 9 and 10 show examples of analysis areas on samples stored for one year in a ventilated environment at controlled relative humidity (HR(%) 80 and HR(%) 95).

Figure-9. EDS analysis areas after 1 year - aerated environment at RH(%) 80.

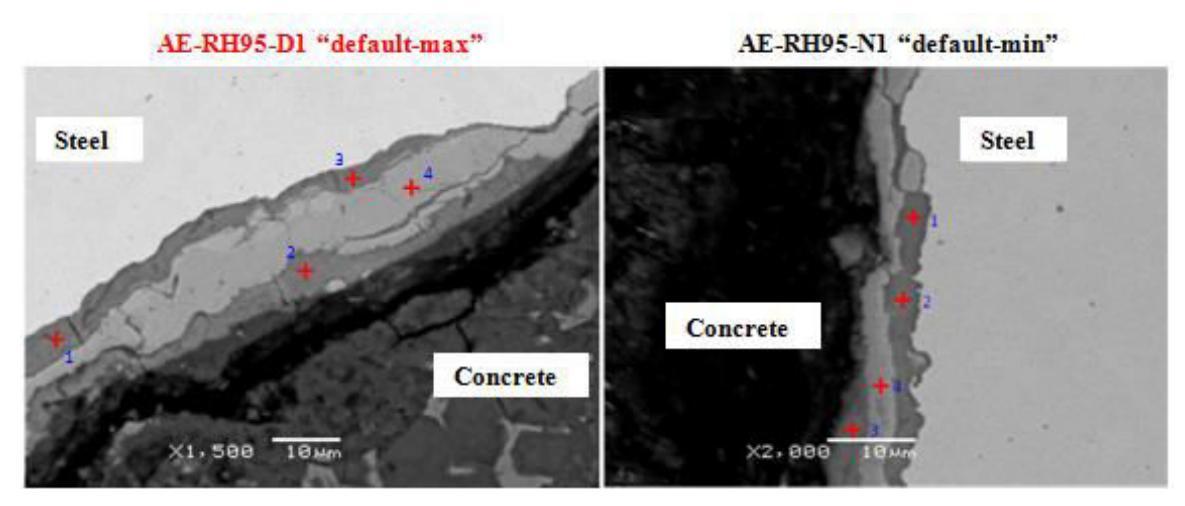
Figure-10. EDS analysis areas after 1 year - aerated environment at RH(%) 95.
